# FACILITY CONDITION ASSESSMENT

**Montgomery County Public Schools**  
45 West Gude Drive, Suite 4000  
Rockville, MD 20850

Somerset Elementary School  
5811 Warwick Place  
Chevy Chase, MD 20815

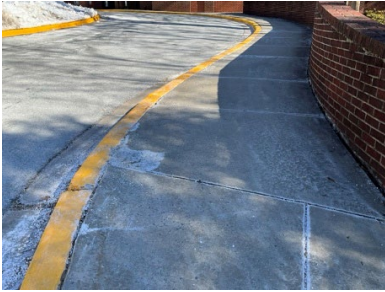
#### Sidewalk in Poor Condition.

Concrete, Large Areas  
Site Somerset Elementary School Site

Need pavement for throughout the sidewalks for their better lifespan. - AssetCALC ID: 10320623

Uniformat Code: G2030  
Recommendation: **Replace in 2026**

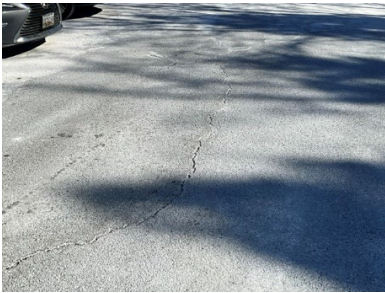
#### Parking Lots in Poor Condition.

Pavement, Asphalt  
Site Somerset Elementary School Site

Asphalt pavement exhibits cracks, surface deterioration, and localized depressions. - AssetCALC ID: 10320626

Uniformat Code: G2020  
Recommendation: **Cut & Patch in 2026**

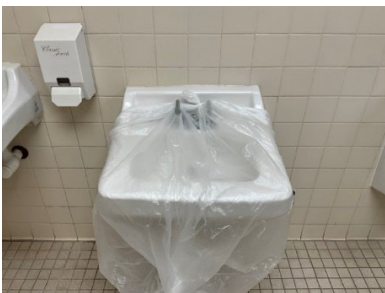
#### Sink/Lavatory in Failed Condition.

Service Sink, Wall-Hung  
Somerset Elementary School Somerset  
Elementary School Lower level boys Restroom

A wall-hung sink in the boys' restroom located on the lower level was observed to be broken. The fixture is damaged and not fully functional and should be repaired or replaced. - AssetCALC ID: 10320161

Uniformat Code: D2010  
Recommendation: **Replace in 2026**

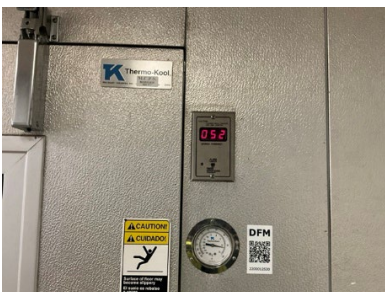
#### Foodservice Equipment in Failed Condition.

Walk-In, Freezer  
Somerset Elementary School Somerset  
Elementary School Kitchen

Freezer is in poor condition; it does not cool properly and the temperature is reportedly high all the time. - AssetCALC ID: 10320224

Uniformat Code: E1030  
Recommendation: **Replace in 2026**
