FACILITY CONDITION ASSESSMENT

Montgomery County Public Schools

Stone Mill Elementary School
14323 Stonebridge View Drive
North Potomac, MD 20878

February 26, 2026

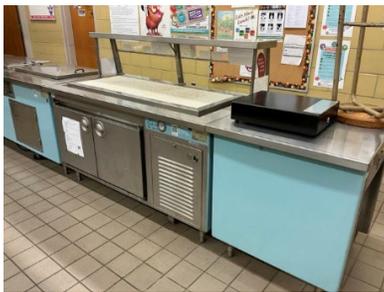
Foodservice Equipment in Poor condition.

Food Warmer, Tabletop Drawers (Set of 4)
Main Building Stone Mill Elementary School
Commercial Kitchen

Not in service. - AssetCALC ID: 10066751

Uniformat Code: E1030
Recommendation: **Replace in 2026**

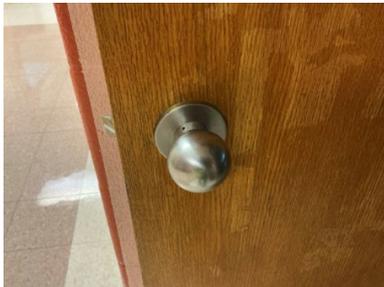
ADA Entrances and Doors

Hardware, Lever Handle
Main Building Stone Mill Elementary School
Classrooms, etc.

Entrance hardware not compliant - AssetCALC ID: 10233799

Uniformat Code: Y1030
Recommendation: **Install in 2025**

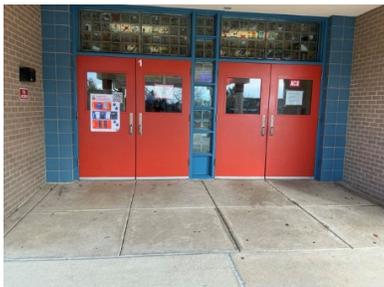
ADA Paths of Travel

Signage, Directional Wall-Mounted
Main Building Stone Mill Elementary School
Building Entrances

No signage for alternate entrance - AssetCALC ID: 10233815

Uniformat Code: Y1020
Recommendation: **Install in 2025**

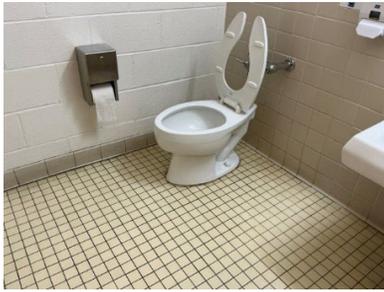
ADA Restrooms

Restroom Layout, Full Reconfiguration
Main Building Stone Mill Elementary School
Public Restrooms

Restroom reconfiguration and compliance - AssetCALC ID: 10233930

Uniformat Code: Y1050
Recommendation: **Renovate in 2025**

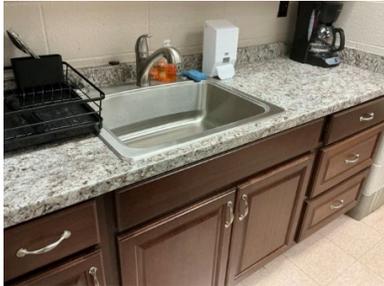
ADA Kitchen and Laundry Areas

Cabinetry, Height/Location/Clearance
Main Building Stone Mill Elementary School
Teacher Lounge

Sink not accessible - AssetCALC ID: 10233928

Uniformat Code: Y1060
Recommendation: **Modify in 2025**

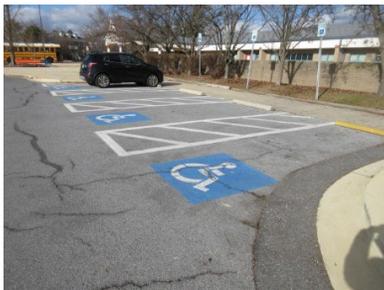
ADA Parking

Signage, Pole-Mounted
Site Stone Mill Elementary School Parking Lot

Uniformat Code: Y1010
Recommendation: **Install in 2025**

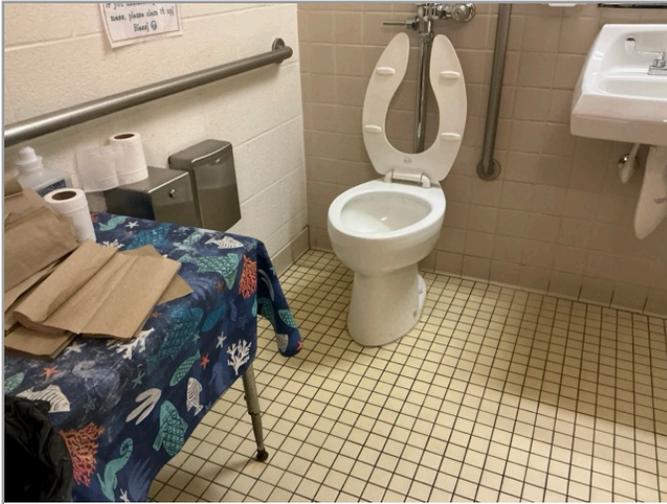
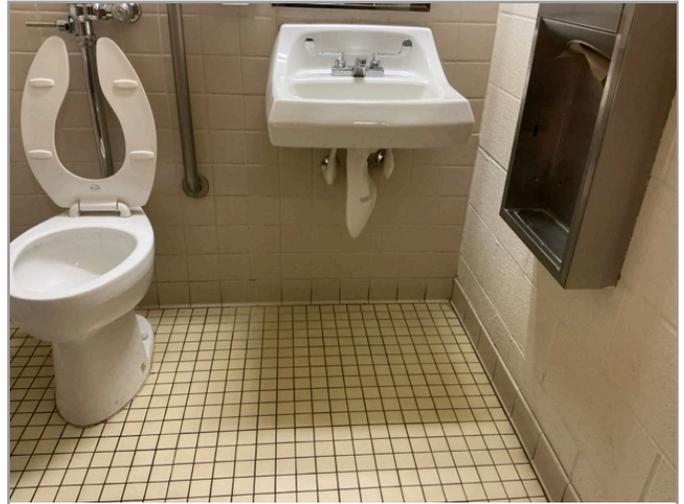
Question		Yes	No	NA	Comments
1	Do publicly accessible toilet rooms appear to have a minimum compliant floor area ?		✗		Staff lavatories may not accommodate a 60 inch diameter. Clearance at front of WC is 52 inches.
2	Does the lavatory appear to be mounted at a compliant height and with compliant knee area ?	✗			
3	Does the lavatory faucet have compliant handles ?	✗			
4	Is the plumbing piping under lavatories configured to protect against contact ?	✗			
5	Are grab bars provided at compliant locations around the toilet ?	✗			
6	Do toilet stall doors appear to provide the minimum compliant clear width ?	✗
