FACILITY CONDITION ASSESSMENT

Montgomery County Public Schools
45 West Gude Drive, Suite 4000
Rockville, MD 20850

Strawberry Knoll Elementary School
18820 Strawberry Knoll Road
Gaithersburg, MD 20879

August 15, 2025

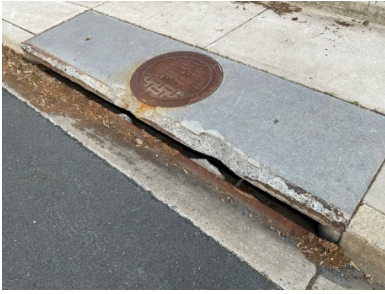
Storm Drainage Components in Poor Condition.

Catch Basin, 6' Deep
Site Strawberry Knoll Elementary School Site
Parking Areas

Catch basin inlet cover rust damaged and chipped - AssetCALC ID: 9283331

Uniformat Code: G3030
Recommendation: **Replace in 2026**

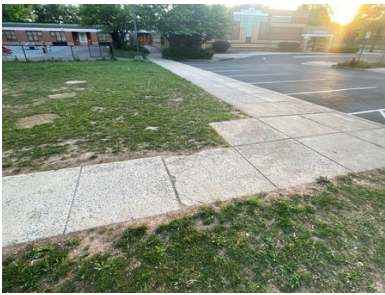
Sidewalk in Poor Condition.

Any pavement type, Sectional Repairs per
Man-Day
Site Strawberry Knoll Elementary School Site
Parking Areas

Cracked concrete - AssetCALC ID: 9283336

Uniformat Code: G2030
Recommendation: **Repair in 2025**

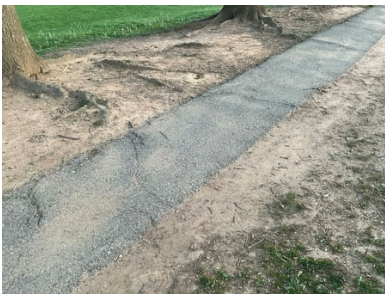
Sidewalk in Poor Condition.

Asphalt
Site Strawberry Knoll Elementary School Site

Poor surface - AssetCALC ID: 9283335

Uniformat Code: G2030
Recommendation: **Replace in 2027**

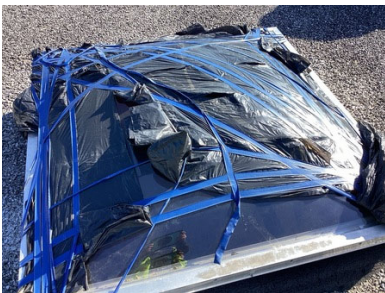
Roof Skylight in Poor Condition.

per unit, up to 20 SF
Main Building Strawberry Knoll Elementary
School Roof

Damaged surface - AssetCALC ID: 9292986

Uniformat Code: B3060
Recommendation: **Replace in 2025**

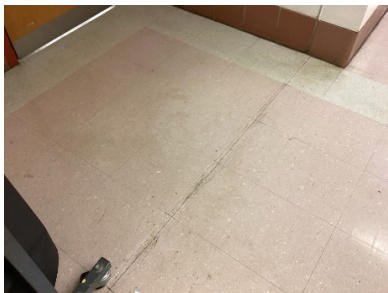
Flooring in Poor Condition.

Vinyl Tile (VCT)
Main Building Strawberry Knoll Elementary
School Throughout Building

Cracked tiles in scattered locations - AssetCALC ID: 9293053

Uniformat Code: C2030
Recommendation: **Replace in 2027**
