# FACILITY CONDITION ASSESSMENT

Summit Hall Elementary School  
101 West Deer Park Road,  
Gaithersburg, MD 20877

172559.25R000-118.354

May 4, 2026

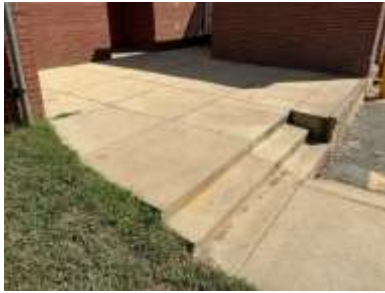
### Loading Dock in Poor condition.

Concrete  
Summit Hall Elementary School Building  
Exterior

Spalling and several large cracks throughout - AssetCALC ID: 9863346

Uniformat Code: B1010  
Recommendation: **Replace in 2027**

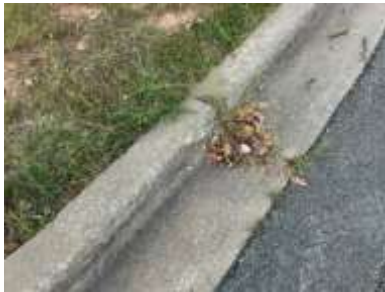
### Parking Lots in Poor condition.

Curb and Gutter, Concrete  
Site Summit Hall Elementary School Site  
Parking Areas

Curbs broken and cracked - AssetCALC ID: 9863172

Uniformat Code: G2020  
Recommendation: **Replace in 2026**

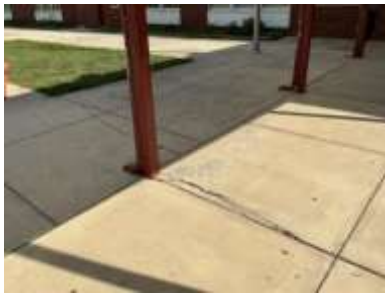
### Parking Lots in Poor condition.

Pavement, Concrete  
Site Summit Hall Elementary School Building  
Entry

Large cracks and heaving - AssetCALC ID: 9863176

Uniformat Code: G2020  
Recommendation: **Replace in 2026**

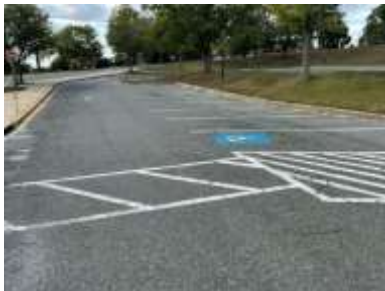
### Parking Lots in Poor condition.

Pavement, Asphalt  
Site Summit Hall Elementary School Front  
Parking Lot

Potholes, alligator cracks and large cracks - AssetCALC ID: 9863205

Uniformat Code: G2020  
Recommendation: **Seal and Stripe in 2026**

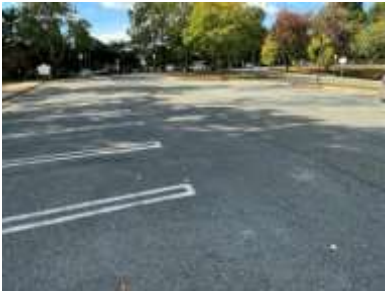
**Parking Lots in Poor condition.**

Pavement, Asphalt  
Site Summit Hall Elementary School Right  
Parking Lot

Alligator and large cracks - AssetCALC ID: 9863174

Uniformat Code: G2020  
Recommendation: **Seal and Stripe in 2026**

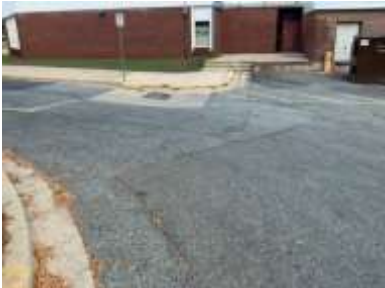
**Parking Lots in Poor condition.**

Pavement, Asphalt  
Site Summit Hall Elementary School Right  
Parking Lot

Alligator and large cracks - AssetCALC ID: 9863171

Uniformat Code: G2020  
Recommendation: **Mill and Overlay in 2026**

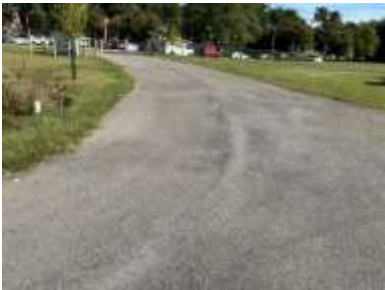
**Parking Lots in Poor condition.**

Pavement, Asphalt  
Site Summit Hall Elementary School  
Classroom Buildings A and B

Large long cracks - AssetCALC ID: 9863188

Uniformat Code: G2020  
Recommendation: **Mill and Overlay in 2026**

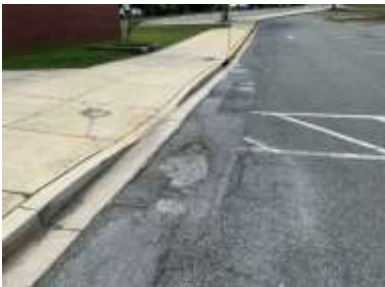
**Parking Lots in Poor condition.**

Pavement, Asphalt  
Site Summit Hall Elementary School Front  
Parking Lot

Potholes, alligator cracks and large cracks - AssetCALC ID: 9863177

Uniformat Code: G2020  
Recommendation: **Mill and Overlay in 2026**

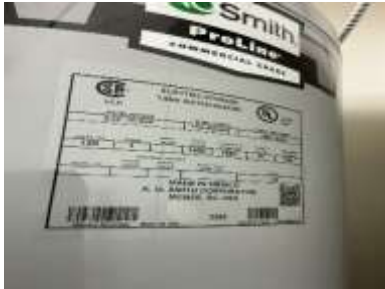
**Water Heater in Poor condition.**

Electric, Residential, 5 to 15 GAL  
Modular Classrooms A Summit Hall  
Elementary School Building A Custodial Closet

Unit rusting at bottom - AssetCALC ID: 9863144

Uniformat Code: D2010  
Recommendation: **Replace in 2026**

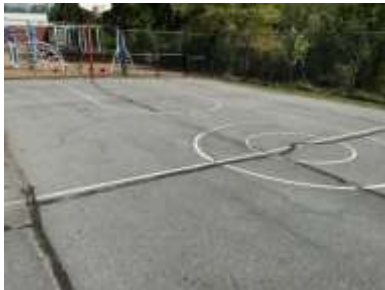
**Athletic Surfaces and Courts in Poor condition.**

Basketball/General, Asphalt Pavement  
Site Summit Hall Elementary School Rear Play  
Area

Large cracks throughout - AssetCALC ID: 9863194

Uniformat Code: G2050  
Recommendation: **Seal and Stripe in 2026**

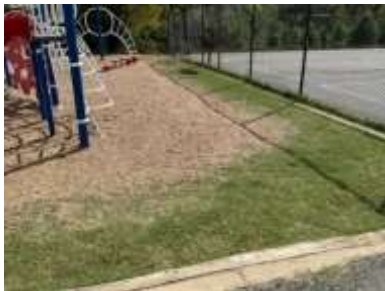
**Playground Surfaces in Poor condition.**

Chips Wood, 6" Depth  
Site Summit Hall Elementary School Rear Play  
Area

Weeds growing in surface - AssetCALC ID: 9863198

Uniformat Code: G2050  
Recommendation: **Replace in 2026**

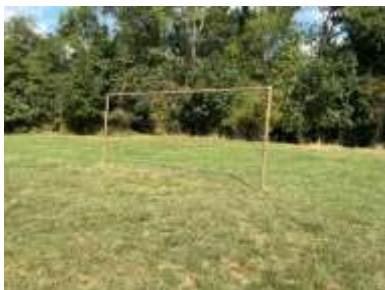
**Sports Apparatus in Poor condition.**

Soccer, Regulation Goal  
Site Summit Hall Elementary School Site  
Sports Field

Rusted and bent. - AssetCALC ID: 9863197

Uniformat Code: G2050  
Recommendation: **Replace in 2026**

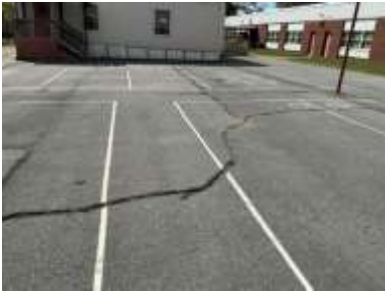
### Athletic Surfaces and Courts in Poor condition.

Basketball/General, Asphalt Pavement  
Site Summit Hall Elementary School Rear Play Area

Large cracks and pavement heaving throughout - AssetCALC ID: 9863202

Uniformat Code: G2050  
Recommendation: **Replace in 2026**

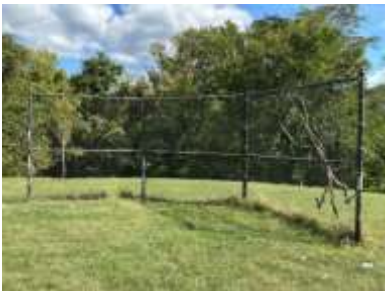
### Sports Apparatus in Poor condition.

Baseball, Backstop Chain-Link  
Site Summit Hall Elementary School Site Sports Field

Large weeds growing through chain link. Rusting. - AssetCALC ID: 9863212

Uniformat Code: G2050  
Recommendation: **Replace in 2026**

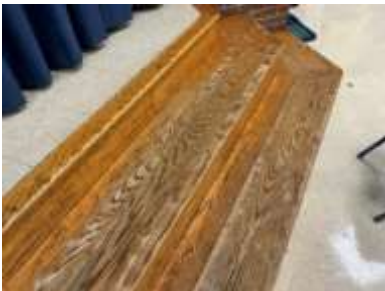
### Flooring in Poor condition.

Wood, Strip  
Summit Hall Elementary School Cafeteria Stage

Steps creak and very weathered - AssetCALC ID: 9863336

Uniformat Code: C2030  
Recommendation: **Replace in 2026**

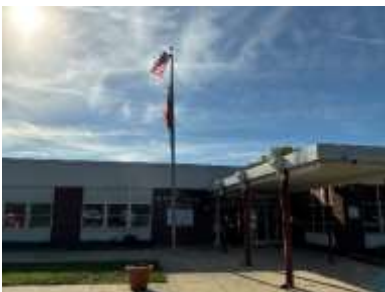
### Flagpole in Poor condition.

Metal  
Site Summit Hall Elementary School Building Entry

Flagpole Leaning - AssetCALC ID: 9863180

Uniformat Code: G2060  
Recommendation: **Replace in 2026**

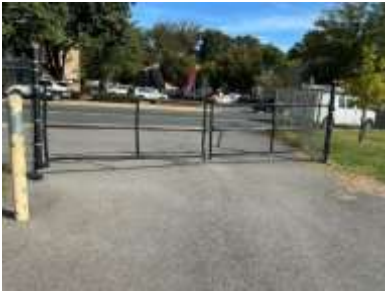
**Fences and Gates in Poor condition.**Priority Score: **81.8**

Vehicle Gate, Chain Link Manual  
Site Summit Hall Elementary School Site Front

Gates bent - AssetCALC ID: 9863226

Uniformat Code: G2060  
Recommendation: **Replace in 2026**

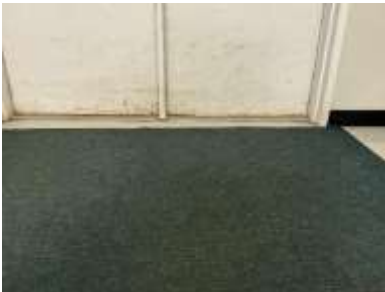
**Exterior Door in Poor condition.**Priority Score: **81.8**

Steel, Standard  
Modular Classrooms B Summit Hall  
Elementary School Classroom Building B

Large gap below doors and damaged weatherstripping - AssetCALC ID: 9863125

Uniformat Code: B2050  
Recommendation: **Replace in 2026**

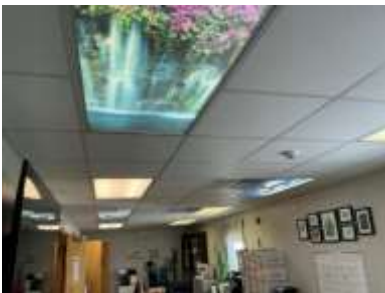
**Interior Lighting System in Poor condition.**Priority Score: **81.8**

Full Upgrade, Low Density and Standard  
Fixtures  
Modular Judy Center Summit Hall Elementary  
School Judy Center Modular

Users report insufficient light throughout - AssetCALC ID: 9863185

Uniformat Code: D5040  
Recommendation: **Replace in 2026**

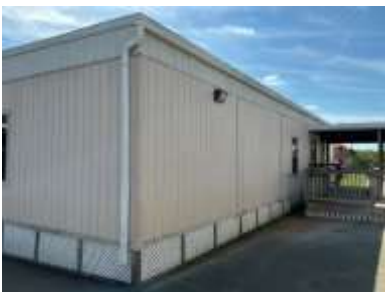
**Roof Appurtenances in Poor condition.**Priority Score: **81.8**

Gutters and Downspouts, Aluminum with  
Fittings  
Modular Judy Center Summit Hall Elementary  
School Judy Center Roof

Gutters bent and downspouts discharge onto playground - AssetCALC ID: 9875199

Uniformat Code: B3020  
Recommendation: **Replace in 2026**

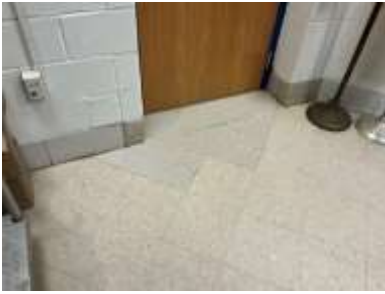
**Flooring in Poor condition.**

Vinyl Tile (VCT)  
Summit Hall Elementary School Cafeteria  
Stage

VCT broken at edges and buckling in areas - AssetCALC ID: 9863256

Uniformat Code: C2030  
Recommendation: **Replace in 2026**

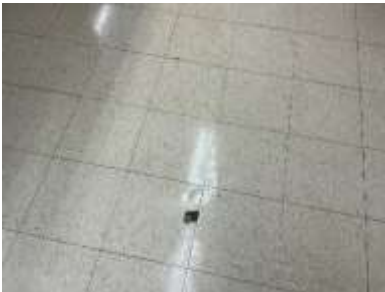
**Flooring in Poor condition.**

Vinyl Tile (VCT)  
Summit Hall Elementary School Kitchen

Tile broken, buckling and stained - AssetCALC ID: 9863292

Uniformat Code: C2030  
Recommendation: **Replace in 2026**

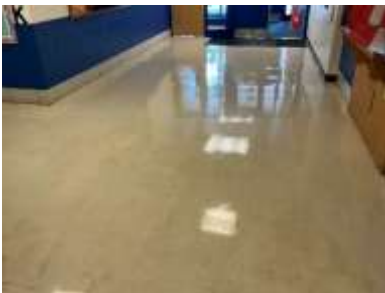
**Flooring in Poor condition.**

Vinyl Tile (VCT)  
Summit Hall Elementary School Throughout  
Building

VCT buckled, cracked and stained throughout - AssetCALC ID: 9863345

Uniformat Code: C2030  
Recommendation: **Replace in 2026**

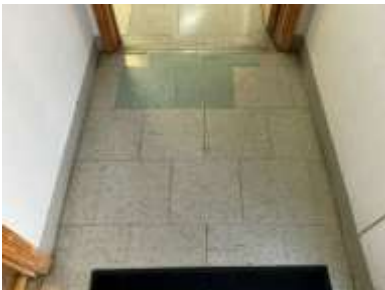
**Flooring in Poor condition.**

Vinyl Tile (VCT)  
Modular Judy Center Summit Hall Elementary  
School Judy Center Modular

Stained and buckling VCT - AssetCALC ID: 9863200

Uniformat Code: C2030  
Recommendation: **Replace in 2026**

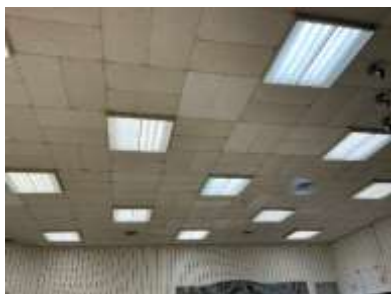
**Suspended Ceilings in Poor condition.**Priority Score: **81.7**

Acoustical Tile (ACT)  
Summit Hall Elementary School Throughout  
Building

Uniformat Code: C1070  
Recommendation: **Replace in 2027**
