# FACILITY CONDITION ASSESSMENT

**Montgomery County Public Schools**  
45 West Gude Drive, Suite 4000  
Rockville, MD 20850

Takoma Park Elementary School  
7511 Holly Avenue  
Takoma Park, MD 20912

May 4, 2026

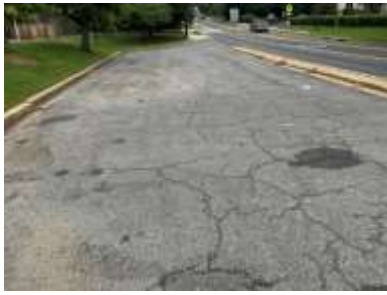
### Parking Lots in Poor condition.

Pavement, Asphalt  
Site Takoma Park Middle School Athletic Field  
Parking

Widespread alligator cracking - AssetCALC ID: 9705990

Uniformat Code: G2020  
Recommendation: **Mill & Overlay in 2026**

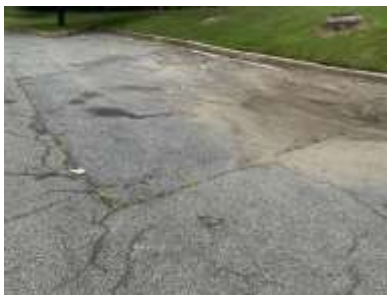
### Parking Lots in Poor condition.

Pavement, Asphalt  
Site Takoma Park Middle School Site - Athletic  
Field Parking

Widespread alligator cracking - AssetCALC ID: 9705875

Uniformat Code: G2020  
Recommendation: **Cut & Patch in 2026**

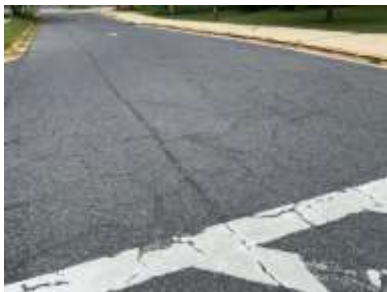
### Parking Lots in Poor condition.

Pavement, Asphalt  
Site Takoma Park Middle School Site - Main  
Parking Lot

Widespread alligator cracking observed - AssetCALC ID: 9705800

Uniformat Code: G2020  
Recommendation: **Cut & Patch in 2026**

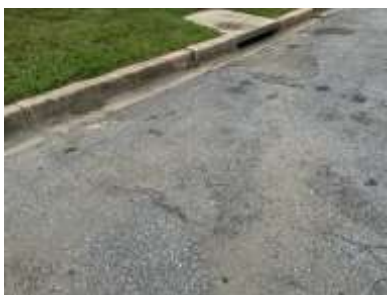
### Parking Lots in Poor condition.

Pavement, Asphalt  
Site Takoma Park Middle School Site - Athletic  
Field Parking

Striping has been worn away - AssetCALC ID: 9705716

Uniformat Code: G2020  
Recommendation: **Seal & Stripe in 2026**

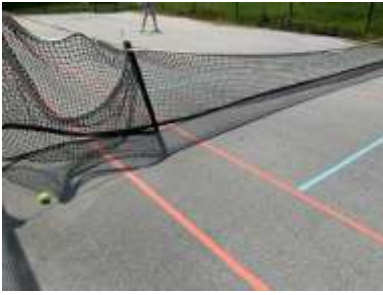
### Sports Apparatus in Poor condition.

Tennis/Volleyball, Net w/ Posts & Anchors  
Site Takoma Park Middle School Site Sports  
Fields & Courts

Damaged net - AssetCALC ID: 9705759

Uniformat Code: G2050  
Recommendation: **Replace in 2027**

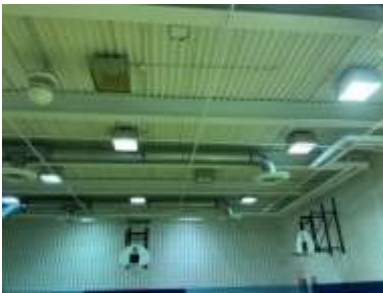
### High Intensity Discharge (HID) Fixtures in Poor condition.

Metal Halide, Gymnasium Lighting, 400 W  
Main Building Takoma Park Elementary School  
Gymnasium

Gymnasium lighting was observed to be inadequate. Replacement is anticipated in the short term. -  
AssetCALC ID: 10150299

Uniformat Code: D5040  
Recommendation: **Replace in 2026**

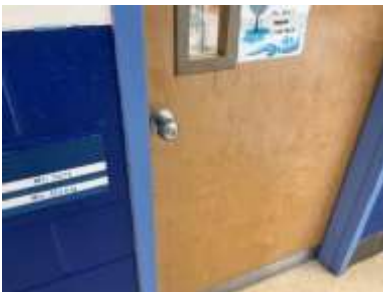
### ADA Entrances & Doors

Hardware, Lever Handle  
Main Building Takoma Park Elementary School  
Throughout

Several doors throughout the campus were observed to have non-ADA compliant hardware. Replacement is anticipated in the short term. - AssetCALC ID: 10150257

Uniformat Code: Y1030  
Recommendation: **Install in 2025**

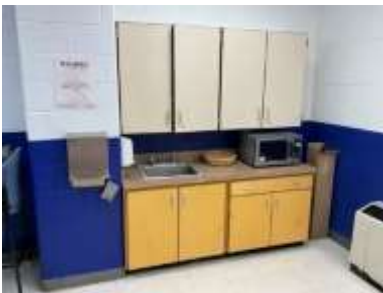
### ADA Kitchen & Laundry Areas

Sink/Counter/Maneuverability, Full  
Reconfiguration  
Main Building Takoma Park Elementary School  
Staff Lounge

Kitchenette located in the staff lounge requires renovation for ADA compliance. - AssetCALC ID: 10150330

Uniformat Code: Y1060  
Recommendation: **Renovate in 2025**

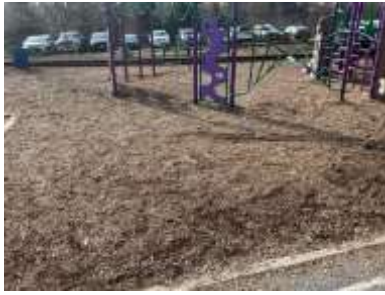
## Playground Surfaces

Rubber, Poured-in-Place  
Site Takoma Park Elementary School Site

The play surface is currently wood chips, requiring frequent maintenance and creating an uneven surface that can be challenging to maneuver. Replacement with rubberized surfacing is recommended and included in the five-year plan. - AssetCALC ID: 10150347

Unifomat Code: G2050  
Recommendation: **Replace in 2028**
