# FACILITY CONDITION ASSESSMENT

**Montgomery County Public Schools**  
45 West Gude Drive, Suite 4000  
Rockville, MD 20850

Travilah Elementary School  
13801 DuFief Mill Road  
North Potomac, MD 20878

*May 4, 2026*

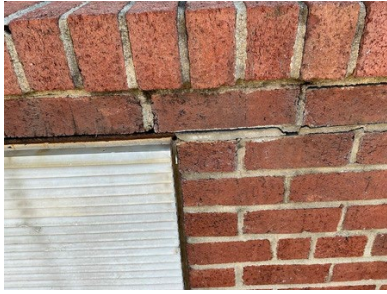
### Exterior Walls in Poor Condition.

Brick  
Main Building Travilah Elementary School  
Building Exterior

Mortar joints deterioration - AssetCALC ID: 10061195

Uniformat Code: B2010  
Recommendation: **Repair in 2026**

| UF L3 Code | Location | Condition | Component/Attributes/Capacity | Quantity | RUL | ID |
|---|---|---|---|---|---|---|
| B2010 | Building Exterior | Poor | Exterior Walls, Brick, Repair | 100 SF | 0 | 10061195 |

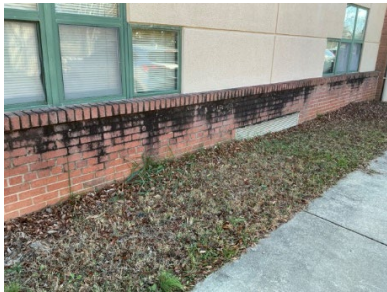
### Exterior Walls in Poor Condition.

Brick/Masonry/Stone, Clean & Seal  
Main Building Travilah Elementary School  
Building Exterior

Brick walls are stained and some general pointing of open mortar joints is needed. - AssetCALC ID: 10061344

Uniformat Code: B2010  
Recommendation: **Repair in 2026**

| UF L3 Code | Location | Condition | Component/Attributes/Capacity | Quantity | RUL | ID |
|---|---|---|---|---|---|---|
| B2010 | Building Exterior | Poor | Exterior Walls, Brick/Masonry/Stone, Clean & Seal, Repair | 7,670 SF | 0 | 10061344 |

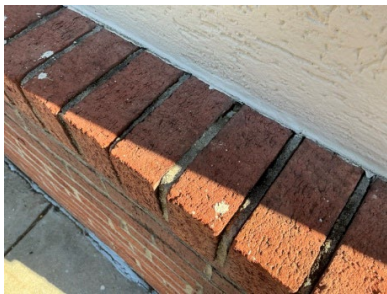
### Exterior Walls in Poor Condition.

any type, Repairs per Man-Day  
Main Building Travilah Elementary School  
Building Exterior

Mortar joints deterioration - AssetCALC ID: 10061321

Uniformat Code: B2010  
Recommendation: **Repair in 2026**

| UF L3 Code | Location | Condition | Component/Attributes/Capacity | Quantity | RUL | ID |
|---|---|---|---|---|---|---|
| B2010 | Building Exterior | Poor | Exterior Walls, any type, Repairs per Man-Day, Repair | 5 | 0 | 10061321 |

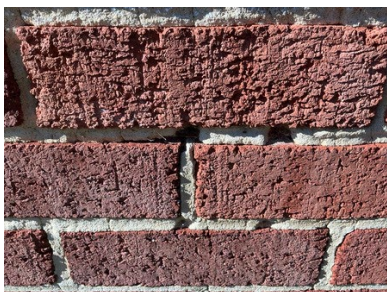
### Exterior Walls in Poor Condition.

Brick  
Main Building Travilah Elementary School  
Building Exterior (Gymnasium)

Mortar joints deterioration - AssetCALC ID: 10061261

Uniformat Code: B2010  
Recommendation: **Repair in 2026**

| UF L3 Code | Location | Condition | Component/Attributes/Capacity | Quantity | RUL | ID |
|---|---|---|---|---|---|---|
| B2010 | Building Exterior (Gymnasium) | Poor | Exterior Walls, Brick, Repair | 100 SF | 0 | 10061261 |

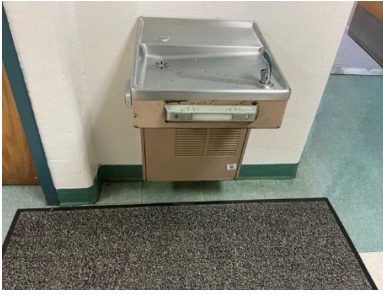
### Drinking Fountain in Poor Condition.

Wall-Mounted, Single-Level  
Main Building Travilah Elementary School  
Hallways & Common Areas

Old, rusted. - AssetCALC ID: 10061637

Uniformat Code: D2010  
Recommendation: **Replace in 2026**

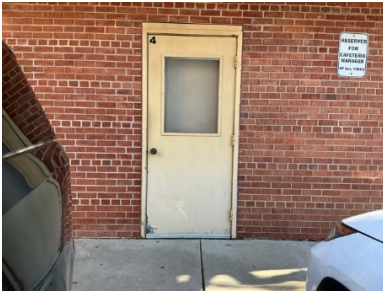
### Exterior Door in Poor Condition.

Wood, Solid-Core  
Main Building Travilah Elementary School  
Building Exterior

Dents and corrosion damaged - AssetCALC ID: 10061354

Uniformat Code: B2050  
Recommendation: **Replace in 2026**

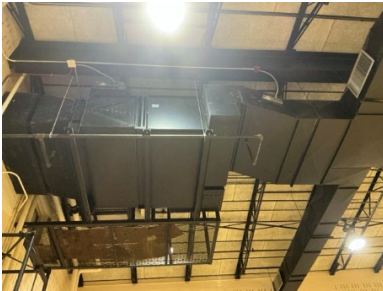
### Air Handler in Poor Condition.

Interior AHU, Easy/Moderate Access, 4001 to 6000 CFM  
Main Building Travilah Elementary School  
Gymnasium

Uniformat Code: D3050  
Recommendation: **Replace in 2026**
