FACILITY CONDITION ASSESSMENT

Waters Landing Elementary School
13100 Waters Landing Drive
Germantown, MD 20874

172559.25R000-125.354

May 4, 2026

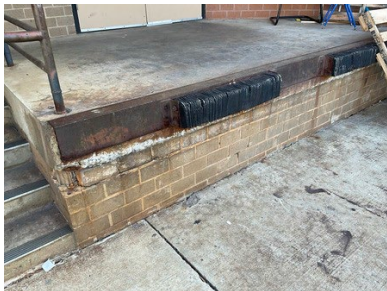
Exterior Walls in Poor Condition.

There are isolated areas of cracked brick/mortar joints at the exterior walls at the loading dock. - AssetCALC ID: 10220663

Uniformat Code: B2010
Recommendation: **Repair in 2026**

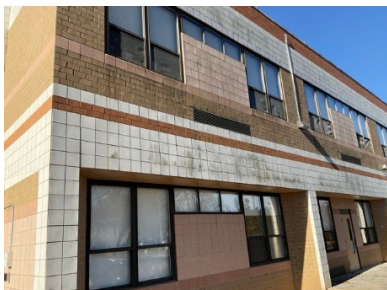
Exterior Walls in Poor Condition.

There is isolated areas of exterior moss staining. - AssetCALC ID: 10245103

Uniformat Code: B2010
Recommendation: **Maintain in 2026**

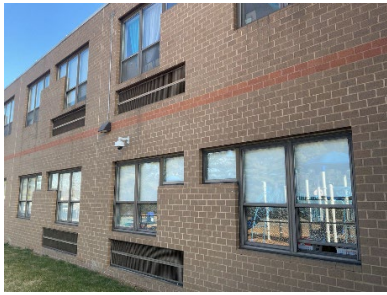
Glazing in Poor Condition.

The original windows have exceeded their EUL and show significant areas of wear, with some windows hard to open and close. Reportedly, some windows have had some glazing panels fall out and temporary fixes made by the maintenance staff. - AssetCALC ID: 10220744

Uniformat Code: B2020
Recommendation: **Replace in 2027**

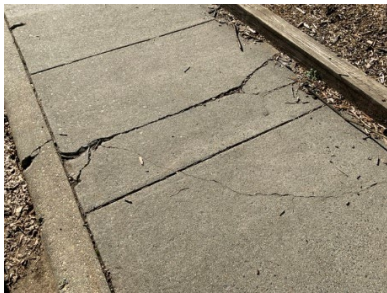
Sidewalk in Poor Condition.

There are isolated areas of spalling and cracking concrete sidewalks around the building. - AssetCALC ID: 10220869

Uniformat Code: G2030
Recommendation: **Repair in 2026**

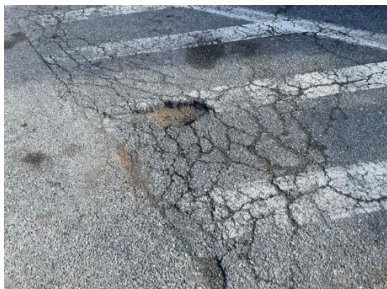
Parking Lots in Poor Condition.

There are severe areas of alligator cracking and potholes in the parking areas and drive lanes. - AssetCALC ID: 10220784

Uniformat Code: G2020
Recommendation: **Cut & Patch in 2026**

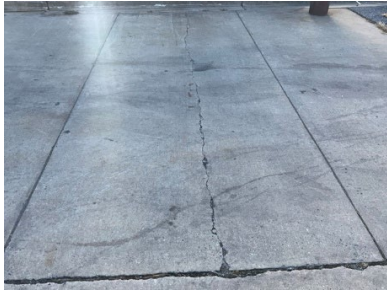
Parking Lots in Poor Condition.

There are isolated areas of spalling and cracking concrete pavement at the loading dock area. - AssetCALC ID: 10220801

Uniformat Code: G2020
 Recommendation: **Repair in 2026**

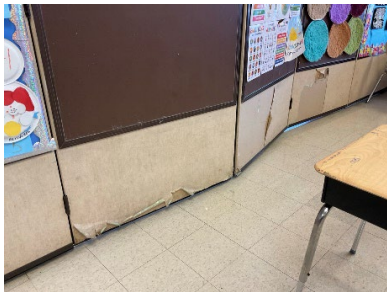
Movable Partition in Poor Condition.

The movable partition between classrooms 113 and 115 shows significant areas of deterioration and damage. - AssetCALC ID: 10220752

Uniformat Code: C1010
 Recommendation: **Replace in 2026**

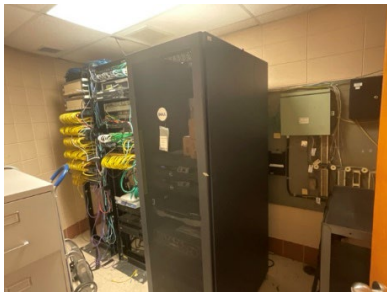
Recommended Follow-up Study: Mechanical, General Design

There are reported inconsistencies with proper heating & cooling various areas throughout the building, including in the kindergarten classroom wing, 3rd grade classroom wing, 2nd floor 4th grade classroom wing, and the wire room stays extremely hot. A professional engineer should be retained to analyze the existing condition, provide recommendations and, if necessary estimate the scope and cost of any required repairs. The cost of this study is included in the cost tables. The cost of any HVAC upgrades cannot be accurately determined without the recommended study; however, costs are included for replacement of the existing heating system equipment over the reserve term. - AssetCALC ID: 10220626

Uniformat Code: P2030
 Recommendation: **Design in 2026**

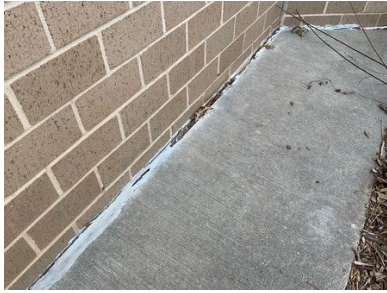
**Recommended Follow-up Study:
Structural, Superstructure**

There is isolated evidence of deflection and movement reported and observed, as there are areas of cracked terrazzo flooring in the hallways on the 1st & 2nd floors of the building, as well as some areas of cracked mortar joints at the glazed block walls in the commercial kitchen. In addition, there is concern with the foundation on the building front exterior: there are numerous areas that are either missing caulking or have deteriorated caulking around the building exterior along the base of the building exterior walls/foundation. A Professional Engineer with specific expertise in structural design and construction in this geographical area must be retained to evaluate the structure and to provide remedial recommendations consistent with local regulatory and code requirements. The cost of this study is included in the cost tables. Although the estimated cost of repair cannot be accurately determined without the recommended study, a budgetary cost allowance to repair the affected elements is also included. - AssetCALC ID: 10220831

Uniformat Code: P2030
Recommendation: **Evaluate/Report in 2026**

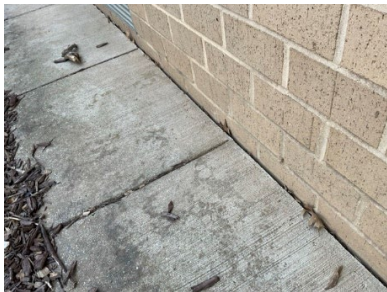
Caulking in Poor Condition.

There is concern with the foundation on the building front exterior: there are numerous areas that are either missing caulking or have deteriorated caulking around the building exterior along the base of the building exterior walls/foundation. - AssetCALC ID: 10237352

Uniformat Code: B2010
Recommendation: **Replace in 2026**

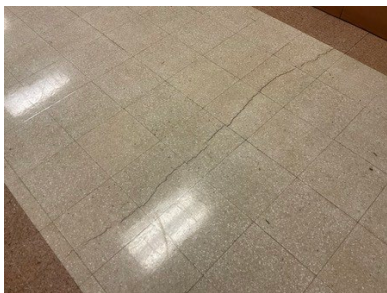
Flooring in Poor Condition.

There are areas of cracked terrazzo flooring in the hallways on the 1st & 2nd floors of the building. - AssetCALC ID: 10220855

Uniformat Code: C2030
Recommendation: **Repair in 2026**

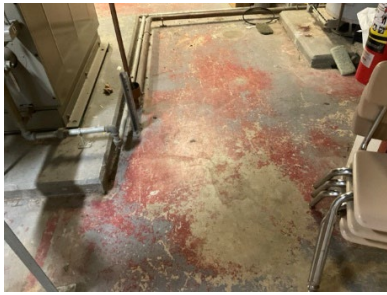
Flooring in Poor Condition.

There are significant areas of deteriorated painted floor finishes. - AssetCALC ID: 10220731

Uniformat Code: C2030
Recommendation: **Prep & Paint in 2026**

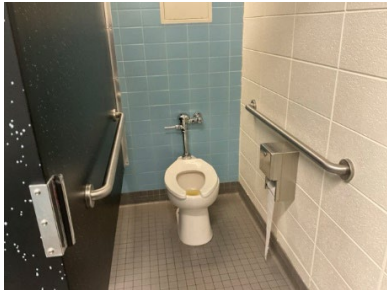
ADA Miscellaneous

Potential moderate/major issues have been identified at this building and a detailed accessibility study is recommended. See the appendix for associated photos and additional information. - AssetCALC ID: 10225562

Uniformat Code: Y1090
Recommendation: **Evaluate/Report in 2026**

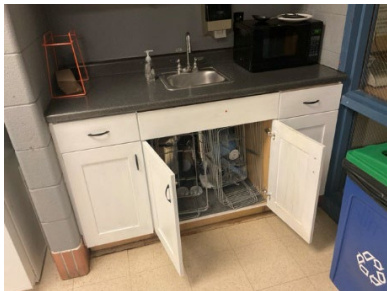
ADA Kitchen & Laundry Areas

Uniformat Code: Y1060
Recommendation: **Renovate in 2026**

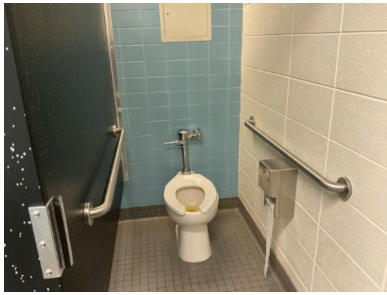
ADA Restrooms

Uniformat Code: Y1050
Recommendation: **Install in 2026**

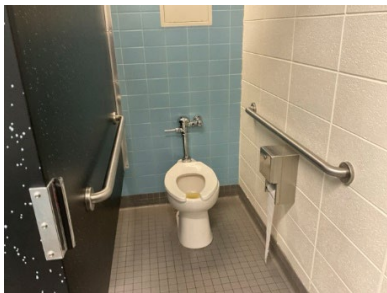
ADA Restrooms

Uniformat Code: Y1050
Recommendation: **Modify in 2026**

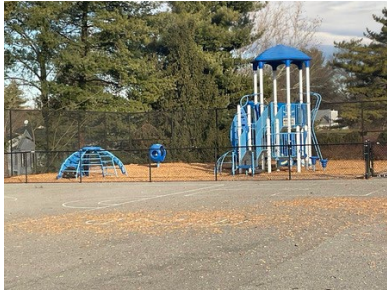
Playfield Surfaces

The play surface is currently wood chips, requiring frequent maintenance and creating an uneven surface that can be challenging to maneuver. Replacement with rubberized surfacing is recommended and included in the five-year plan. - AssetCALC ID: 10220679

Uniformat Code: G2050
Recommendation: **Replace in 2029**
