# FACILITY CONDITION ASSESSMENT

Weller Road Elementary School  
3301 Weller Road  
Silver Spring, MD 20906

172559.25R000-128.354

*January 6, 2026*

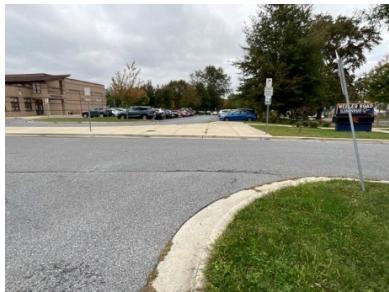
### Roadways in Poor condition.

Signage, Guide and Directional  
Site Weller Road Elementary School Site

Signs are faded with age - AssetCALC ID: 9899589

Uniformat Code: G2010  
Recommendation: **Replace/Install in 2026**

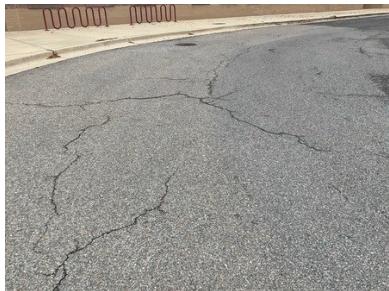
### Parking Lots in Poor condition.

Pavement, Asphalt  
Site Weller Road Elementary School Site

Uniformat Code: G2020  
Recommendation: **Seal and Stripe in 2026**
