FACILITY CONDITION ASSESSMENT

Montgomery County Public Schools

Wood Acres Elementary School

May 7, 2026

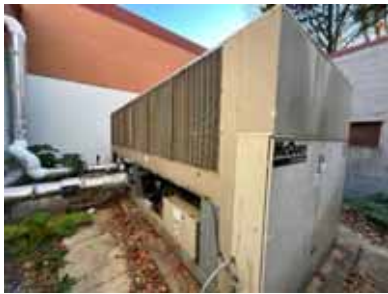
Chiller in Poor condition.

Air-Cooled, 151 to 200 TON
 Wood Acres Elementary School Wood Acres
 Elementary School Building Exterior

The exterior casing shows corrosion and paint deterioration. The interior compressor compartment also exhibits significant corrosion and aged wiring. This unit uses R22 refrigerant, which is obsolete and no longer supported. - AssetCALC ID: 10048017

Uniformat Code: D3030
 Recommendation: **Replace in 2027**

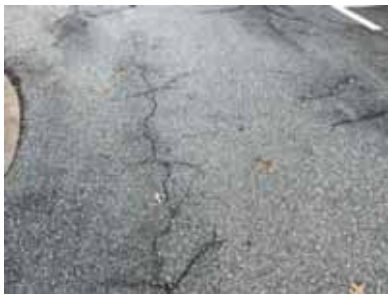
Parking Lots in Poor condition.

Pavement, Asphalt
 Site Wood Acres Elementary School Site

Pavements needs attention throughout due to cracks and surface degradation. - AssetCALC ID: 10048217

Uniformat Code: G2020
 Recommendation: **Cut and Patch in 2027**

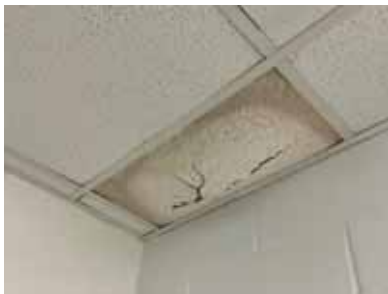
Suspended Ceilings in Poor condition.

Acoustical Tile (ACT)
 Wood Acres Elementary School Wood Acres
 Elementary School Throughout Building

Damaged and stained ceiling tiles throughout - AssetCALC ID: 10048106

Uniformat Code: C1070
 Recommendation: **Replace in 2027**
