FACILITY CONDITION ASSESSMENT

Montgomery County Public Schools
45 West Gude Drive, Suite 4000
Rockville, MD 20850

Wyngate Elementary School
9300 Wadsworth Drive
Bethesda, MD 20817

Bureau Veritas
6021 University Boulevard, Suite 200
Ellicott City, MD 21043
800.733.0660
www.bvna.com

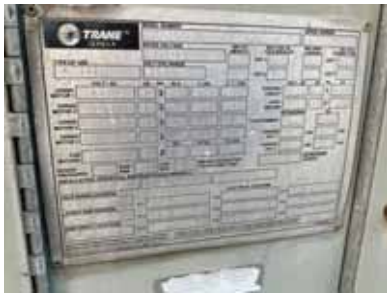
Chiller in Poor condition.

Air-Cooled
Main Building Wyngate Elementary School
Roof

The chiller is aged and requires a phased out refrigerant R22 - AssetCALC ID: 10218547

Uniformat Code: D3030
Recommendation: **Replace in 2026**

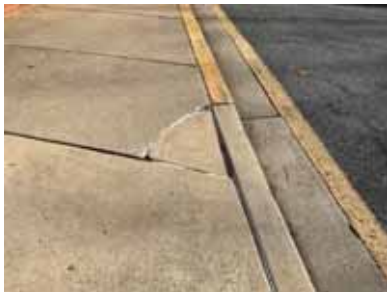
Sidewalk in Poor condition.

any pavement type, Sectional Repairs (per
Man-Day)
Site Wyngate Elementary School Site

Cost allowance to repair cracked sidewalk - AssetCALC ID: 10222860

Uniformat Code: G2030
Recommendation: **Repair in 2027**

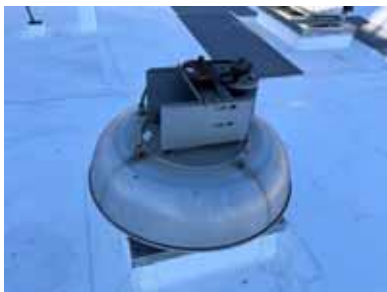
Exhaust Fan in Poor condition.

Roof or Wall-Mounted, 10" Damper
Main Building Wyngate Elementary School
Roof

The fan is missing cover - AssetCALC ID: 10218565

Uniformat Code: D3060
Recommendation: **Replace in 2027**

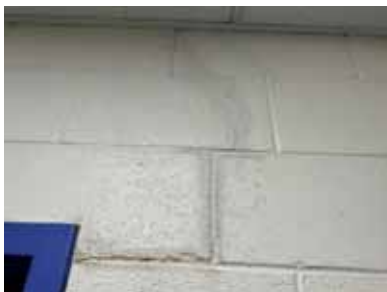
**Recommended Follow-up Study:
Structural, General Design**

Structural, General Design
Main Building Wyngate Elementary School Rm
32

The wall has evidence of possible movement - AssetCALC ID: 10218624

| Main Building : Systems Summary | | |
|--|--|---|
| Additional Studies | <p>The interior CMU wall located above room 32 and other classrooms has cracks. A professional engineer must be retained to analyze the existing condition, provide recommendations and, if necessary, estimate the scope and cost of any required repairs. The cost of this study is included in the cost tables. Due to the ambiguity of the required repair scope at the time of this assessment, the cost for any possible subsequent repairs is not included.</p> <p>The HVAC pipe insulation located in room 212 and other fan coil rooms has mold growth in localized areas. A consultant must be retained to analyze the existing condition, provide recommendations and, if necessary, estimate the scope and cost of any required repairs. The cost of this study is included in the cost tables. A budgetary cost allowance to replace the damaged insulation is also included.</p> | |

Uniformat Code: P2030
Recommendation: **Design in 2026**

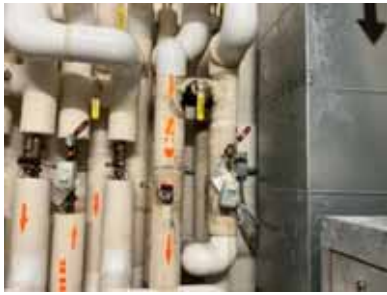
**Recommended Follow-up Study:
Environmental, Analysis of
Suspect Fungal Growth**

Environmental Analysis of Suspect Fungal Growth
Main Building Wyngate Elementary School 212

Insulation exhibits mold growth this room and in other fan coil rooms - AssetCALC ID: 10218675

Uniformat Code: P2030
Recommendation: **Evaluate/Report in 2027**

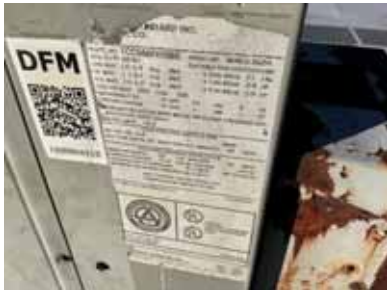
Packaged Unit in Poor condition.

RTU, Pad or Roof-Mounted
Main Building Wyngate Elementary School
Roof

The unit is aged and requires a phased out refrigerant R22 - AssetCALC ID: 10218707

Uniformat Code: D3050
Recommendation: **Replace in 2027**

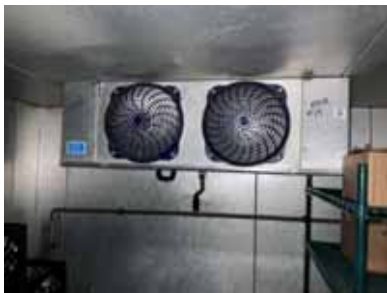
Foodservice Equipment in Poor condition.

Walk-In, Evaporator for Refrigerator/Freezer
Main Building Wyngate Elementary School
Kitchen

The refrigeration equipment requires a phased on refrigerant R-22 - AssetCALC ID: 10218706

Uniformat Code: E1030
Recommendation: **Replace in 2027**

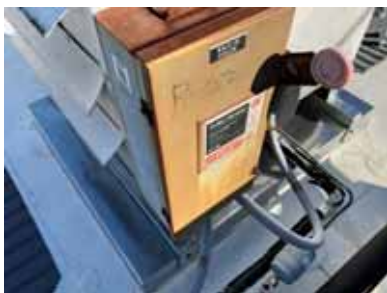
Foodservice Equipment in Poor condition.

Walk-In, Condenser for Refrigerator/Freezer
Main Building Wyngate Elementary School
Roof

The unit requires a phased our refrigerant R22 - AssetCALC ID: 10218674

Uniformat Code: E1030
Recommendation: **Replace in 2027**

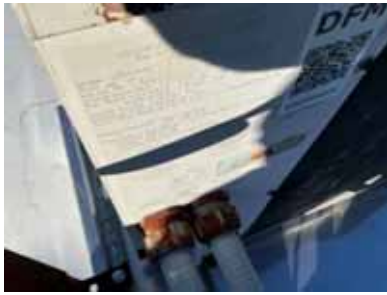
Split System Ductless in Poor condition.

Single Zone
Main Building Wyngate Elementary School
Roof

The split system requires a phased out refrigerant R22 - AssetCALC ID: 10218711

Uniformat Code: D3030
Recommendation: **Replace in 2027**

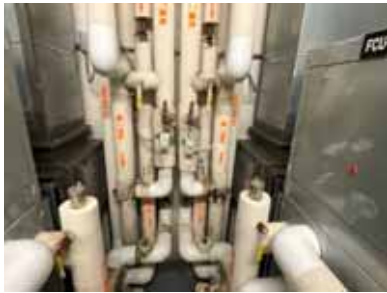
Piping and Valves

Fiberglass Insulation, HVAC Chilled Water
Main Building Wyngate Elementary School Fan
coil rooms

Cost allowance to replace molded insulation in fan coil rooms - AssetCALC ID: 10218545

Uniformat Code: D3050
Recommendation: **Replace in 2027**
