FACILITY CONDITION ASSESSMENT

Montgomery County Public Schools
45 West Gude Drive, Suite 4000
Rockville, MD 20850

Benjamin Banneker Middle School
14800 Perrywood Drive
Burtonsville, MD 20866

August 15, 2025

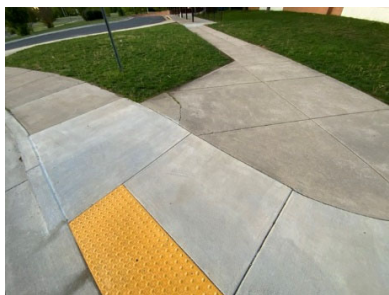
<p>Sidewalk in Poor condition.</p> <p>Any Pavement Type, Sectional Repairs per Man-Day Site Benjamin Banneker Middle School Throughout Building</p> <p>Unifomat Code: G2030 Recommendation: Repair in 2026</p>	<p>Priority Score: 85.8</p> <p>Plan Type: Performance/Integrity</p> <p>Cost Estimate: \$1,000</p> <p>\$\$\$\$</p>
--	--	--

Cracked concrete walkway near the main entrance - AssetCALC ID: 9286564
