FACILITY CONDITION ASSESSMENT

Montgomery County Public Schools

Cabin John Middle School
10701 Gainsborough Road
Potomac, MD 20854

May 7, 2026

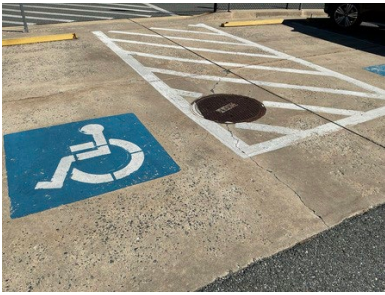
Pedestrian Aisle in Poor condition.

any pavement type, Sectional Repairs per Man-Day
Site Cabin John Middle School ADA parking Front

Concrete pavement cracked at accessible parking area. - AssetCALC ID: 9956916

Uniformat Code: G2030
Recommendation: **Repair cracks in 2025**

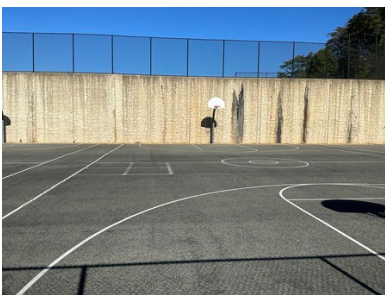
Retaining Wall in Poor condition.

POC reports that retaining wall has chunks falling out and being studied for possible replacement. Unable to access due to safety issues. - AssetCALC ID: 9956921

Uniformat Code: G2060
Recommendation: **Replace in 2026**

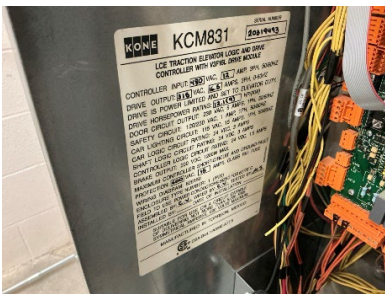
Passenger Elevator in Poor condition.

POC reports loud constant screeching while in operation - AssetCALC ID: 9920823

Uniformat Code: D1010
Recommendation: **Renovate in 2026**

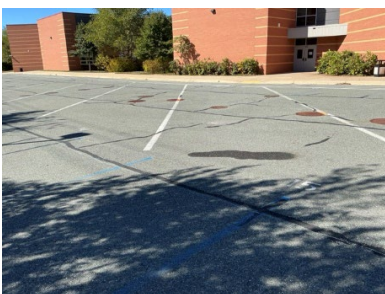
Parking Lots in Poor condition.

Several large cracks throughout - AssetCALC ID: 9956946

Uniformat Code: G2020
Recommendation: **Mill and Overlay in 2027**

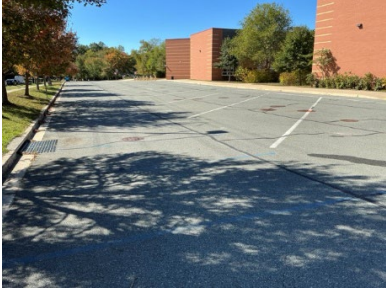
Parking Lots in Poor condition.

Pavement, Asphalt
Site Cabin John Middle School Bus Loop/Right Parking

Surface cracks and faded lines - AssetCALC ID: 9956944

Uniformat Code: G2020
Recommendation: **Seal and Stripe in 2027**

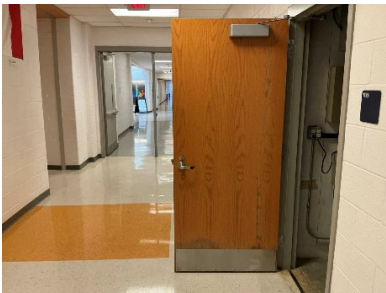
Interior Door in Poor condition.

Wood, Solid-Core
Main Building Cabin John Middle School Room 1135

Door water damaged and signs of mold per POC - AssetCALC ID: 9920656

Uniformat Code: C1030
Recommendation: **Replace in 2026**

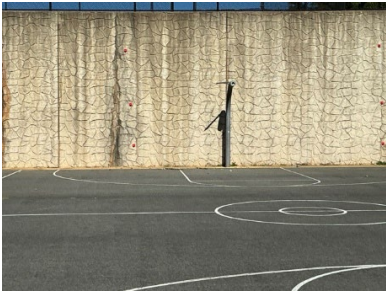
Sports Apparatus in Failed condition.

Basketball, Backboard/Rim/Pole
Site Cabin John Middle School Basketball Court

Backboard missing - AssetCALC ID: 9956914

Uniformat Code: G2050
Recommendation: **Replace in 2026**

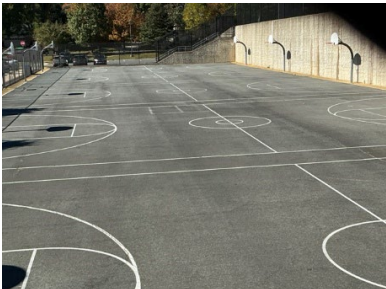
Athletic Surfaces and Courts in Poor condition.

Basketball/General, Asphalt Pavement
Site Cabin John Middle School Basketball Court

Large cracks - AssetCALC ID: 9956929

Uniformat Code: G2050
Recommendation: **Seal and Stripe in 2027**

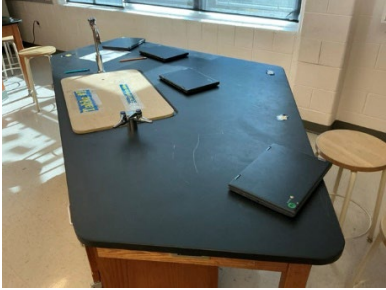
Casework in Poor condition.

Countertop, Solid Surface
Main Building Cabin John Middle School
Science Labs

Teachers reports that countertop missing seal coat - AssetCALC ID: 9920630

Uniformat Code: E2010
Recommendation: **Replace in 2027**

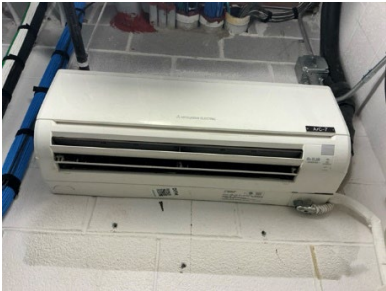
Split System Ductless in Poor condition.

Single Zone
Main Building Cabin John Middle School Room
1135

POC reports and was observed that unit continuously has mold - AssetCALC ID: 9920731

Uniformat Code: D3030
Recommendation: **Replace in 2026**

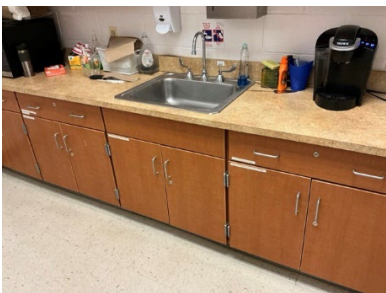
ADA Kitchen and Laundry Areas

Kitchen Sink and Counter, Full Reconfiguration
Main Building Cabin John Middle School
Teachers Lounge

Uniformat Code: Y1060
Recommendation: **Renovate in 2026**
