FACILITY CONDITION ASSESSMENT

Roberto W. Clemente Middle School
18808 Waring Station Road
Germantown, MD 20874

172559.25R000-143.354

May 11, 2026

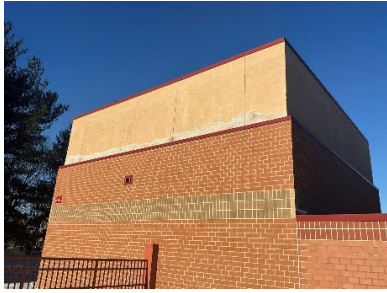
Exterior Walls in Poor condition.

Stucco
Main Building Roberto W. Clemente Middle School Building Exterior

Stucco material was observed to be weather damaged. - AssetCALC ID: 10322283

Uniformat Code: B2010
Recommendation: **Prep & Fog Coat or Paint in 2027**

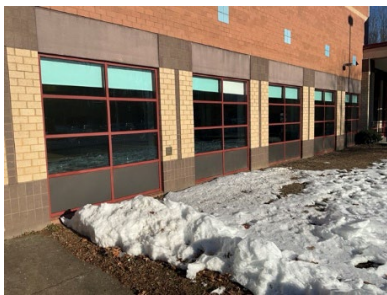
Glazing in Poor condition.

any type by SF
Main Building Roberto W. Clemente Middle School Building Exterior

Original exterior windows are age deteriorated with evidence of moisture intrusion. - AssetCALC ID: 10322269

Uniformat Code: B2020
Recommendation: **Replace in 2027**

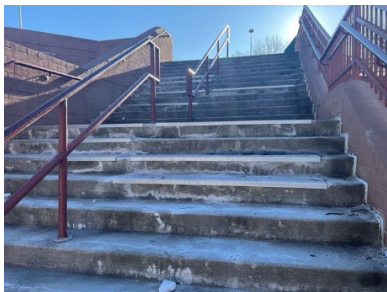
Site Stairs & Ramps in Poor condition.

Steps, Concrete (per LF of nosing)
Site Roberto W. Clemente Middle School Site

Site stairs were observed to be deteriorated which could create tripping hazards. - AssetCALC ID: 10322474

Uniformat Code: G2030
Recommendation: **Repair in 2026**

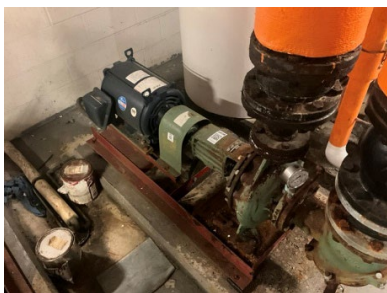
Pump in Poor condition.

Distribution, HVAC Heating Water, 11 to 15 HP
Main Building Roberto W. Clemente Middle School Boiler Room 247

Heating hot water pump is corroded and deteriorated. - AssetCALC ID: 10322233

Uniformat Code: D3050
Recommendation: **Replace in 2027**

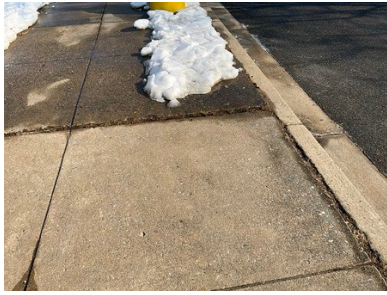
Sidewalk in Poor condition.

Concrete, Large Areas
 Site Roberto W. Clemente Middle School Site Areas

Sidewalks at the parking areas and school perimeter were observed to be deteriorated. - AssetCALC ID: 10322462

Uniformat Code: G2030
 Recommendation: **Replace in 2027**

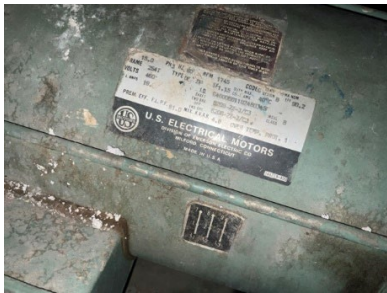
Pump in Poor condition.

Distribution, HVAC Heating Water, 11 to 15 HP
 Main Building Roberto W. Clemente Middle School Boiler Room 247

Heating hot water pump is corroded and deteriorated. - AssetCALC ID: 10322392

Uniformat Code: D3050
 Recommendation: **Replace in 2027**

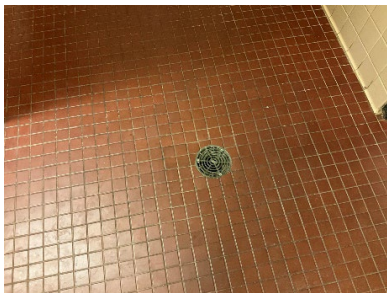
Plumbing System in Poor condition.

Supply & Sanitary, Low Density (excludes fixtures)
 Main Building Roberto W. Clemente Middle School Throughout Building

The plumbing sanitary system emits odors at floor drains and staff reported problems with frequent clogged drains and backups. - AssetCALC ID: 10322433

Uniformat Code: D2010
 Recommendation: **Replace in 2027**

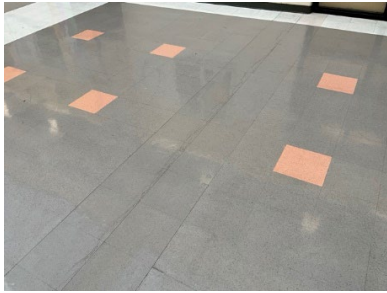
**Recommended Follow-up Study:
Structural, Superstructure**

Structural, Superstructure
Main Building Roberto W. Clemente Middle School Main Entry/Cafeteria Restroom/Room 235

During the assessment a representative sample of the building was observed. However, BV recommends a expanding the structural study to other areas of the building to verify the extent of the damage of sinking floor.
- AssetCALC ID: 10322273

Uniformat Code: P2030
Recommendation: **Evaluate/Report in 2026**

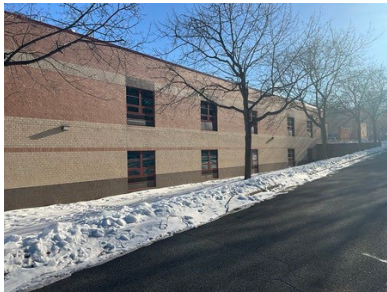
**Recommended Follow-up Study:
Civil, Site Drainage**

Civil, Site Drainage
Site Roberto W. Clemente Middle School Lower Level

Inadequate drainage allows water to seep into the lower level at the retaining area of the building. -
AssetCALC ID: 10366323

Uniformat Code: P2030
Recommendation: **Evaluate/Report in 2026**

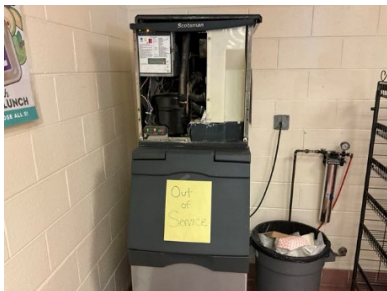
Foodservice Equipment in Poor condition.

Icemaker, Freestanding
Main Building Roberto W. Clemente Middle School Commercial Kitchen

The icemaker was observed to be inoperative. - AssetCALC ID: 10322406

Uniformat Code: E1030
Recommendation: **Replace in 2026**

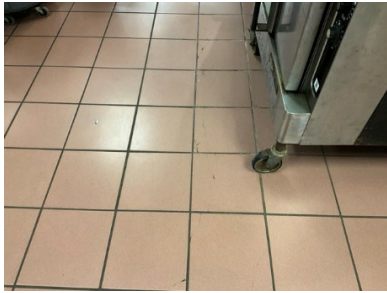
Flooring in Poor condition.

Quarry Tile
Main Building Roberto W. Clemente Middle School Commercial kitchen

Quarry tile and ceramic cove base are cracked in scattered locations. - AssetCALC ID: 10322243

Uniformat Code: C2030
Recommendation: **Repair in 2026**

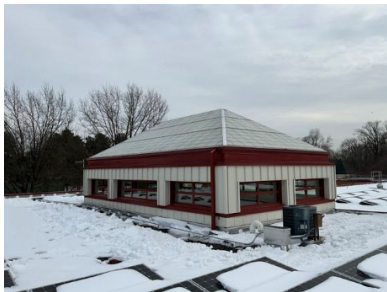
Roof Skylight in Poor condition.

per SF of glazing
Main Building Roberto W. Clemente Middle School Roof

The skylights were observed to be deteriorated and showed signs of moisture intrusion and microbial growth. - AssetCALC ID: 10322443

Uniformat Code: B3060
Recommendation: **Replace in 2027**

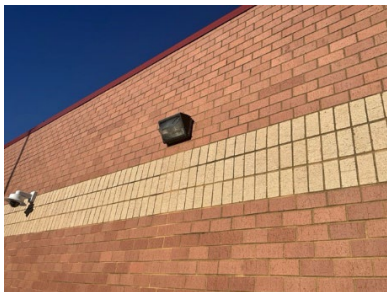
Exterior Light in Poor condition.

Building-Mounted, Higher-Lumen for Large Areas
Main Building Roberto W. Clemente Middle School Building exterior

Exterior lighting at the campus was observed to be inadequate. - AssetCALC ID: 10322451

Uniformat Code: D5040
Recommendation: **Replace in 2027**

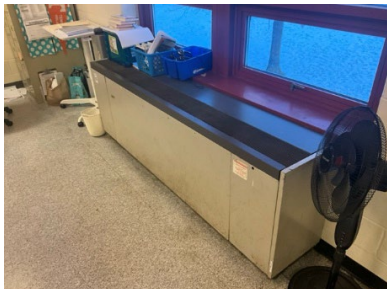
Unit Ventilator in Poor condition.

approx/nominal 3 Ton, 751 to 1250 CFM
Main Building Roberto W. Clemente Middle School Classrooms General

Unit ventilators appear corroded and are believed to be original equipment. - AssetCALC ID: 10322376

Uniformat Code: D3030
Recommendation: **Replace in 2027**

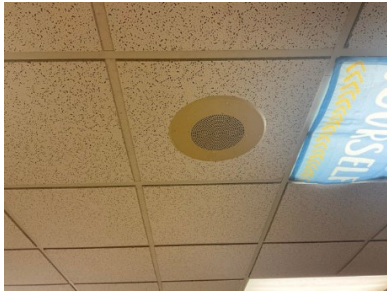
Intercom/PA System in Poor condition.

Public Address Upgrade, Facility-Wide
Main Building Roberto W. Clemente Middle School Throughout Building

Uniformat Code: D6060
Recommendation: **Replace in 2027**

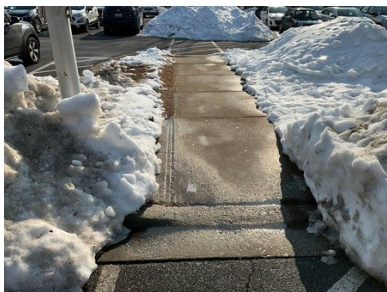
ADA Paths of Travel

Walkways, Curb Cut Ramp
Main Building Roberto W. Clemente Middle School Main Parking Lot

ADA path of travel was observed to be deteriorated and appears to be a hazard. - AssetCALC ID: 10322251

Uniformat Code: Y1020
Recommendation: **Install in 2026**

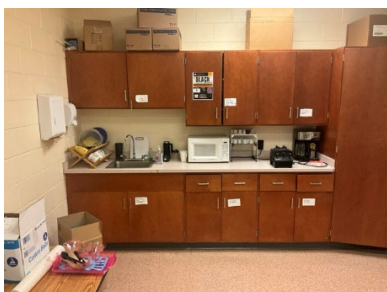
ADA Kitchen & Laundry Areas

Sink/Counter/Maneuverability, Full Reconfiguration
Main Building Roberto W. Clemente Middle School 215

Kitchen area at the staff lounge was observed not to be ADA compliant. - AssetCALC ID: 10322348

Uniformat Code: Y1060
Recommendation: **Renovate in 2026**

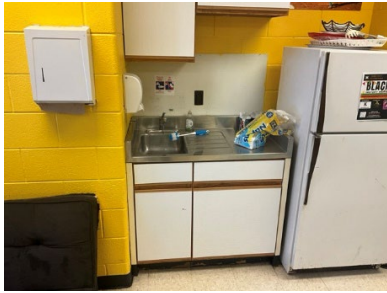
ADA Kitchen & Laundry Areas

Sink/Counter/Maneuverability, Full Reconfiguration
 Main Building Roberto W. Clemente Middle School Staff Lounge

Kitchen area at the staff lounge was observed not to be ADA compliant. - AssetCALC ID: 10322408

Uniformat Code: Y1060
 Recommendation: **Renovate in 2026**

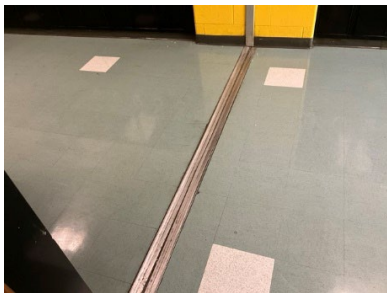
Expansion Joint Covers

Aluminum Assembly, up to 2"
 Main Building Roberto W. Clemente Middle School Special Education

Expansion joint covers at the special education section of the building were observed to be damaged and creates a safety and accessibility hazard. - AssetCALC ID: 10322390

Uniformat Code: B2010
 Recommendation: **Replace in 2026**
