FACILITY CONDITION ASSESSMENT

Montgomery County Public Schools
45 West Gude Drive, Suite 4000
Rockville, MD 20850

Forest Oak Middle School
651 Saybrooke Oaks Boulevard
Gaithersburg, MD 20877

May 8, 2026

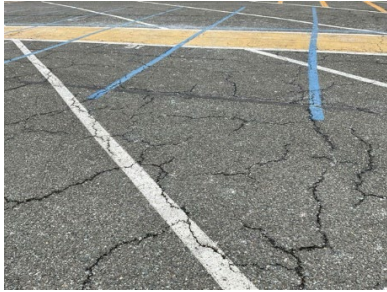
Parking Lots in Poor Condition.

Pavement, Asphalt
Site Forest Oak Middle School Site

Pavement displays excessive cracking throughout. - AssetCALC ID: 10399538

Uniformat Code: G2020
Recommendation: **Seal & Stripe in 2027**

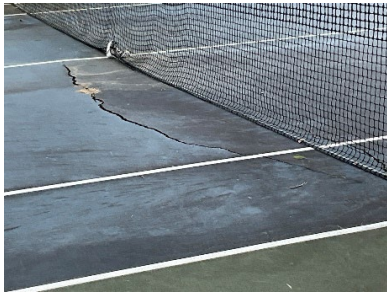
Athletic Surfaces & Courts in Poor Condition.

Tennis/Volleyball, 2-Color Surface
Site Forest Oak Middle School Site

Play court displays excessive cracking and general surface deterioration. - AssetCALC ID: 10399534

Uniformat Code: G2050
Recommendation: **Seal & Stripe in 2027**

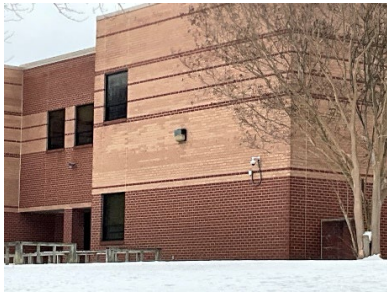
Exterior Light in Poor Condition.

Any type, with LED Replacement
Main Building Forest Oak Middle School
Building Exterior

Site exterior lighting is aged and overall illumination is inadequate. - AssetCALC ID: 10399372

Uniformat Code: D5040
Recommendation: **Replace in 2026**

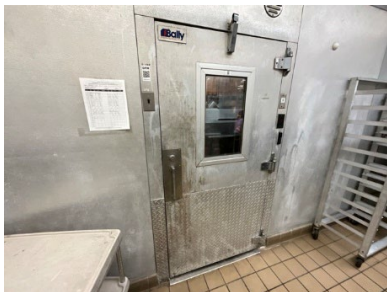
Foodservice Equipment in Poor Condition.

Walk-In, Freezer
Main Building Forest Oak Middle School
Kitchen

Freezer has exceeded EUL and has recurring issues according to staff. - AssetCALC ID: 10394540

Uniformat Code: E1030
Recommendation: **Replace in 2027**

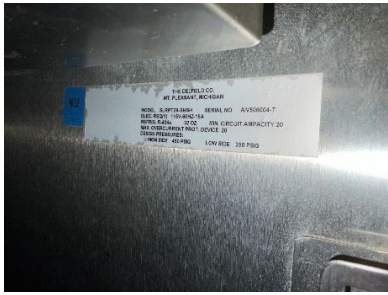
Foodservice Equipment in Poor Condition.

Food Warmer, Proofing Cabinet on Wheels
Main Building Forest Oak Middle School
Kitchen

The units are not heating as originally designed. - AssetCALC ID: 10394561

Uniformat Code: E1030
Recommendation: **Replace in 2027**

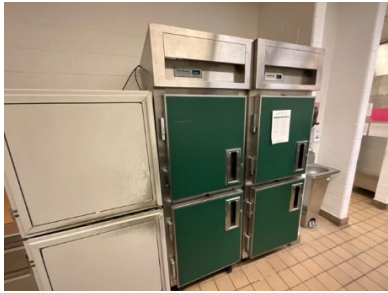
Foodservice Equipment in Poor Condition.

Food Warmer, Proofing Cabinet on Wheels
Main Building Forest Oak Middle School
Kitchen

Unit is having intermittent operational issue. - AssetCALC ID: 10394567

Uniformat Code: E1030
Recommendation: **Replace in 2027**

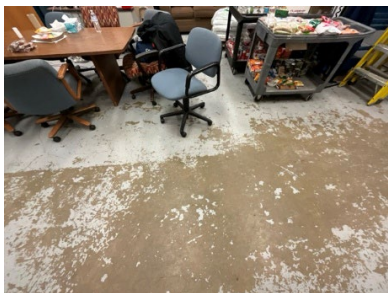
Flooring in Poor Condition.

Any surface, with Paint or Sealant
Main Building Forest Oak Middle School
Building Service and Boiler Room

Floor paint is significantly worn away. - AssetCALC ID: 10399382

Uniformat Code: C2030
Recommendation: **Prep & Paint in 2027**
