# FACILITY CONDITION ASSESSMENT

Gaithersburg Middle School  
2 Teachers Way  
Gaithersburg, MD 20877

172559.25R000-148.354

*August 14, 2025 (original)*  
*October 29, 2025 (revised)*

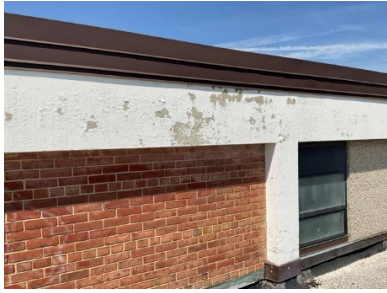
### Exterior Walls in Poor condition.

any painted surface, 1-2 Story Building  
Main Building Gaithersburg Middle School  
Building Exterior

Paint is peeling. - AssetCALC ID: 9274707

Recommendation: **Prep & Paint in 2027**

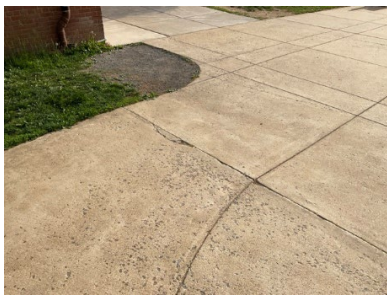
### Sidewalk in Poor condition.

any pavement type, Sectional Repairs per Man-Day  
Site Gaithersburg Middle School Site Parking  
Areas

Large crack in sidewalk in front of school - AssetCALC ID: 9276046

Recommendation: **Repair in 2025**

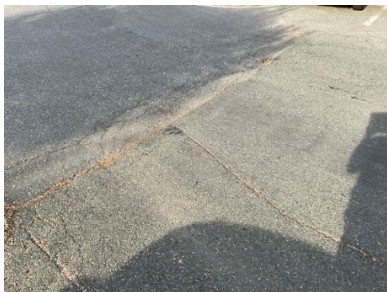
### Parking Lots in Poor condition.

Pavement, Asphalt  
Site Gaithersburg Middle School Site

Large cracks and crazing across most of the surface. - AssetCALC ID: 9276047

Recommendation: **Cut & Patch in 2025**

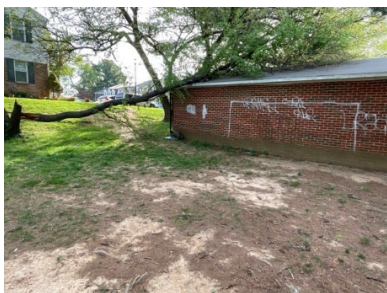
### Landscaping in Failed condition.

Mature Trees, Removal or Heavy Trimming  
Site Gaithersburg Middle School Storage  
Building

Large tree has fallen onto roof of storage shed building in the rear of school. The tree does not appear to be on the school property, but a neighboring residential property. - AssetCALC ID: 9276039

Recommendation: **Repair in 2025**

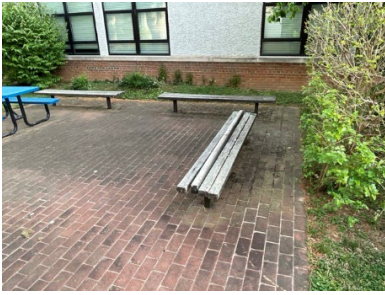
### Park Bench in Poor condition.

Wood/Composite/Fiberglass  
Site Gaithersburg Middle School Site

Wood benches have become damaged of time and now have boards coming loose. - AssetCALC ID: 9276053

Uniformat Code: G2060  
Recommendation: **Replace in 2025**

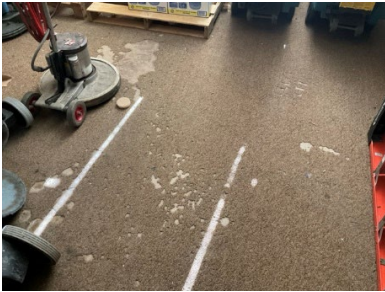
Some specific areas require attention, such as the carpet in the IDF closet, which is in poor condition and needs replacement. While most interior elements are functional, many may be approaching the end of their lifecycle.

### Flooring in Poor condition.

Carpet, Commercial Standard  
Main Building Gaithersburg Middle School IDF

Damage throughout - AssetCALC ID: 9274824

Uniformat Code: C2030  
Recommendation: **Replace in 2026**

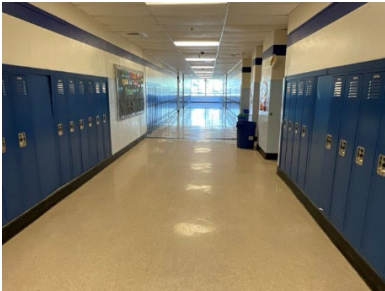
### ADA Paths of Travel

Ramp, Concrete Up to 48" Wide  
Main Building Gaithersburg Middle School  
Throughout building

Ramps do not appear to have the correct rise and run. - AssetCALC ID: 9313794

Uniformat Code: Y1020  
Recommendation: **Install in 2025**

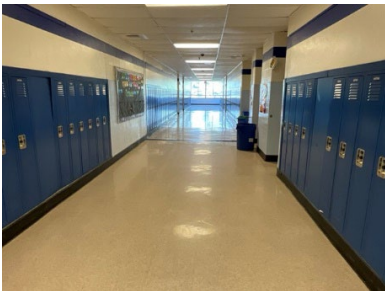
### ADA Paths of Travel

Ramp/Stair Handrails, Full Rail Modifications  
Main Building Gaithersburg Middle School  
Throughout building

Ramps without railings - AssetCALC ID: 9313790

Uniformat Code: Y1020  
Recommendation: **Modify in 2025**

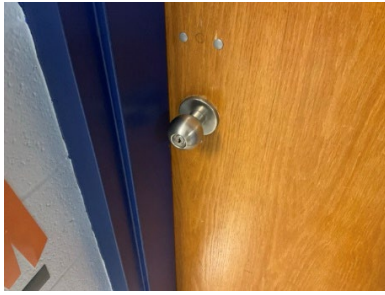
## ADA Entrances & Doors

Hardware, Lever Handle  
Main Building Gaithersburg Middle School  
Throughout Building

Doors without lever hardware in accessible areas. - AssetCALC ID: 9313793

Uniformat Code: Y1030  
Recommendation: **Install in 2025**

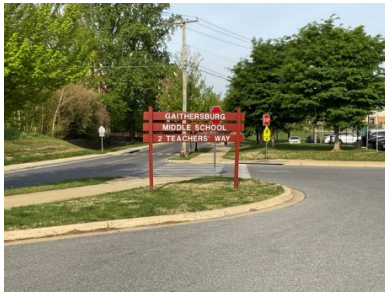
## ADA Miscellaneous

Level III Study, Includes Measurements  
Main Building Gaithersburg Middle School  
Throughout

Potential moderate/major issues have been identified at this building and a detailed accessibility study is recommended. See the appendix for associated photos and additional information - AssetCALC ID: 9340335

Uniformat Code: Y1090  
Recommendation: **Evaluate/Report in 2025**
