**BUREAU
VERITAS**

FACILITY CONDITION ASSESSMENT

Francis Scott Key Middle School
910 Schindler Drive
Silver Spring, MD 20903

May 26, 2026

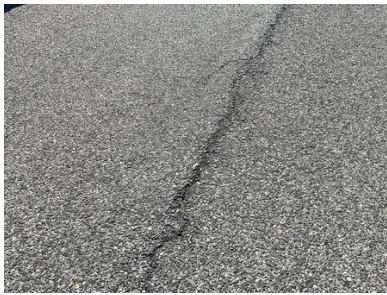
Parking Lots in Failed Condition.

Pavement, Asphalt
Site Francis Scott Key Middle School Site

Needs to be repaved throughout the parking lot for better lifespan. - AssetCALC ID: 10594693

Uniformat Code: G2020
Recommendation: **Cut & Patch in 2027**

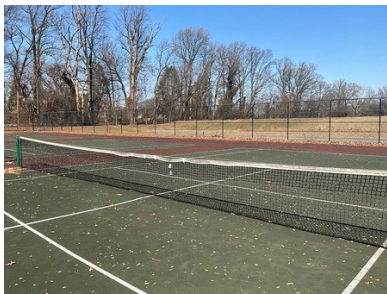
Sports Apparatus in Poor Condition.

Tennis/Volleyball, Net w/ Posts & Anchors
Site Francis Scott Key Middle School Site

The tennis netting needs to be replaced. - AssetCALC ID: 10594700

Uniformat Code: G2050
Recommendation: **Replace in 2027**

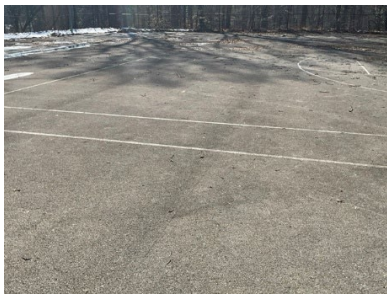
Athletic Surfaces & Courts in Poor Condition.

Basketball/General, Asphalt Pavement
Site Francis Scott Key Middle School Site

The basketball court needs to be repaved throughout for kids safety and the safety. - AssetCALC ID: 10594686

Uniformat Code: G2050
Recommendation: **Replace in 2027**

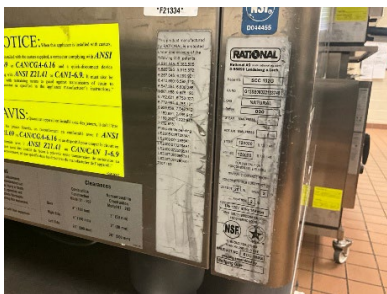
Foodservice Equipment in Poor Condition.

Convection Oven, Single
Main Building Francis Scott Key Middle School
Kitchen

Uniformat Code: E1030
Recommendation: **Replace in 2026**
