FACILITY CONDITION ASSESSMENT

Dr. Martin Luther King, Jr. Middle School
13737 Wisteria Drive
Germantown, Maryland 20874

172559.25R000-151.354

May 8, 2026

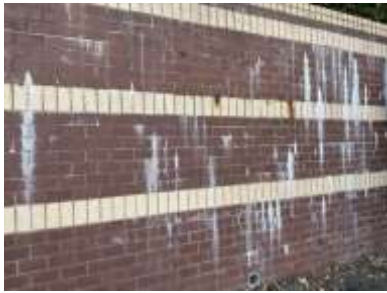
Retaining Wall/Fence in Poor condition.

Brick/Stone, Clean & Seal
 Site Dr. Martin Luther King, Jr. Middle School
 Site General

There are significant areas of efflorescence of the brick masonry retaining wall/fence at the southwest corner of the school - by service drive and play area - AssetCALC ID: 9960567

Uniformat Code: B2010
 Recommendation: **Maintain in 2026**

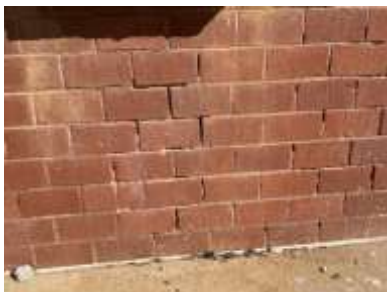
Exterior Walls in Poor condition.

There are isolated areas of deteriorated brick mortar joints at the exterior walls by the loading docks. - AssetCALC ID: 9997477

Uniformat Code: B2010
 Recommendation: **Repair in 2026**

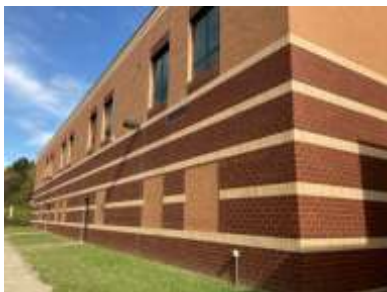
Exterior Walls in Poor condition.

There are significant areas of moss staining that occur on the north exterior wall. - AssetCALC ID: 9960414

Uniformat Code: B2010
 Recommendation: **Maintain in 2026**

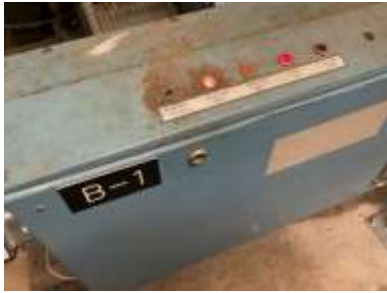
Boiler in Poor condition.

The unit shows significant evidence of corrosion and has exceeded its EUL. - AssetCALC ID: 9960585

Uniformat Code: D3020
 Recommendation: **Replace in 2026**

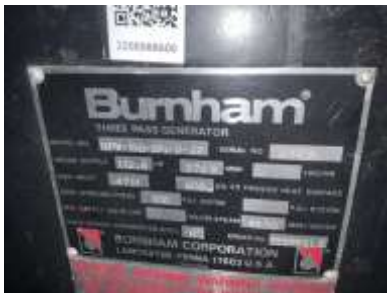
Boiler in Poor condition.

The unit shows significant evidence of corrosion and has exceeded its EUL. - AssetCALC ID: 9960660

Uniformat Code: D3020
 Recommendation: **Replace in 2026**

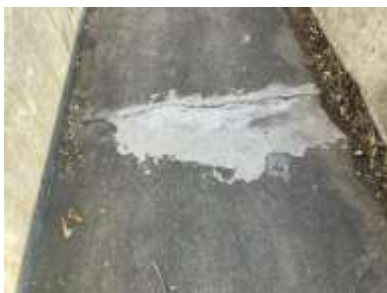
Sidewalk in Poor condition.

There are isolated areas of spalling and cracking concrete sidewalks on east side concrete ramp and on the north and west sides of the building. - AssetCALC ID: 9960604

Uniformat Code: G2030
 Recommendation: **Repair in 2025**

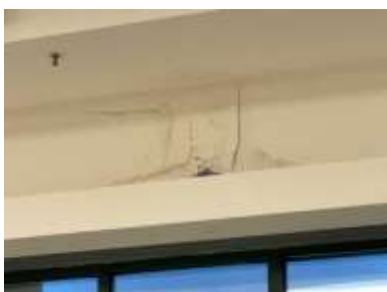
Interior Wall Construction in Poor condition.

There is an isolated area of water damaged gypsum board wall in the cafeteria (south wall). - AssetCALC ID: 9960626

Uniformat Code: C1010
 Recommendation: **Repair in 2026**

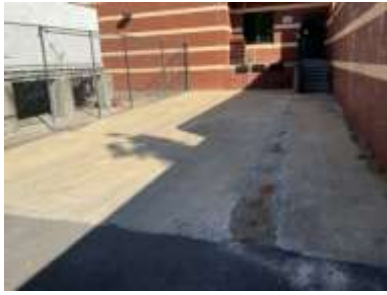
Parking Lots in Poor condition.

There are isolated areas of spalling and cracking concrete pavement at the loading dock areas. - AssetCALC ID: 9960641

Uniformat Code: G2020
 Recommendation: **Repair in 2026**

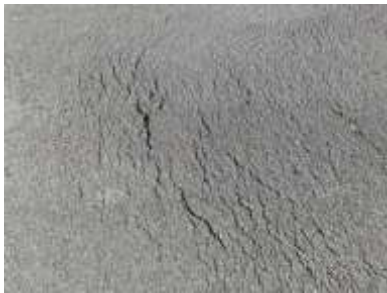
Parking Lots in Poor condition.

There are isolated areas of cracking and slight depressions of the asphalt pavement in the bus parking lot and exit drive areas. - AssetCALC ID: 9960681

Uniformat Code: G2020
 Recommendation: **Cut & Patch in 2026**

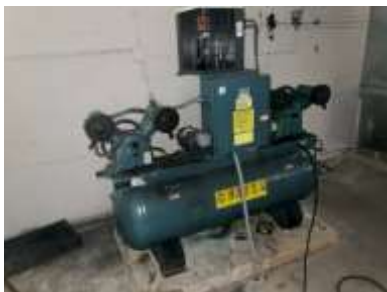
Air Compressor in Failed condition.

The facility HVAC is controlled using an outdated pneumatic system supplied by an air compressor; the main air compressor reportedly failed and replaced with an air compressor from another school. - AssetCALC ID: 9960565

Uniformat Code: D2060
 Recommendation: **Replace in 2025**

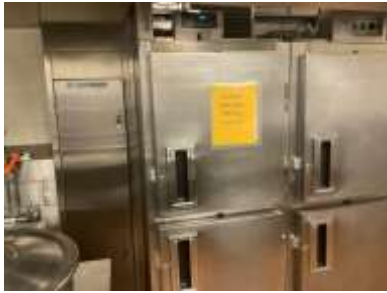
Foodservice Equipment in Failed condition.

The Refrigerator is reportedly not cooling. - AssetCALC ID: 9960579

Uniformat Code: E1030
 Recommendation: **Replace in 2025**

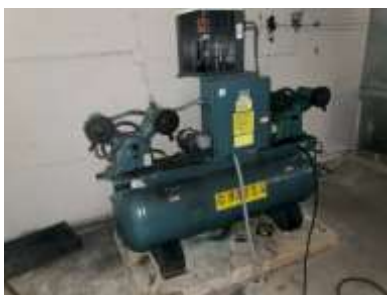
Supplemental Components in Failed condition.

The facility HVAC is controlled using an outdated pneumatic system supplied by an air compressor; the main air compressor reportedly failed and replaced with an air compressor from another school. - AssetCALC ID: 9960468

Uniformat Code: D2060
 Recommendation: **Replace in 2025**

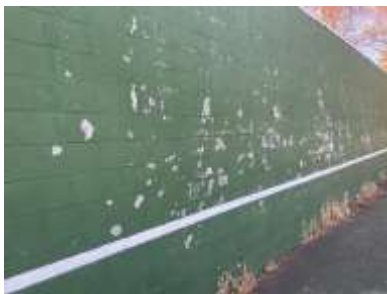
Fence Wall in Poor condition.

There are significant areas of deteriorated painted finishes and a hole through CMU block at the tennis/basketball courts CMU fence wall. - AssetCALC ID: 9960684

Uniformat Code: G2060
 Recommendation: **Repair in 2025**

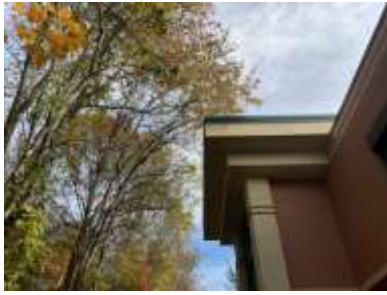
Landscaping in Poor condition.

There are overgrown trees overhanging the roof surfaces on the north side of the building. - AssetCALC ID: 9960637

Uniformat Code: G2080
Recommendation: **Repair in 2026**

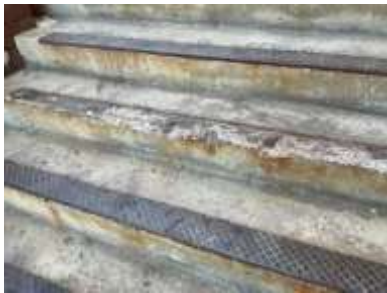
Stairs in Poor condition.

There are isolated areas of deteriorated concrete stair treads by the load dock area. - AssetCALC ID: 9960633

Uniformat Code: B1080
Recommendation: **Repair in 2026**

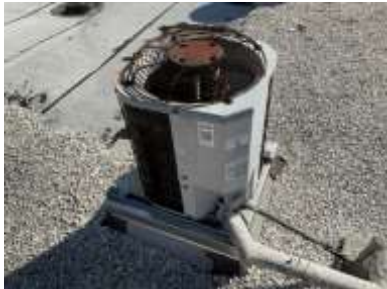
Split System in Poor condition.

The unit shows significant evidence of corrosion, has exceeded its EUL, and utilizes discontinued R-22 refrigerant. - AssetCALC ID: 9960617

Uniformat Code: D3030
Recommendation: **Replace in 2026**

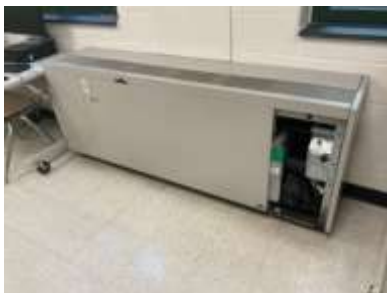
Fan Coil Unit in Poor condition.

The units show significant evidence of corrosion and leaks, have exceeded their EUL, and utilize discontinued R-22 refrigerant. - AssetCALC ID: 9960552

Uniformat Code: D3050
Recommendation: **Replace in 2026**

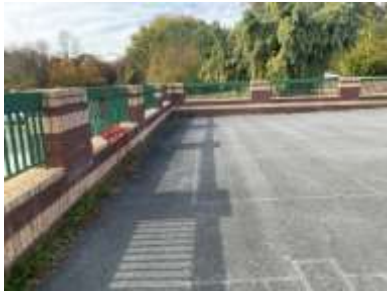
Retaining Wall/Fence in Poor condition.

There are isolated areas of damaged brick and bent metal guardrail at the brick masonry retaining wall/fence at the southwest corner of the school. - AssetCALC ID: 9960443

Uniformat Code: G2060
 Recommendation: **Repair in 2026**

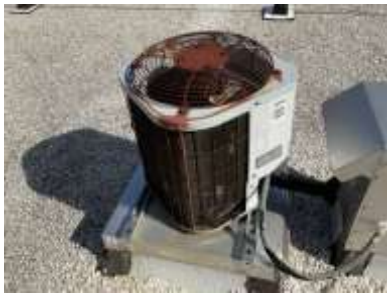
Split System in Poor condition.

The unit shows significant evidence of corrosion, has exceeded its EUL, and utilizes discontinued R-22 refrigerant. - AssetCALC ID: 9960514

Uniformat Code: D3030
 Recommendation: **Replace in 2026**

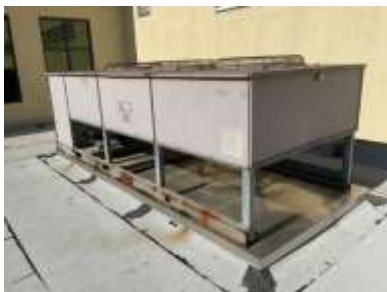
Split System in Poor condition.

The unit shows significant corrosion, has exceeded its EUL, and utilizes discontinued R-22 refrigerant. - AssetCALC ID: 9960649

Uniformat Code: D3030
 Recommendation: **Replace in 2026**

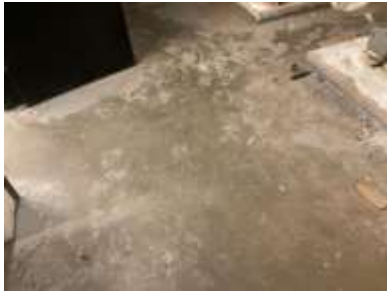
Flooring in Poor condition.

There are significant areas of deteriorated painted finishes on the concrete floors in the mechanical and electrical rooms. - AssetCALC ID: 9960581

Uniformat Code: C2030
 Recommendation: **Prep & Paint in 2026**

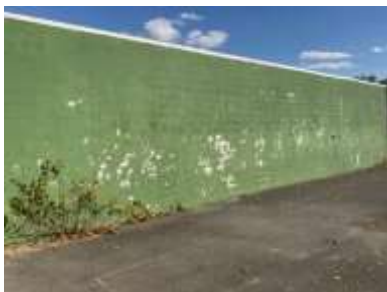
Fence Wall in Poor condition.

There are significant areas of deteriorated painted finishes and a hole through CMU block at the tennis/basketball courts CMU fence wall. - AssetCALC ID: 9983809

Uniformat Code: G2060
 Recommendation: **Prep & Paint in 2026**

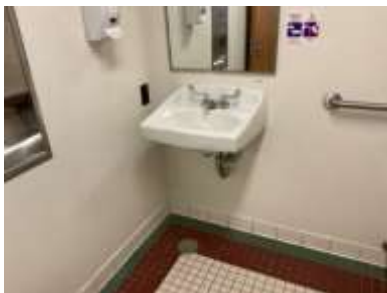
ADA Miscellaneous

Potential moderate/major issues have been identified at this building and a detailed accessibility study is recommended. See the appendix for associated photos and additional information. - AssetCALC ID: 9979259

Uniformat Code: Y1090
 Recommendation: **Evaluate/Report in 2025**

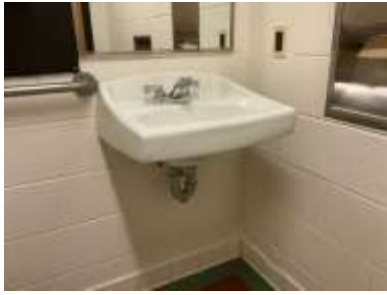
ADA Restrooms

ADA restroom sinks have some missing pipe wraps - AssetCALC ID: 9960613

Uniformat Code: Y1050
Recommendation: **Install in 2025**

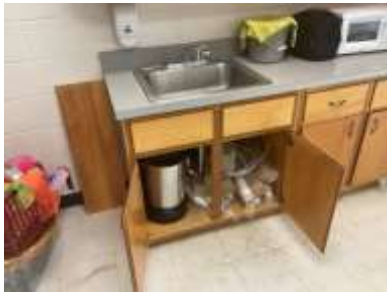
ADA Kitchen & Laundry Areas

Staff Lounge Kitchen counter and sink ADA Maneuverability - AssetCALC ID: 9960593

Uniformat Code: Y1060
Recommendation: **Renovate in 2025**

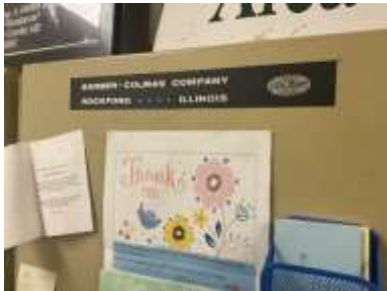
BAS/HVAC Controls in Poor condition.

The facility HVAC is controlled using an outdated pneumatic system supplied by an air compressor. For improved reliability and efficiency and increased control, full conversion to a web-based direct digital control (DDC) platform is highly recommended. A budgetary cost is included in the three-year plan. - AssetCALC ID: 9960418

Uniformat Code: D8010
Recommendation: **Upgrade/Install in 2026**
