# FACILITY CONDITION ASSESSMENT

**Montgomery County Public Schools**  
45 West Gude Drive, Suite 4000  
Rockville, MD 20850

Kingsview Middle School  
18909 Kingsview Road  
Germantown, MD 20874

May 8, 2026

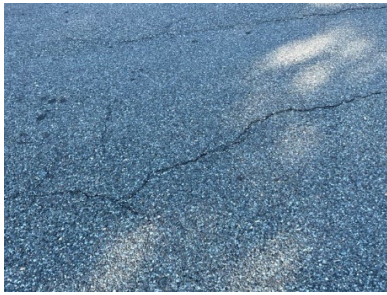
**Parking Lots in Poor Condition.**

Pavement, Asphalt  
Site Kingsview Middle School Site

Asphalt pavement in this area shows multiple cut-and-patch repairs with visible cracking, separation, and surface deterioration. Previous patch work appears uneven and has not held up. - AssetCALC ID: 10200865

Uniformat Code: G2020  
Recommendation: **Cut & Patch in 2027**

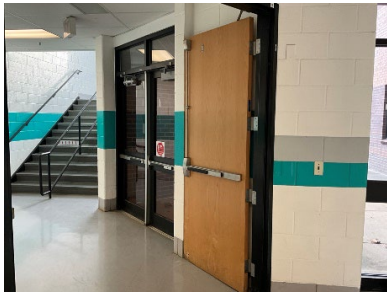
**Interior Door in Poor Condition.**

Steel, Fire-Rated at 90 Minutes or Over  
Main Building Kingsview Middle School  
Hallways

Multiple 90-minute fire-rated corridor doors were observed to be in poor operating condition, with failed or non-functional magnetic hold-open devices. As a result, approximately 80% of the doors do not close properly and are routinely left open, limiting their intended fire and life-safety function. - AssetCALC ID: 10200537

Uniformat Code: C1030  
Recommendation: **Replace in 2026**

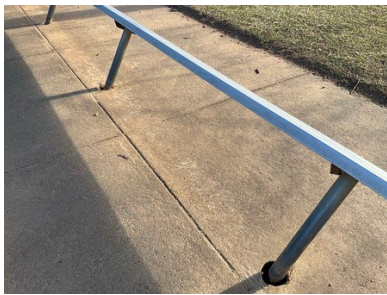
**Sports Apparatus in Failed Condition.**

Player/Dugout Benches, 12' Length  
Site Kingsview Middle School Site

The dugout bench seating does not provide proper support and poses a potential safety concern for users. - AssetCALC ID: 10200857

Uniformat Code: G2050  
Recommendation: **Replace in 2026**

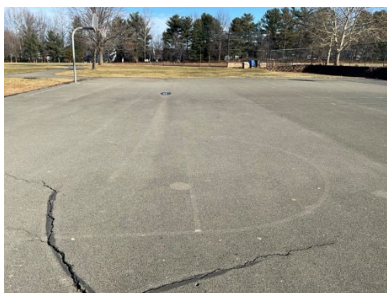
**Athletic Surfaces & Courts in Poor Condition.**

Basketball/General, Asphalt Pavement  
Site Kingsview Middle School Site

The asphalt surface within the basketball court exhibits multiple visible cracks and age-related deterioration. - AssetCALC ID: 10200852

Uniformat Code: G2050  
Recommendation: **Replace in 2027**

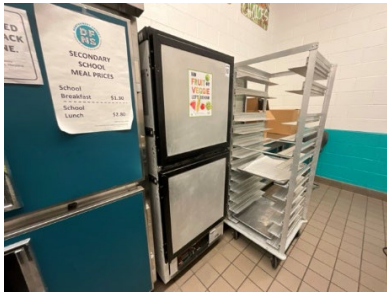
**Foodservice Equipment in Failed Condition.**

Food Warmer, Proofing Cabinet on Wheels  
Main Building Kingsview Middle School Kitchen

The mobile food warmer/proofing cabinet is non-operational at the time of inspection and considered failed. - AssetCALC ID: 10200585

Uniformat Code: E1030  
Recommendation: **Replace in 2026**

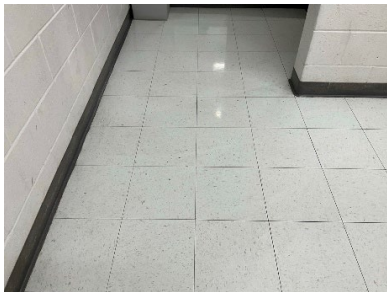
**Flooring in Poor Condition.**

Vinyl Tile (VCT)  
Community Center Kingsview Middle School  
Various

The VCT flooring exhibits widespread cracking, surface wear, cracks, and stains and throughout multiple areas. - AssetCALC ID: 10200894

Uniformat Code: C2030  
Recommendation: **Throughout building in 2027**

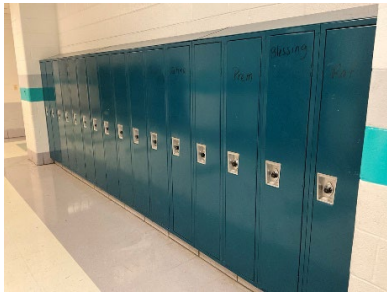
**Lockers in Poor Condition.**

Steel-Baked Enamel, 12" W x 15" D x 72" H  
Main Building Kingsview Middle School  
Hallways & Common Areas

Multiple locker units throughout the corridors do not properly close or latch. The deficiencies are consistent with age-related wear and misalignment. - AssetCALC ID: 10200559

Uniformat Code: C1090  
Recommendation: **Replace in 2027**

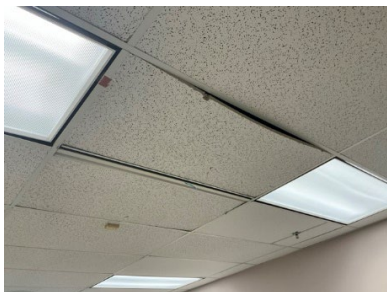
**Suspended Ceilings in Poor Condition.**

Acoustical Tile (ACT)  
Main Building Kingsview Middle School  
Throughout Building

Ceilings tiles are sagging, stained, and cracked throughout the building. - AssetCALC ID: 10200440

Uniformat Code: C1070  
Recommendation: **Replace in 2027**

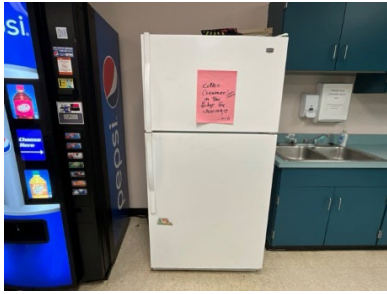
### ADA Kitchen & Laundry Areas

Sink, Height/Location/Clearance  
Main Building Kingsview Middle School Break Room

Uniformat Code: Y1060  
Recommendation: **Modify in 2026**
