FACILITY CONDITION ASSESSMENT

Rosa M. Parks Middle School
19200 Olney Mill Road
Olney, MD 20832

172559.25R000-160.354

May 8, 2026

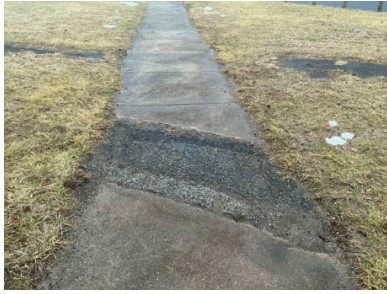
Sidewalk in Poor Condition.

Cracked walkway pavement - AssetCALC ID: 10363929

Any pavement type, Sectional Repairs (per Man-Day)
Site Rosa M. Parks Middle School Site

Uniformat Code: G2030
Recommendation: **Repair in 2026**
