# FACILITY CONDITION ASSESSMENT

**Montgomery County Public Schools**  
45 West Gude Drive, Suite 4000  
Rockville, MD 20850

Ridgeview Middle School  
16600 Raven Rock Drive  
Gaithersburg, MD 20878

May 22, 2026

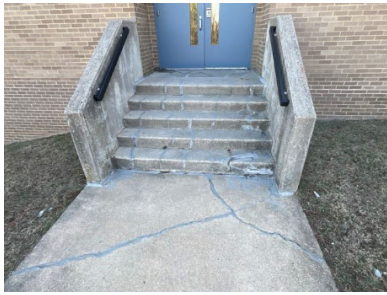
### Site Stairs in Poor condition.

Concrete  
Site Ridgeview Middle School Door 3

Staircase at exterior door 3 has cracks running throughout the concrete. Repairs to seal the cracks have been made but full replacement should be considered in the near term to avoid further damage. - AssetCALC ID: 10819030

Uniformat Code: G2030  
Recommendation: **Replace in 2027**

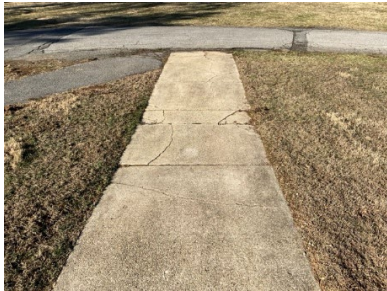
### Sidewalk in Poor condition.

Concrete, Small Areas/Sections  
Site Ridgeview Middle School Site

Small sections of concrete sidewalk are cracking and breaking apart on the side of the school. - AssetCALC ID: 10818991

Uniformat Code: G2030  
Recommendation: **Replace in 2027**

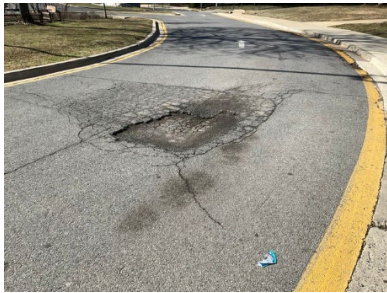
### Parking Lots in Poor condition.

Pavement, Asphalt  
Site Ridgeview Middle School Site

Large pothole in the drop off loop at the front of the building. - AssetCALC ID: 10819061

Uniformat Code: G2020  
Recommendation: **Mill and Overlay in 2027**

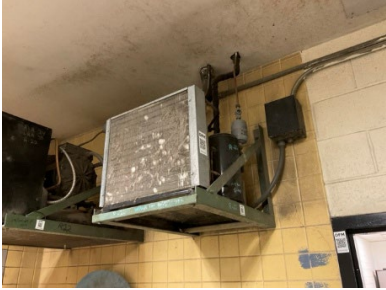
**Foodservice Equipment in Poor condition.**

Walk-In, Condenser for Refrigerator/Freezer  
Main Building Ridgeview Middle School Kitchen

Condenser unit should be located outside of the building but is inside the laundry room at the back of the kitchen. Additionally, the unit is quite old and uses R-22 refrigerant and needs to be replaced. - AssetCALC ID: 10819102

Uniformat Code: E1030  
Recommendation: **Replace in 2026**

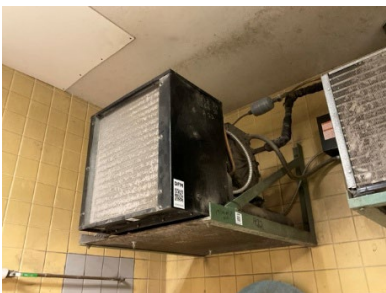
**Foodservice Equipment in Poor condition.**

Walk-In, Condenser for Refrigerator/Freezer  
Main Building Ridgeview Middle School Kitchen

Condenser unit should be located outside of the building but is inside the laundry room at the back of the kitchen. Additionally, the unit is quite old and uses R-22 refrigerant and needs to be replaced. - AssetCALC ID: 10819103

Uniformat Code: E1030  
Recommendation: **Replace in 2026**

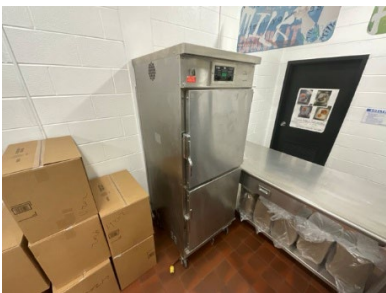
**Foodservice Equipment in Poor condition.**

Steamer, Freestanding  
Main Building Ridgeview Middle School Kitchen

Equipment has been condemned and deemed unsafe to use. - AssetCALC ID: 10819002

Uniformat Code: E1030  
Recommendation: **Replace in 2027**

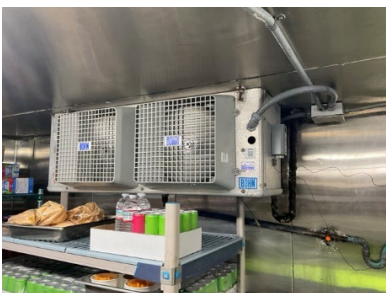
**Foodservice Equipment in Poor condition.**

Walk-In, Evaporator for Refrigerator/Freezer  
Main Building Ridgeview Middle School Kitchen

Building staff noted many recurring issues with old evaporator units in the walk-in freezer and refrigerator. - AssetCALC ID: 10818998

Uniformat Code: E1030  
Recommendation: **Replace in 2027**

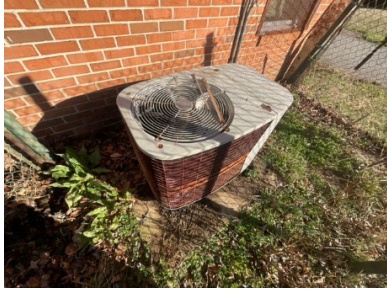
**Split System in Poor condition.**

Condensing Unit/Heat Pump  
Site Ridgeview Middle School Site

Unit is heavily corroded and does not appear to be functional. - AssetCALC ID: 10819196

Uniformat Code: D3030  
Recommendation: **Replace in 2027**

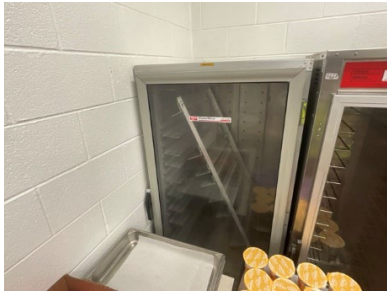
**Foodservice Equipment in Poor condition.**

Food Warmer, Proofing Cabinet on Wheels  
Main Building Ridgeview Middle School Kitchen

Equipment has been condemned and deemed unsafe to use. - AssetCALC ID: 10819010

Uniformat Code: E1030  
Recommendation: **Replace in 2027**

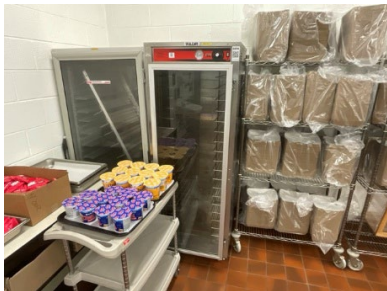
**Foodservice Equipment in Poor condition.**

Food Warmer, Proofing Cabinet on Wheels  
Main Building Ridgeview Middle School Kitchen

Equipment has been condemned and deemed unsafe to use. - AssetCALC ID: 10819011

Uniformat Code: E1030  
Recommendation: **Replace in 2027**

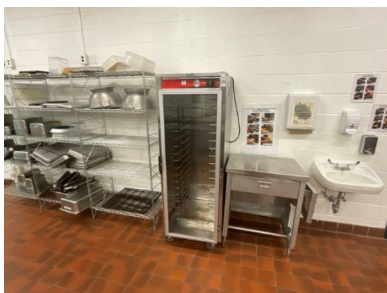
**Foodservice Equipment in Poor condition.**

Food Warmer, Proofing Cabinet on Wheels  
Main Building Ridgeview Middle School Kitchen

Equipment has been condemned and deemed unsafe to use. - AssetCALC ID: 10819111

Uniformat Code: E1030  
Recommendation: **Replace in 2027**

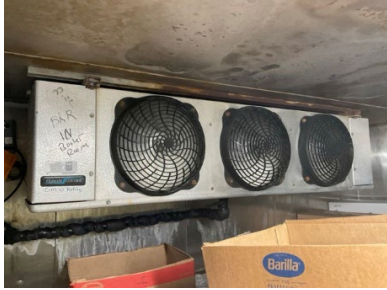
**Foodservice Equipment in Poor condition.**

Walk-In, Evaporator for Refrigerator/Freezer  
Main Building Ridgeview Middle School Kitchen

Building staff noted many recurring issues with old evaporator units in the walk-in freezer and refrigerator. -  
AssetCALC ID: 10819070

Uniformat Code: E1030  
Recommendation: **Replace in 2027**
