FACILITY CONDITION ASSESSMENT

Springbrook High School
201 Valley Brook Drive
Silver Spring, MD 20904

Bureau Veritas
6021 University Boulevard, Suite 200
Ellicott City, MD 21043
800.733.0660
www.bvna.com

May 15, 2026

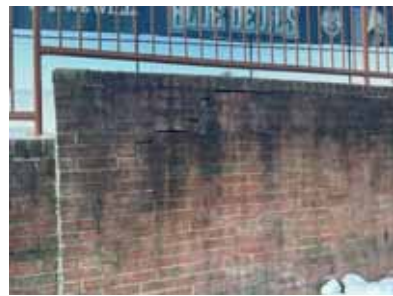
Exterior Walls in Poor condition.

any type, Repairs per Man-Day
Site Springbrook High School Site

Cost allowance to repair retaining wall - AssetCALC ID: 10316224

Uniformat Code: B2010
Recommendation: **Repair in 2026**

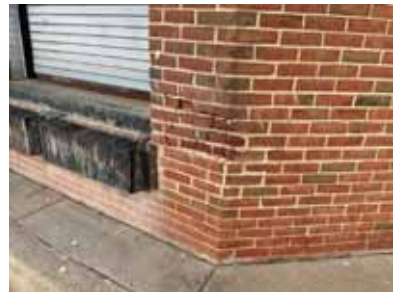
Exterior Walls in Poor condition.

any type, Repairs per Man-Day
Main Building Springbrook High School
Building Exterior

Cost allowance for brick repairs - AssetCALC ID: 10314742

Uniformat Code: B2010
Recommendation: **Repair in 2027**

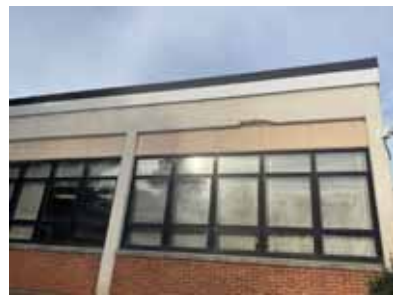
Exterior Walls in Poor condition.

any type, Repairs per Man-Day
Main Building Springbrook High School
Building Exterior

Cost allowance to repair wall - AssetCALC ID: 10314511

Uniformat Code: B2010
Recommendation: **Repair in 2027**

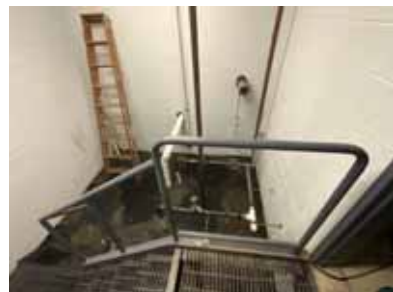
Pump in Failed condition.

Sewage Ejector, Duplex
Main Building Springbrook High School G-7

During the assessment one of pumps failed causing a sewage back up and pungent smell - AssetCALC ID: 10314723

Uniformat Code: D2020
Recommendation: **Replace in 2026**

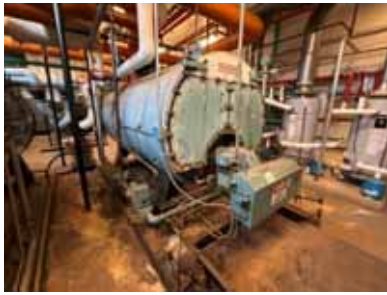
Boiler in Poor condition.

Gas, HVAC
Main Building Springbrook High School B-114

The boiler is exceedingly aged and has heavily rusted areas - AssetCALC ID: 10314739

Uniformat Code: D3020
Recommendation: **Replace in 2027**

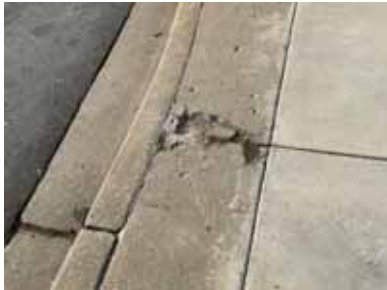
Sidewalk in Poor condition.

Concrete, Small Areas/Sections
Site Springbrook High School Site

Sidewalk has deterioration in isolated areas - AssetCALC ID: 10316233

Uniformat Code: G2030
Recommendation: **Replace in 2027**

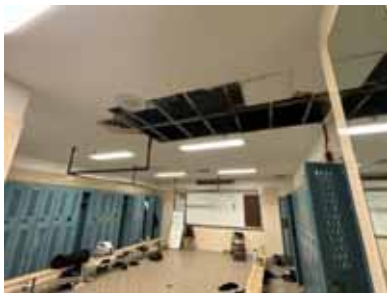
Interior Construction in Poor condition.

any type, Repairs per Man-Day
Main Building Springbrook High School Boys locker room

Cost allowance to replace dry wall - AssetCALC ID: 10314611

Uniformat Code: C1010
Recommendation: **Repair in 2026**

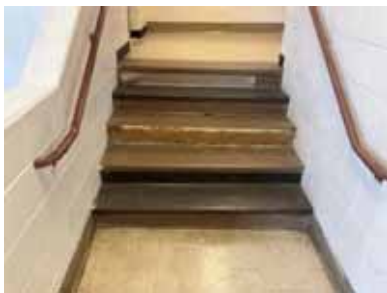
Interior Construction in Poor condition.

any type, Repairs per Man-Day
Main Building Springbrook High School Stairwells

Cost allowance to replace stair treads - AssetCALC ID: 10314637

Uniformat Code: C1010
Recommendation: **Repair in 2027**

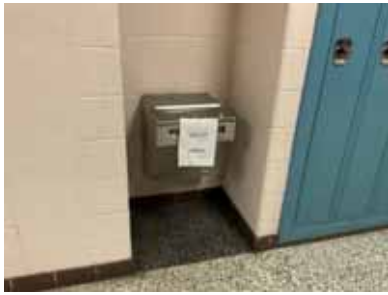
Drinking Fountain in Failed condition.

Wall-Mounted, Single-Level
Main Building Springbrook High School 2nd floor

The fountain is not functional - AssetCALC ID: 10314734

Uniformat Code: D2010
Recommendation: **Replace in 2026**

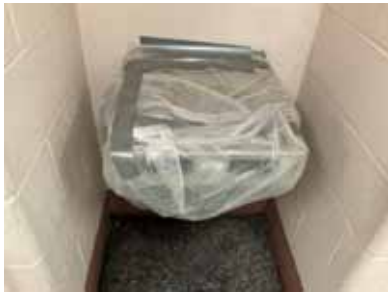
Drinking Fountain in Failed condition.

Wall-Mounted, Single-Level
Main Building Springbrook High School 3rd floor

The drinking fountain is not functional - AssetCALC ID: 10314528

Uniformat Code: D2010
Recommendation: **Replace in 2026**

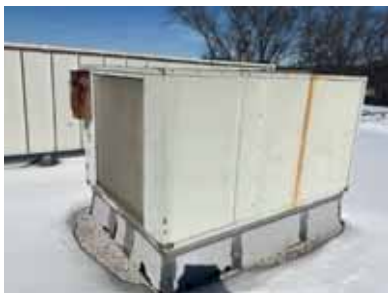
Packaged Unit in Poor condition.

RTU, Pad or Roof-Mounted
Main Building Springbrook High School Roof

The unit is exceedingly aged and requires a phased out refrigerant R-22 - AssetCALC ID: 10314556

Uniformat Code: D3050
Recommendation: **Replace in 2026**

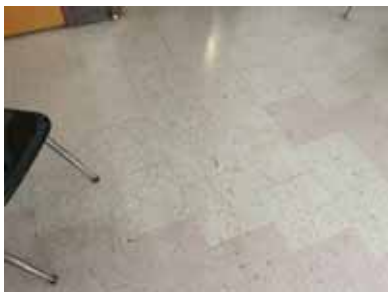
Flooring in Poor condition.

Vinyl Tile (VCT)
Main Building Springbrook High School E211 and E207

The VCT flooring has cracks - AssetCALC ID: 10314646

Uniformat Code: C2030
Recommendation: **Repair in 2026**

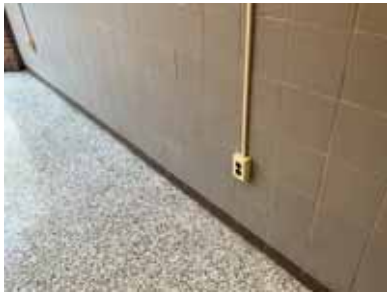
**Recommended Follow-up Study:
Electrical, General Design**

Electrical, General Design
Main Building Springbrook High School
Throughout Building

It was reported that breaker trips under minimal load conditions - AssetCALC ID: 10314592

Uniformat Code: P2030
Recommendation: **Design in 2027**

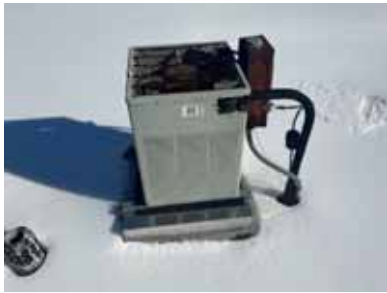
Split System in Poor condition.

Interior & Exterior Component Pairing
Main Building Springbrook High School Roof

The split system is exceedingly aged and requires a phased out refrigerant R-22 - AssetCALC ID: 10314550

Uniformat Code: D3030
Recommendation: **Replace in 2027**

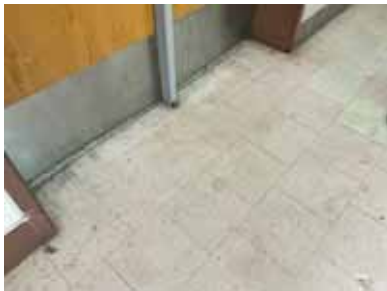
Flooring in Poor condition.

Vinyl Tile (VCT)
Main Building Springbrook High School
Cafeteria

The floor exceedingly aged and worn - AssetCALC ID: 10314543

Uniformat Code: C2030
Recommendation: **Replace in 2027**

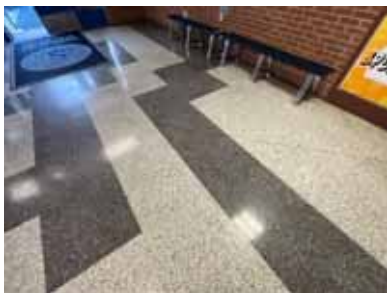
**Recommended Follow-up Study:
Structural, General Design**

Structural, General Design
Main Building Springbrook High School
Throughout Building

The terrazzo flooring throughout the building has cracks - AssetCALC ID: 10314690

Uniformat Code: P2030
Recommendation: **Design in 2027**

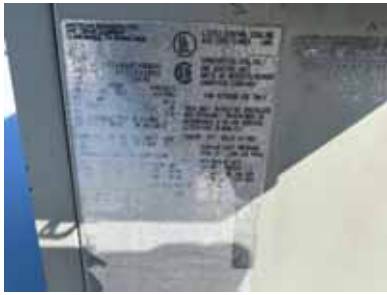
Packaged Unit in Poor condition.

RTU, Pad or Roof-Mounted
Main Building Springbrook High School Roof

The unit is exceedingly aged and requires a phased out refrigerant R-22 - AssetCALC ID: 10314623

Uniformat Code: D3050
Recommendation: **Replace in 2027**

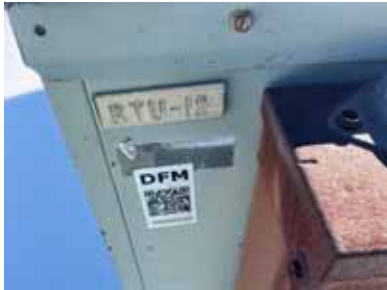
Packaged Unit in Poor condition.

RTU, Pad or Roof-Mounted
Main Building Springbrook High School Roof

The unit is exceedingly aged and requires a phased out refrigerant R-22 - AssetCALC ID: 10314654

Uniformat Code: D3050
Recommendation: **Replace in 2027**

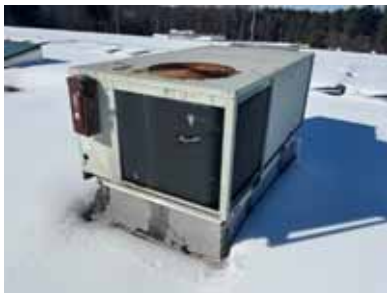
Packaged Unit in Poor condition.

RTU, Pad or Roof-Mounted
Main Building Springbrook High School Roof

The unit is exceedingly aged and requires a phased out refrigerant R-22 - AssetCALC ID: 10314597

Uniformat Code: D3050
Recommendation: **Replace in 2027**

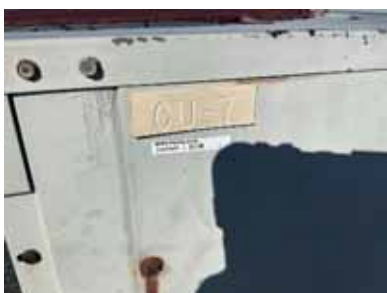
Split System in Poor condition.

Condensing Unit/Heat Pump
Main Building Springbrook High School Roof

The split system is exceedingly aged and requires a phased out refrigerant R-22 - AssetCALC ID: 10314753

Uniformat Code: D3030
Recommendation: **Replace in 2027**

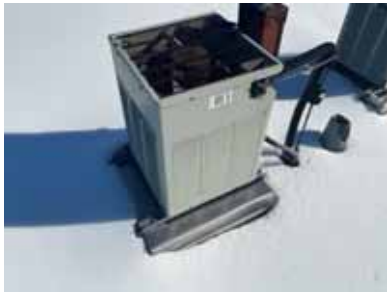
Split System in Poor condition.

Interior and Exterior Component Pairing
Main Building Springbrook High School Roof

The split system is exceedingly aged and requires a phased out refrigerant R-22 - AssetCALC ID: 10314534

Uniformat Code: D3030
Recommendation: **Replace in 2027**

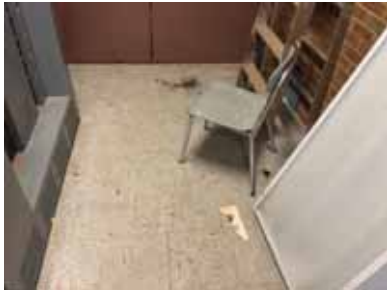
Flooring in Poor condition.

Vinyl Tile (VCT)
Main Building Springbrook High School
Electrical Room Door 39

Scuffed and damaged flooring in main electrical room. - AssetCALC ID: 10693477

Uniformat Code: C2030
Recommendation: **Replace in 2027**
