# FACILITY CONDITION ASSESSMENT

## **Montgomery County Public Schools**

Longview School  
13900 Bromfield Road  
Germantown, MD 20874

*May 28, 2026*

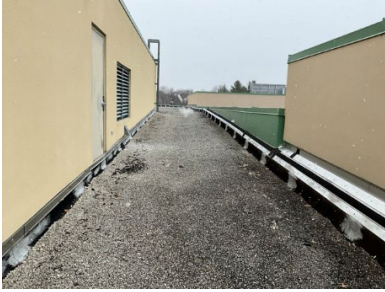
#### Roofing in Poor condition.

Built-Up  
Main Building Longview School Roof

The roof has had recent leaks and is at the end of its expected life. - AssetCALC ID: 10559259

Uniformat Code: B3010  
Recommendation: **Replace in 2027**

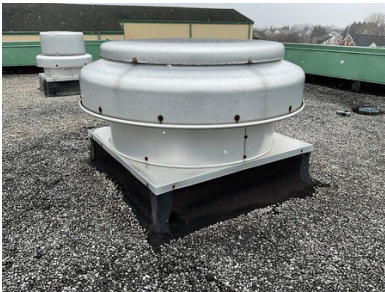
#### Exhaust Fan in Poor condition.

Centrifugal, 42" Damper  
Main Building Longview School Roof

The unit is at the end of its expected life and all are scheduled to be replaced this summer - AssetCALC ID: 10559271

Uniformat Code: D3060  
Recommendation: **Replace in 2026**

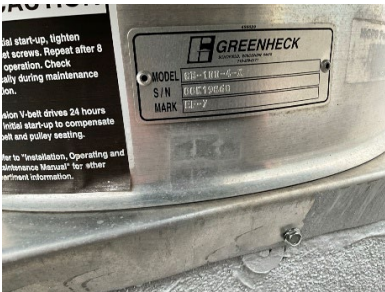
#### Exhaust Fan in Poor condition.

Centrifugal, 24" Damper  
Main Building Longview School Roof

The unit is at the end of its expected life and all are scheduled to be replaced this summer - AssetCALC ID: 10559236

Uniformat Code: D3060  
Recommendation: **Replace in 2027**

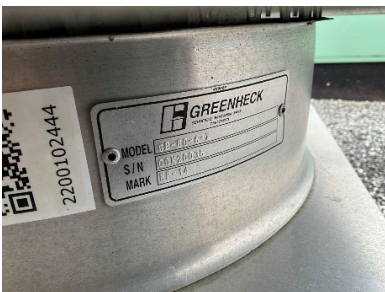
#### Exhaust Fan in Poor condition.

Centrifugal, 24" Damper  
Main Building Longview School Roof

The unit is at the end of its expected life and scheduled to be replaced this summer - AssetCALC ID: 10559275

Uniformat Code: D3060  
Recommendation: **Replace in 2027**

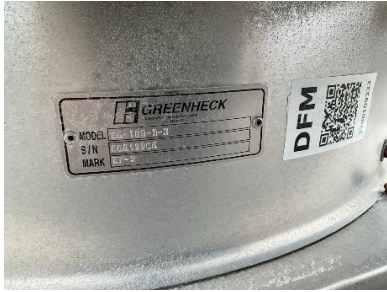
**Exhaust Fan in Poor condition.**

Centrifugal, 24" Damper  
Main Building Longview School Roof

The unit is at the end of its expected life and all are scheduled to be replaced this summer - AssetCALC ID: 10559292

Uniformat Code: D3060  
Recommendation: **Replace in 2027**

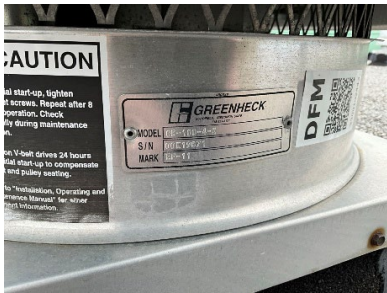
**Exhaust Fan in Poor condition.**

Centrifugal, 24" Damper  
Main Building Longview School Roof

The unit is at the end of its expected life and all are scheduled to be replaced this summer - AssetCALC ID: 10559269

Uniformat Code: D3060  
Recommendation: **Replace in 2027**

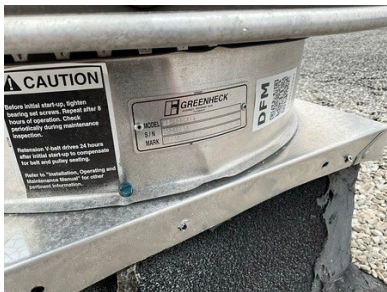
**Exhaust Fan in Poor condition.**

Centrifugal, 24" Damper  
Main Building Longview School Roof

The unit is at the end of its expected life and all are scheduled to be replaced this summer - AssetCALC ID: 10559268

Uniformat Code: D3060  
Recommendation: **Replace in 2027**

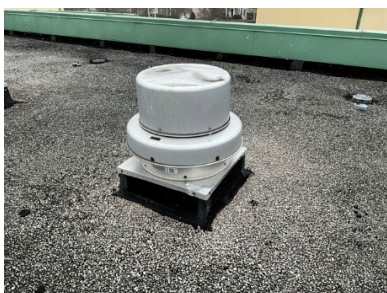
**Exhaust Fan in Poor condition.**

Centrifugal, 24" Damper  
Main Building Longview School Roof

The unit is at the end of its expected life and all are scheduled to be replaced this summer - AssetCALC ID: 10559290

Uniformat Code: D3060  
Recommendation: **Replace in 2027**

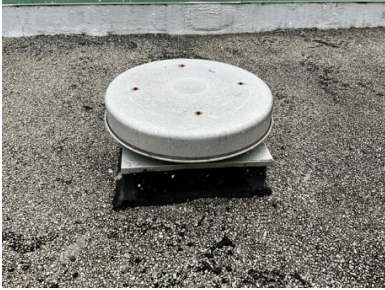
**Exhaust Fan in Poor condition.**

Centrifugal, 36"Damper  
Main Building Longview School Roof

The unit is at the end of its expected life and all are scheduled to be replaced this summer - AssetCALC ID: 10559239

Uniformat Code: D3060  
Recommendation: **Replace in 2027**

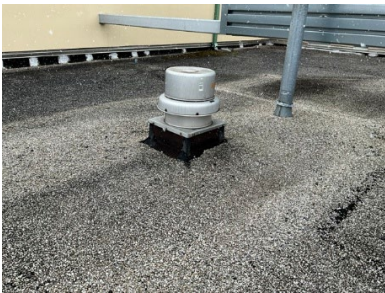
**Exhaust Fan in Poor condition.**

Centrifugal, 36"Damper  
Main Building Longview School Roof

The unit is at the end of its expected life and all are scheduled to be replaced this summer - AssetCALC ID: 10559272

Uniformat Code: D3060  
Recommendation: **Replace in 2027**

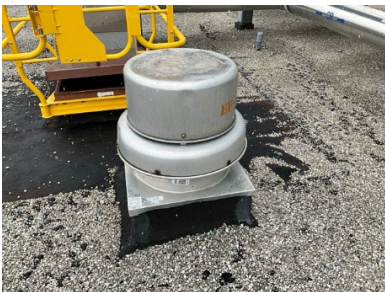
**Exhaust Fan in Poor condition.**

Centrifugal, 24" Damper  
Main Building Longview School Roof

The unit is at the end of its expected life and all are scheduled to be replaced this summer - AssetCALC ID: 10559262

Uniformat Code: D3060  
Recommendation: **Replace in 2027**

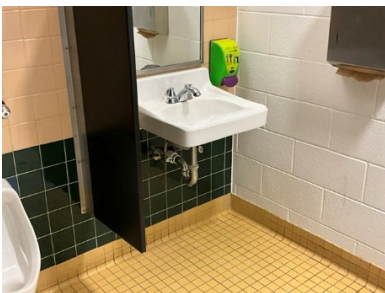
**ADA Restrooms**

Lavatory, Pipe Wraps/Insulation  
Main Building Longview School Throughout Building

Sink drainpipe cover is missing for ADA compliance - AssetCALC ID: 10559300

Uniformat Code: Y1050  
Recommendation: **Install in 2026**

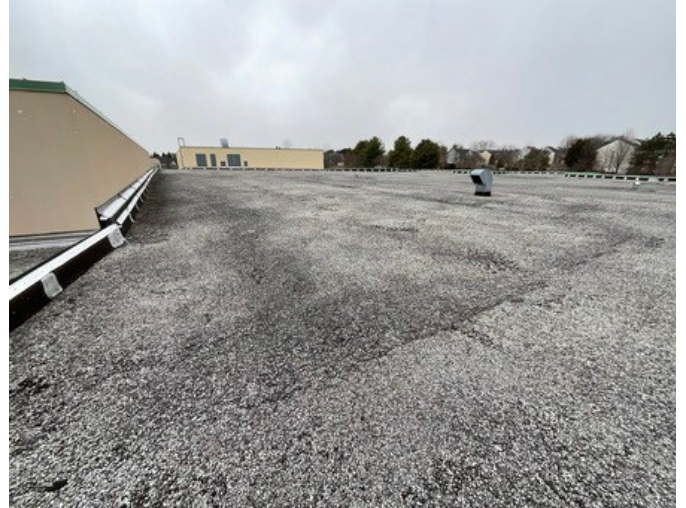
14 - MODIFIED BITUMEN ROOF

The facility has masonry construction with a modified bitumen roof. The roof reportedly leaks sometimes. It is reaching the end of its expected life and is recommended for replacement in the coming years. Overall, the exterior envelope systems and components were observed to be performing adequately. The VCT throughout the building is becoming aged and discolored. It is recommended for replacement in the near term. Apart from this, interior finishes are anticipated for lifecycle replacement based on useful life and normal wear. There has been a history of mold in the autism hallway but it is currently resolved.
