FACILITY CONDITION ASSESSMENT

Montgomery County Public Schools

Carl Sandburg Learning Center
1002 First Street
Rockville, MD 20850

November 10, 2025

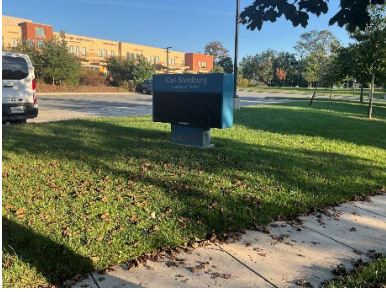
Property, Pylon Robust/Electronic
 Programmable
 Site Carl Sandburg Learning Center Site

However, the electrical property signage is not functioning, and repairs are recommended.

Signage in Failed condition.

Uniformat Code: G2060
 Recommendation: **Replace in 2025**
