# FACILITY CONDITION ASSESSMENT

*prepared for*

172559.25R000-209.354

Up County Early Childhood Center at Emory Grove  
18100 Washington Grove Lane  
Gaithersburg, MD 20877

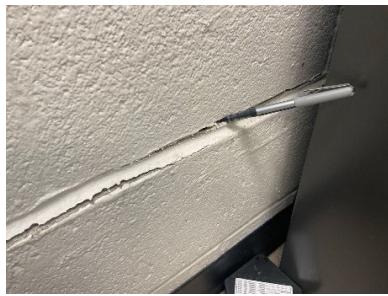
### Structural Elements in Poor condition.

any type, Repairs per Man-Day  
Main Building Up County Early Childhood Center at Emory Grove Office Areas

Isolated areas of the interior CMU walls and exterior brick walls are in poor condition. The interior CMU walls in the main office area show evidence of cracking and movement and the exterior brick walls of this location exhibit cracking brick and popping mortar joints. In addition, the interior CMU walls in the multi-purpose room also have portions of cracked CMU walls. A professional engineer must be retained to analyze the existing condition, provide recommendations and, if necessary, estimate the scope and cost of any required repairs. The cost of this study is included in the cost tables. A budgetary cost allowance for repairs is also included. - AssetCALC ID: 9506237

Uniformat Code: B1010  
Recommendation: **Repair in 2025**

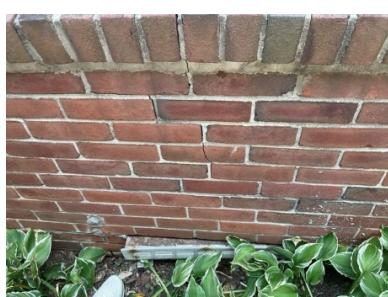
### Recommended Follow-up Study: Structural Superstructure

Isolated areas of the interior CMU walls and exterior brick walls are in poor condition. The interior CMU walls in the main office area show evidence of cracking and movement and the exterior brick walls of this location exhibit cracking brick and popping mortar joints. In addition, the interior CMU walls in the multi-purpose room also have portions of cracked CMU walls. A professional engineer must be retained to analyze the existing condition, provide recommendations and, if necessary, estimate the scope and cost of any required repairs. The cost of this study is included in the cost tables. A budgetary cost allowance for repairs is also included. - AssetCALC ID: 9541396

Uniformat Code: P2030  
Recommendation: **Evaluate/Report in 2025**

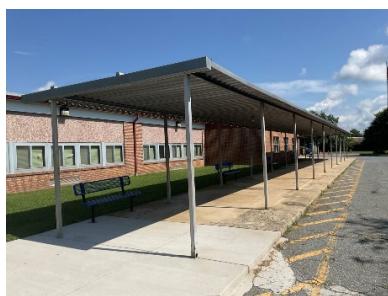
### Roofing in Poor condition.

any type, Repairs per Man-Day  
Site Up County Early Childhood Center at Emory Grove Covered walkway front

The front covered walkway structure has roof leaks at the metal roof - AssetCALC ID: 9541282

Uniformat Code: B3010  
Recommendation: **Repair in 2025**

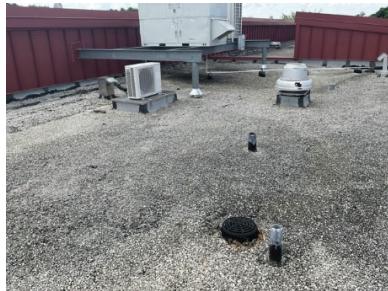
## Roofing in Poor condition.

any type, Repairs per Man-Day  
Main Building Up County Early Childhood Center at Emory Grove Roof

Reported active roof leaks into the commercial kitchen - AssetCALC ID: 9506305

Uniformat Code: B3010  
Recommendation: **Repair in 2025**

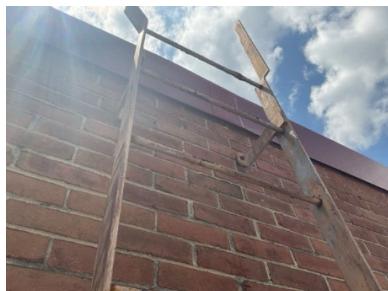
## Roof Appurtenances in Poor condition.

Roof Access Ladder, Steel  
Main Building Up County Early Childhood Center at Emory Grove Roof

The wall-mounted steel ladder at the roof is corroded and loose towards the top - AssetCALC ID: 9506238

Uniformat Code: B3020  
Recommendation: **Replace in 2025**

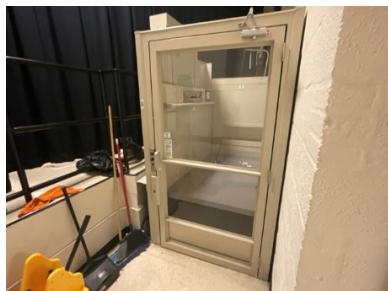
## Vertical Lift in Failed condition.

Wheelchair, 5' Rise  
Main Building Up County Early Childhood Center at Emory Grove Multi-Purpose room stage

The Vertical Lift is reportedly non-functional - AssetCALC ID: 9506385

Uniformat Code: D1010  
Recommendation: **Renovate in 2025**

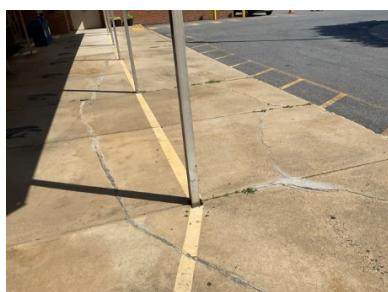
## Sidewalk in Poor condition.

any pavement type, Sectional Repairs (per Man-Day)  
Site Up County Early Childhood Center at Emory Grove Site General

Concrete sidewalk settlement, cracking and spalling at the front and left side (south) of the building. - AssetCALC ID: 9506129

Uniformat Code: G2030  
Recommendation: **Repair in 2025**

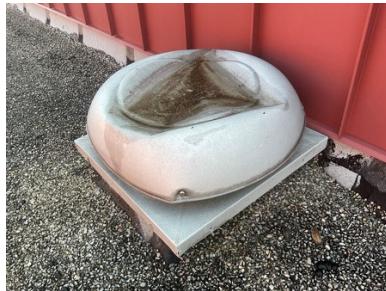
### Exhaust Fan in Poor condition.

Centrifugal, 12" Damper  
Main Building Up County Early Childhood Center at Emory Grove Roof

The exhaust fans are worn and damaged. - AssetCALC ID: 9506242

Uniformat Code: D3060  
Recommendation: **Replace in 2025**

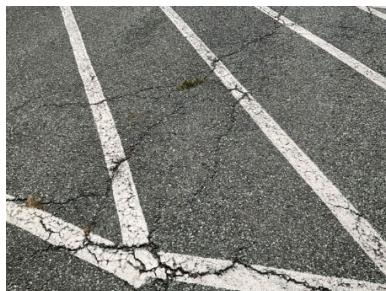
### Parking Lots in Poor condition.

Pavement, Asphalt  
Site Up County Early Childhood Center at Emory Grove Site Parking Areas

Significant areas of alligator cracking and potholes in the parking lots and drive aisles - AssetCALC ID: 9506105

Uniformat Code: G2020  
Recommendation: **Cut & Patch in 2025**

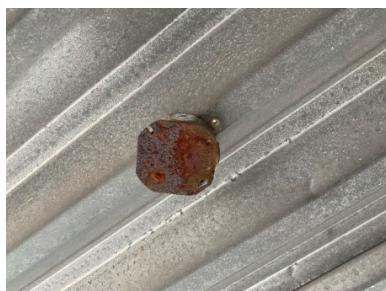
### Exterior Light in Failed condition.

any type, w/ LED Replacement  
Site Up County Early Childhood Center at Emory Grove Covered walkway front

Front covered walkway lights are missing and damaged - AssetCALC ID: 9506106

Uniformat Code: D5040  
Recommendation: **Replace in 2025**

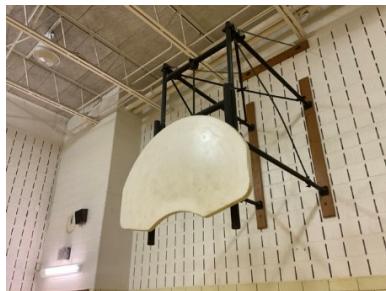
### Basketball Backboard in Failed condition.

Wall-Mounted, Fixed  
Main Building Up County Early Childhood Center at Emory Grove Gymnasium

The basketball backstop is missing the rim/hoop - AssetCALC ID: 9506333

Uniformat Code: E1070  
Recommendation: **Fixed in 2025**

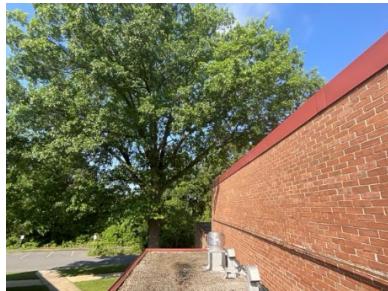
## Landscaping in Poor condition.

Mature Trees, Removal or Heavy Trimming  
Site Up County Early Childhood Center at  
Emory Grove Building Exterior

Overgrown trees with branches overhanging portions of the roof surface, as observed in the courtyard and left side of the building. - AssetCALC ID: 9506120

Uniformat Code: G2080  
Recommendation: **Repair in 2025**

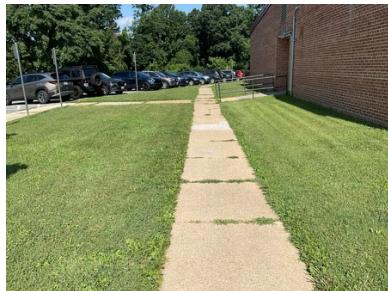
## Recommended Follow-up Study: Civil, Site Drainage

The storm water system appears to provide inadequate site drainage at the school property; the south side of the building (left elevation) has settled concrete sidewalk areas which reportedly has storm water ponding at this area during rainstorms. In addition, the large playground area on the north side of the property appears to have significant water runoff from the adjacent asphalt paved play court onto the wood chips playground surface with evidence of ponding and no proper storm water drainage. It is recommended that a site drainage study be performed at the property to determine the proper corrective action for the drainage issues and to recommend the scope and any necessary repairs. The cost to retain a civil engineering professional is included. A budgetary cost allowance for repairs is also included. - AssetCALC ID: 9506421

Uniformat Code: P2030  
Recommendation: **Evaluate/Report in 2025**

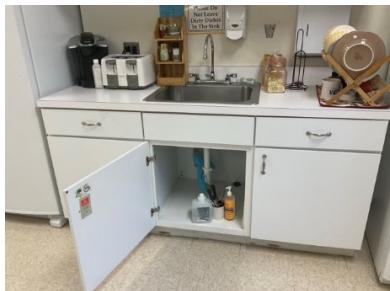
## ADA Restrooms

Lavatory, Pipe Wraps/Insulation  
Main Building Up County Early Childhood Center at Emory Grove Staff lounge

ADA - Staff lounge; sink/counter/maneuverability - AssetCALC ID: 9506332

Uniformat Code: Y1050  
Recommendation: **Install in 2025**

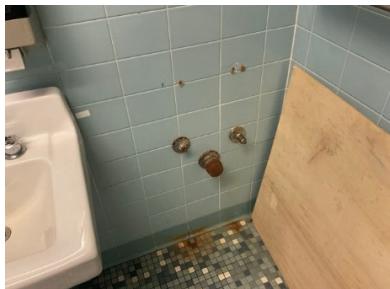
## Sink/Lavatory in Failed condition.

Wall-Hung, Enameled Steel  
Main Building Up County Early Childhood Center at Emory Grove Restrooms

The sinks are missing and have exposed pipes in classrooms 136, 139, 140, & 141 - AssetCALC ID: 9506352

Uniformat Code: D2010  
Recommendation: **Replace in 2025**

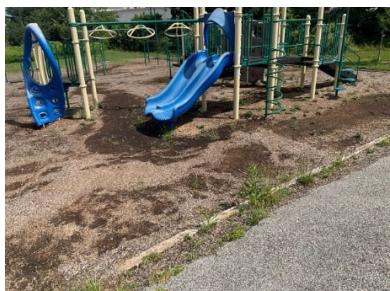
## Playfield Surfaces

Rubber, Poured-in-Place  
Site Up County Early Childhood Center at Emory Grove Site Playground Areas

The play surface is currently wood chips, requiring frequent maintenance and creating an uneven surface that can be challenging to maneuver. Replacement with rubberized surfacing is recommended and included in the five-year plan. - AssetCALC ID: 9506130

Uniformat Code: G2050  
Recommendation: **Replace in 2028**
