# FACILITY CONDITION ASSESSMENT

## **Montgomery County Public Schools**

MacDonal Knolls Early Childhood Center  
10611 Tenbrook Drive  
Silver Spring, MD 20901

*May 15, 2026*

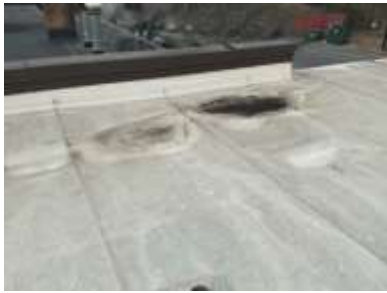
### Roofing in Poor condition.

Single-Ply Membrane, TPO/PVC  
Main Building MacDonald Knolls Early  
Childhood Center Roof

Ponding at parapet walls. Loose membrane at parapet walls. POC reports several roof leaks throughout - AssetCALC ID: 10220409

Uniformat Code: B3010  
Recommendation: **Replace in 2027**

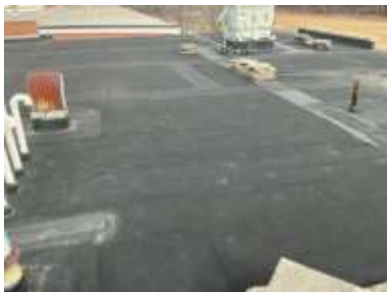
### Roofing in Poor condition.

Single-Ply Membrane, EPDM  
Main Building MacDonald Knolls Early  
Childhood Center Roof

POC reports several roof leaks throughout - AssetCALC ID: 10220446

Uniformat Code: B3010  
Recommendation: **Replace in 2027**

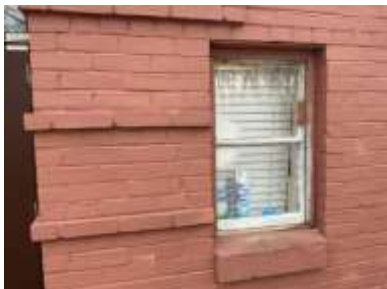
### Glazing in Poor condition.

any type by SF  
Main Building MacDonald Knolls Early  
Childhood Center Building Exterior

All windows are single pane and significantly aged and weather damaged. - AssetCALC ID: 10220440

Uniformat Code: B2020  
Recommendation: **Replace in 2026**

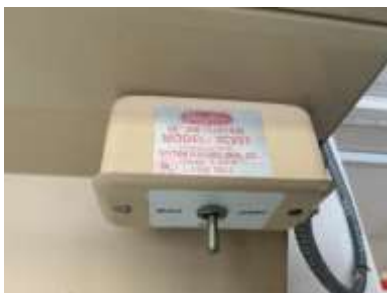
### Supplemental Components in Poor condition.

Air Curtain, 5' Wide Heated  
Main Building MacDonald Knolls Early  
Childhood Center Lobby

POC indicated units does work properly and gives off odor. - AssetCALC ID: 10220382

Uniformat Code: D3060  
Recommendation: **Replace in 2026**

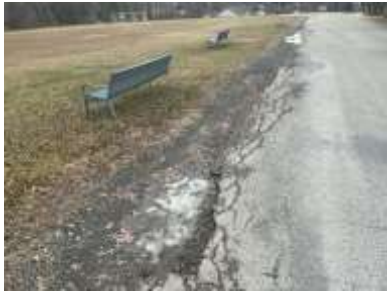
**Roadways in Poor condition.**

Pavement, Asphalt  
 Site MacDonald Knolls Early Childhood Center  
 Rear driveway

Several potholes and missing surface throughout - AssetCALC ID: 10220516

Uniformat Code: G2010  
 Recommendation: **Mill & Overlay in 2027**

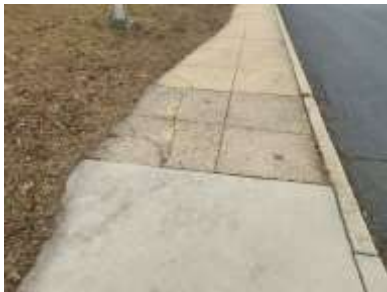
**Parking Lots in Poor condition.**

Pavement, Concrete  
 Site MacDonald Knolls Early Childhood Center  
 Sidewalk Front of Building

Badly cracked sidewalk - AssetCALC ID: 10220499

Uniformat Code: G2020  
 Recommendation: **Replace in 2027**

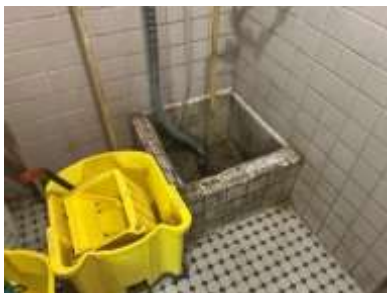
**Sink/Lavatory in Poor condition.**

Service Sink, Floor  
 Main Building MacDonald Knolls Early  
 Childhood Center Janitor Closet

Cracked tile - AssetCALC ID: 10220462

Uniformat Code: D2010  
 Recommendation: **Replace in 2027**

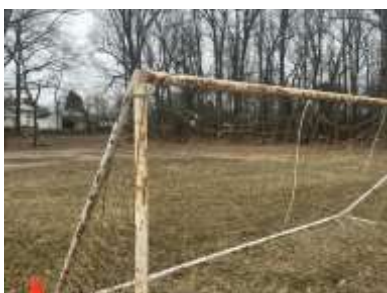
**Sports Apparatus in Poor condition.**

Soccer, Movable Practice Goal  
 Site MacDonald Knolls Early Childhood Center  
 Soccer Field

Rusted throughout and nets broken - AssetCALC ID: 10220495

Uniformat Code: G2050  
 Recommendation: **Replace in 2027**

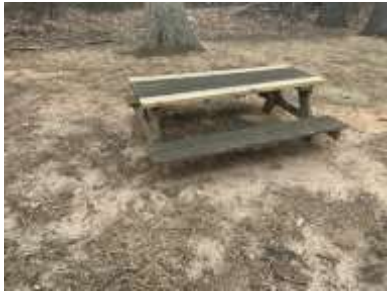
**Picnic Table in Poor condition.**

Wood/Composite/Fiberglass  
 Site MacDonald Knolls Early Childhood Center  
 Site Playground Areas

Weather damaged - AssetCALC ID: 10220491

Uniformat Code: G2060  
 Recommendation: **Replace in 2026**

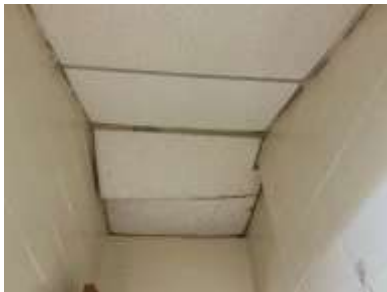
**Suspended Ceilings in Poor condition.**

Acoustical Tile (ACT)  
 Main Building MacDonald Knolls Early  
 Childhood Center Special Needs Classroom

ACT bowed and cracked at special needs entry. - AssetCALC ID: 10220395

Uniformat Code: C1070  
 Recommendation: **Replace in 2027**

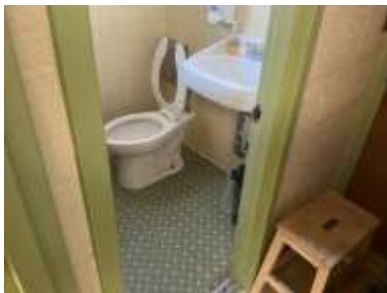
**ADA Restrooms**

Restroom Communal, Full Reconfiguration  
 Main Building MacDonald Knolls Early  
 Childhood Center Health Suite

Bathroom not ADA compliant - AssetCALC ID: 10220432

Uniformat Code: Y1050  
 Recommendation: **Renovate in 2026**

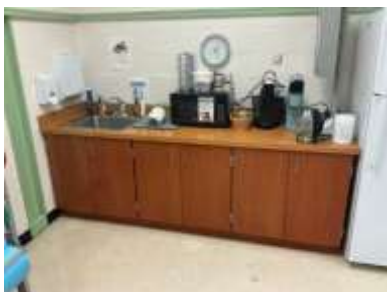
**ADA Kitchen & Laundry Areas**

Kitchen Sink & Counter, Full Reconfiguration  
 Main Building MacDonald Knolls Early  
 Childhood Center Staff lounge

Uniformat Code: Y1060  
 Recommendation: **Renovate in 2026**
