FACILITY CONDITION ASSESSMENT

Montgomery County Public Schools
45 West Gude Drive, Suite 4000
Rockville, MD 20850

Lathrop E. Smith Center
5110 Meadowside Lane
Rockville, MD 20855

June 2, 2026

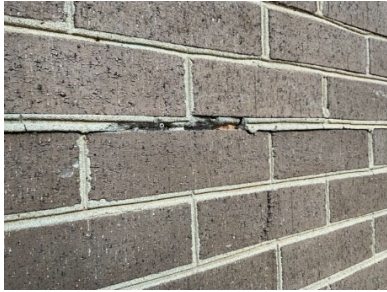
Exterior Walls in Poor condition.

Brick or Brick Veneer, 1-2 Story Building
Dorm Striped Bass Lathrop E. Smith Center
Building Exterior

Uniformat Code: B2010
Recommendation: **Repair/Repoint in 2026**

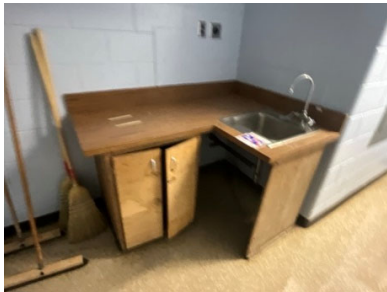
Casework in Poor condition.

Cabinetry, Standard
Dorm Baltimore Oriol Lathrop E. Smith Center
Rear Hallway

Aged, worn, diminished structural integrity - AssetCALC ID: 10386362

Uniformat Code: E2010
Recommendation: **Replace in 2027**

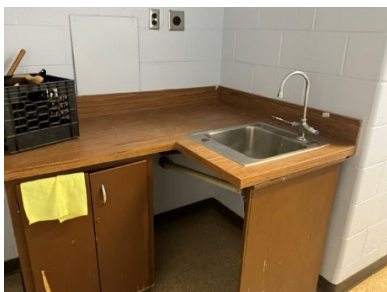
Casework in Poor condition.

Cabinetry, Standard
Dorm Altimore Checkerspot Lathrop E. Smith
Center Rear Hallway

Aged, worn - AssetCALC ID: 10440263

Uniformat Code: E2010
Recommendation: **Replace in 2027**

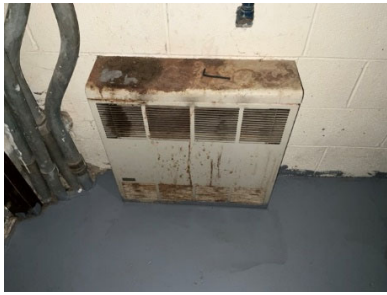
Fan Coil Unit in Poor condition.

Hydronic Terminal
 Dorm Altimore Checkerspot Lathrop E. Smith
 Center Mechanical Room

aged and rusted - AssetCALC ID: 10440274

Uniformat Code: D3050
 Recommendation: **Replace in 2026**
