FACILITY CONDITION ASSESSMENT

Montgomery County Public Schools

Grosvenor Center
5701 Grosvenor Lane
Bethesda, MD 20814

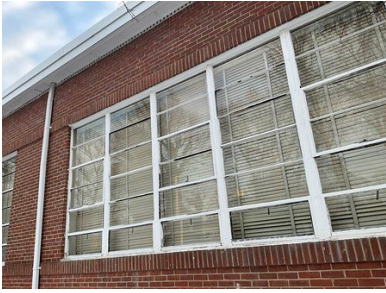
The masonry load bearing structure has single-pane wood windows that are significantly aged and likely causing great energy loss. Near term replacement is recommended for the windows. The built-up roof is performing well with no current leaks reported. Interior finishes are somewhat worn and are anticipated for lifecycle replacement based on useful life and normal wear. The painted concrete flooring in the boiler room has significant wear.

Glazing in Poor condition.

any type by SF
Main Building Grosvenor Center Building
Exterior

Wooden, aged and not double paned - AssetCALC ID: 10293523

Uniformat Code: B2020
Recommendation: **Replace in 2027**

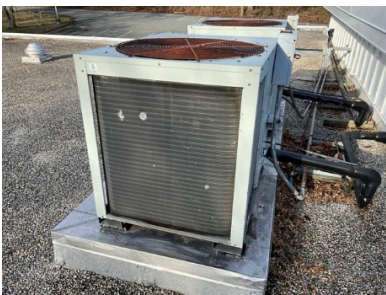
The HVAC equipment has received as-needed upgrades since the building's initial construction, resulting in a range of equipment ages. The building's HVAC is provided by boilers, package units, radiators, and split system condensing units, and ductless split systems on roof and exterior. Scattered exhaust fans are present. A majority of HVAC equipment on the roof is very aged with corrosion evident. These are recommended for replacement in the short term.

Split System in Poor condition.

Condensing Unit/Heat Pump
Main Building Grosvenor Center Roof

The unit is exceedingly aged and rusted - AssetCALC ID: 10703479

Uniformat Code: D3030
Recommendation: **Replace in 2027**

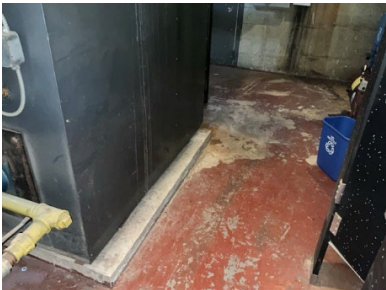
Flooring in Poor condition.

any surface, w/ Paint or Sealant
Main Building Grosvenor Center Boiler Room

The floor paint has significantly peeled - AssetCALC ID: 10293537

Uniformat Code: C2030
Recommendation: **Prep & Paint in 2027**

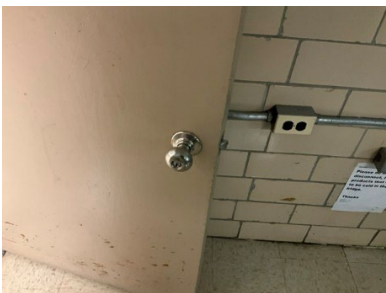
ADA Entrances & Doors

Hardware, Lever Handle
Main Building Grosvenor Center Throughout
Building

Uniformat Code: Y1030
Recommendation: **Install in 2026**
