**BUREAU
VERITAS**

FACILITY CONDITION ASSESSMENT

Radnor Center
7000 Radnor Road
Bethesda, MD 20817

March 28, 2026

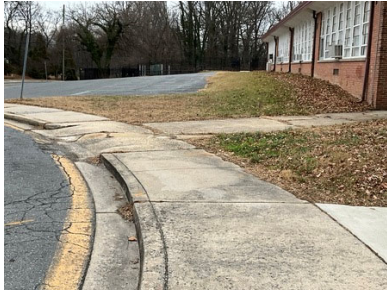
Sidewalk in Poor condition.

Concrete, Small Areas/Sections
Main Building Radnor Center Building Exterior

Concrete sidewalks are significantly cracked in some areas and pose potential trip hazards. - AssetCALC ID: 10207428

Uniformat Code: G2030
Recommendation: **Replace in 2026**

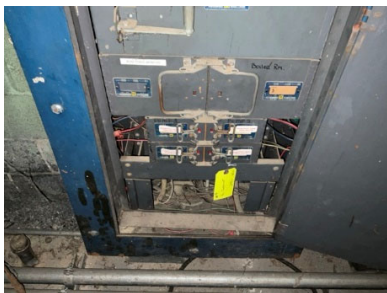
Distribution Panel in Poor condition.

120/240 V
Main Building Radnor Center Mechanical Room

The unit is old and several areas are uncovered - AssetCALC ID: 10207448

Uniformat Code: D5020
Recommendation: **Replace in 2026**

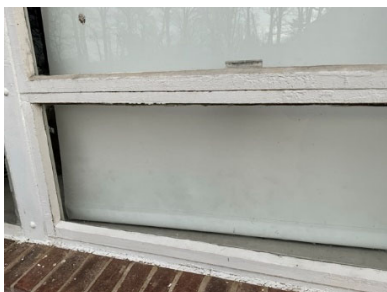
Glazing in Poor condition.

any type by SF
Main Building Radnor Center Building Exterior

Windows are exceedingly aged and single pane - AssetCALC ID: 10207412

Uniformat Code: B2020
Recommendation: **Replace in 2027**

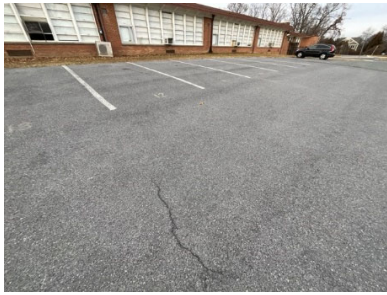
Parking Lots in Poor condition.

Pavement, Asphalt
Site Radnor Center Site

There is cracking and striping is fading - AssetCALC ID: 10207466

Uniformat Code: G2020
Recommendation: **Seal & Stripe in 2027**

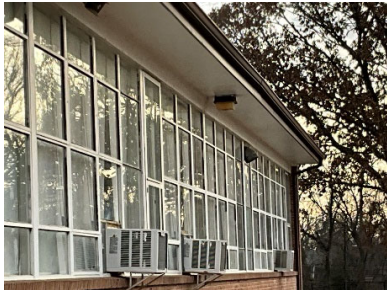
Exterior Light in Poor condition.

any type, w/ LED Replacement
Main Building Radnor Center Building Exterior

Lights are exceedingly aged and corroded. - AssetCALC ID: 10207435

Uniformat Code: D5040
Recommendation: **Replace in 2027**

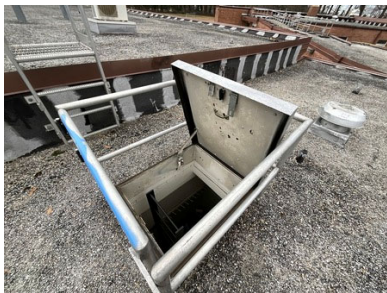
Roof Hatch in Poor condition.

Metal
Main Building Radnor Center Roof

Roof hatch is difficult to open and close. - AssetCALC ID: 10207460

Uniformat Code: B3060
Recommendation: **Replace in 2027**

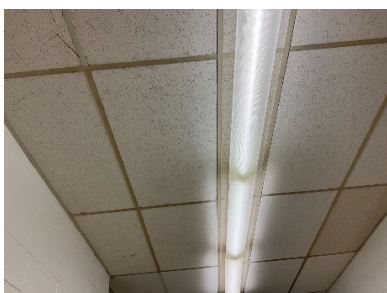
Suspended Ceilings in Poor condition.

Acoustical Tile (ACT)
Main Building Radnor Center Throughout Building

Ceiling tiles and grid are stained and scarred throughout. - AssetCALC ID: 10207461

Uniformat Code: C1070
Recommendation: **Replace in 2027**

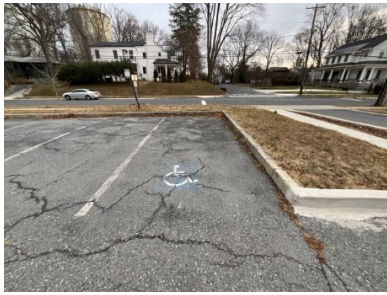
ADA Parking

Signage, Pole-Mounted
Site Radnor Center Site

No pole signage present - AssetCALC ID: 10207413

Uniformat Code: Y1010
Recommendation: **Install in 2026**

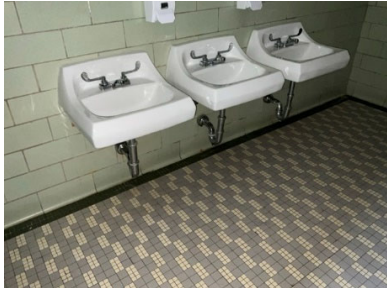
ADA Restrooms

Lavatory, Pipe Wraps/Insulation
Main Building Radnor Center Restrooms

Under sink plumbing is exposed - AssetCALC ID: 10207398

Uniformat Code: Y1050
Recommendation: **Install in 2026**

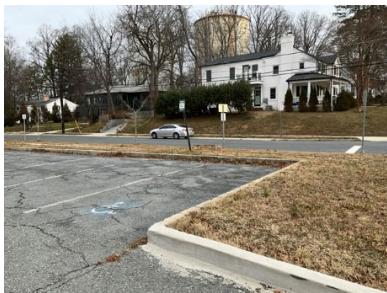
ADA Parking

Designated Stall, Pavement Markings & Signage
Site Radnor Center Site

Not marked as van accessible and no access aisle - AssetCALC ID: 10207451

Uniformat Code: Y1010
Recommendation: **Install in 2026**

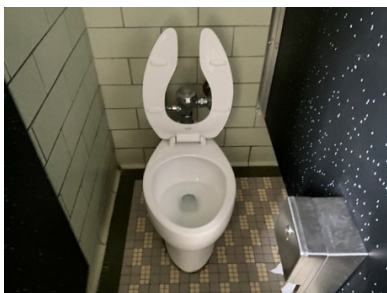
ADA Restrooms

Restroom Layout, Full Reconfiguration
Main Building Radnor Center Restrooms

No accessible bathroom stalls - AssetCALC ID: 10207446

Uniformat Code: Y1050
Recommendation: **Renovate in 2026**

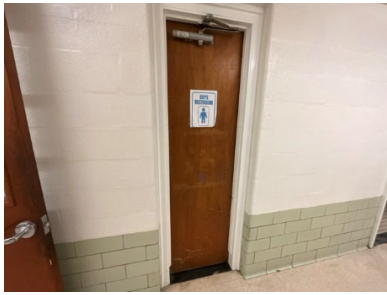
ADA Entrances & Doors

Door Opening, Widen to 32" for Framed Wall
Main Building Radnor Center Throughout
Building

Uniformat Code: Y1030
Recommendation: **Modify in 2026**

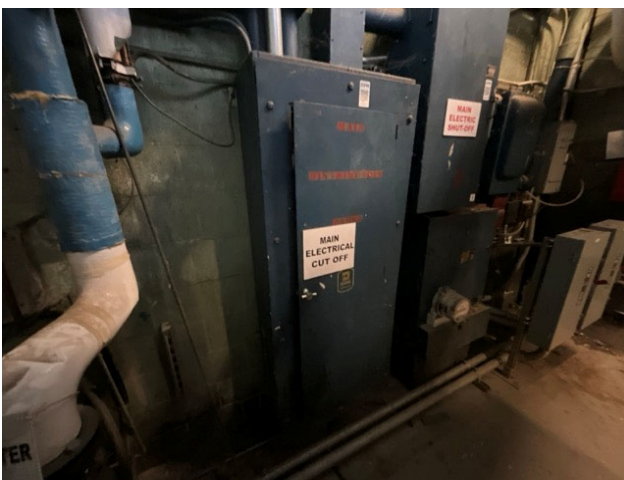
17 - MAIN DISTRIBUTION PANEL

Electrical service equipment and systems appear generally adequate; however, the main distribution panel is significantly aged and is a safety concern due to missing parts of the front shield. A generator and ATS's are in place for backup power.

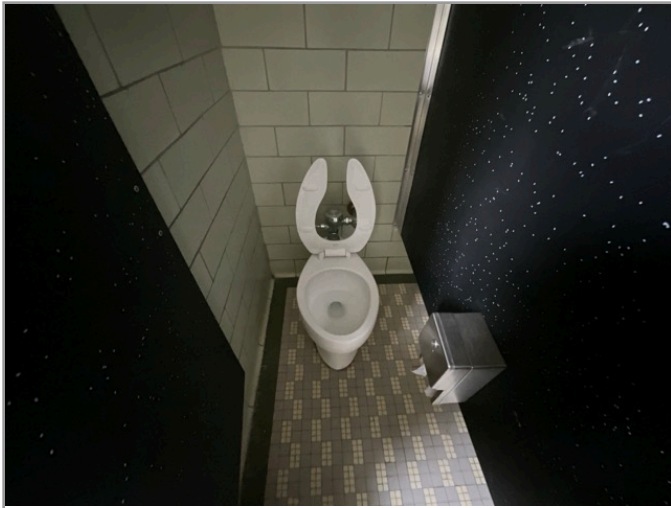
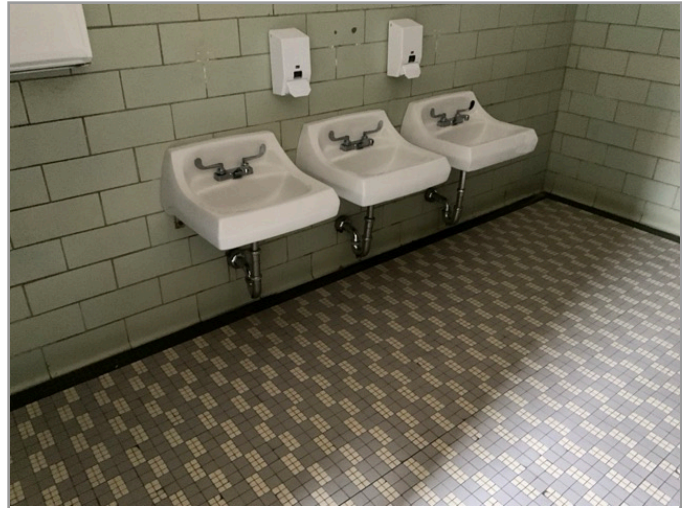
Question		Yes	No	NA	Comments
1	Do publicly accessible toilet rooms appear to have a minimum compliant floor area ?		✗		No accessible bathrooms
2	Does the lavatory appear to be mounted at a compliant height and with compliant knee area ?	✗			
3	Does the lavatory faucet have compliant handles ?	✗			
4	Is the plumbing piping under lavatories configured to protect against contact ?		✗		Not covered
5	Are grab bars provided at compliant locations around the toilet ?		✗		Not present
6	Do toilet stall doors appear to provide the minimum compliant clear width ?		✗		No
