# FACILITY CONDITION ASSESSMENT

**Montgomery County Public Schools**  
45 West Gude Drive, Suite 4000  
Rockville, MD 20850

Concord Center  
7210 Hidden Creek Road  
Bethesda, MD 20817

May 28, 2026

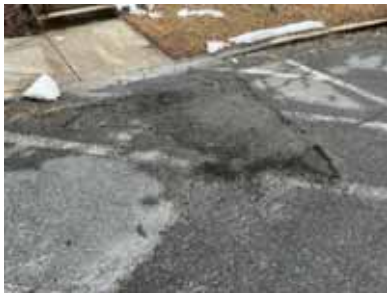
### Roadways in Poor condition.

Pavement, Asphalt  
Site Concord Center Site

Cracked asphalt pavement. - AssetCALC ID: 10429276

Uniformat Code: G2010  
Recommendation: **Mill and Overlay in 2026**

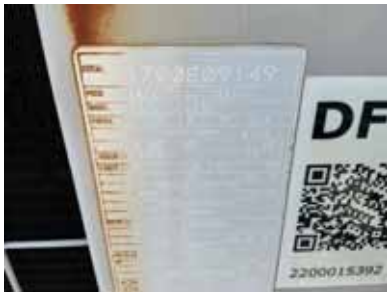
### Split System Pairing in Poor condition.

Interior and Exterior Component, In Tandem, 2  
TON  
Concord Center Concord Center Roof

Split system is exceedingly aged, corroded, and uses R22 outdated refrigerant. - AssetCALC ID: 10429286

Uniformat Code: D3030  
Recommendation: **Replace in 2027**

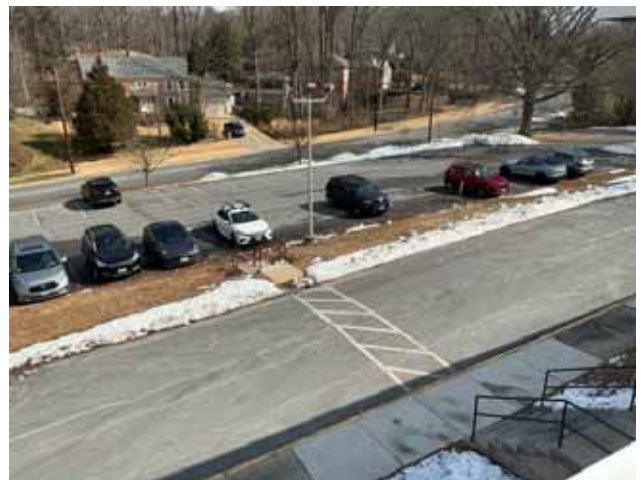
6 - PARKING LOT

The parking lot has developed numerous potholes and heavy surface wear and should be milled and overlaid. The playgrounds and sport courts are generally in fair condition. The majority of the site lighting consists of energy inefficient metal halide and high-pressure sodium fixtures and lamps.

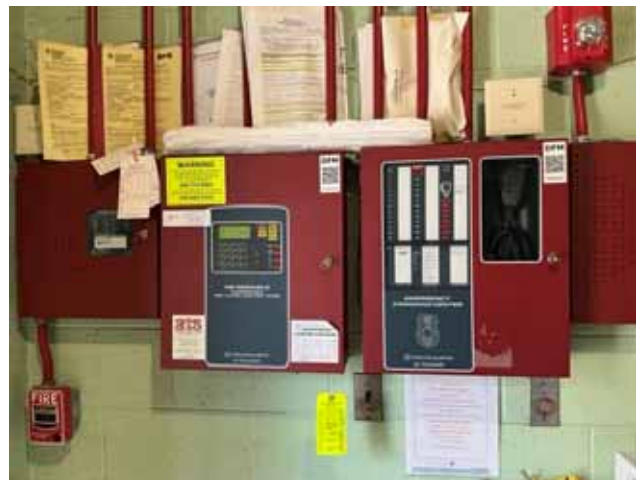
24 - FIRE ALARM PANEL

The central alarm panel appears to be more than 15 years old. Based on its age and because replacement parts and components for this type of equipment may be obsolete, the alarm panel requires replacement.
