# FACILITY CONDITION ASSESSMENT

**Montgomery County Public Schools**  
45 West Gude Drive, Suite 4000  
Rockville, MD 20850

Former Parkside Elementary School  
9500 Brunett Avenue  
Silver Spring, MD 20901

*August 12, 2025*

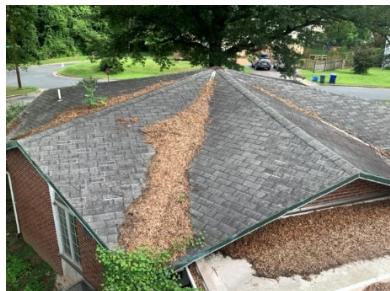
### Roofing in Poor condition.

Asphalt Shingle, 30-Year Premium Main Building Former Parkside Elementary School Roof

Roof appears weathered, covered in debris, supports vegetation growth, and has broken shingles. - AssetCALC ID: 9560700

Recommendation: **Replace in 2026**

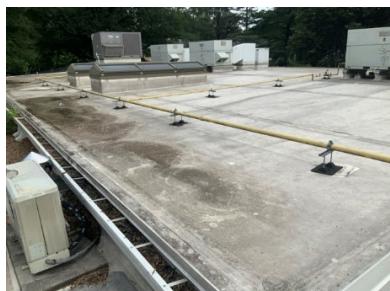
### Roofing in Poor condition.

Single-Ply Membrane, TPO/PVC Main Building Former Parkside Elementary School Roof

Roof has excessive debris, vegetation growth, and history of leaks. - AssetCALC ID: 9560737

Recommendation: **Replace in 2026**

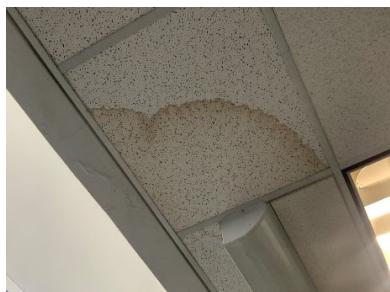
### Interior Construction in Poor condition.

Investigate stained ceiling tile stains near vents and make repairs as necessary. - AssetCALC ID: 9560707

Recommendation: **Repair in 2026**

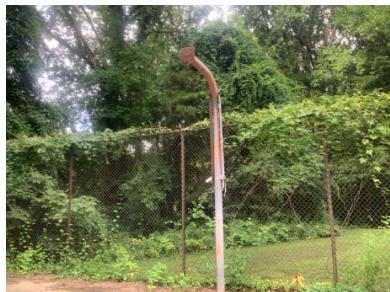
### Sports Apparatus in Poor condition.

Broken backboard and rusted pole - AssetCALC ID: 9560732

Recommendation: **Replace in 2026**
