# FACILITY CONDITION ASSESSMENT

**Montgomery County Public Schools**  
45 West Gude Drive, Suite 4000  
Rockville, MD 20850

Lynnbrook Center  
8001 Lynbrook Drive  
Bethesda, MD 20814

*August 11, 2025*

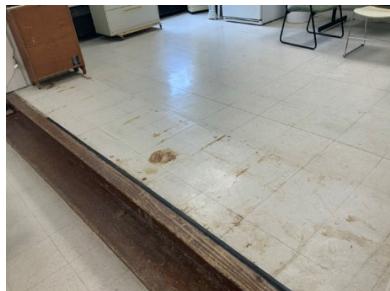
Stained floor - AssetCALC ID: 9554035

### **Flooring in Poor condition.**

Vinyl Tile (VCT), w/ Asbestos Abatement  
Lynnbrook Center Throughout Building

Uniformat Code: C2030  
Recommendation: **Replace in 2026**
