# FACILITY CONDITION ASSESSMENT

## **Montgomery County Public Schools**

Montrose Center  
12301 Academy Way  
Rockville, MD 20852

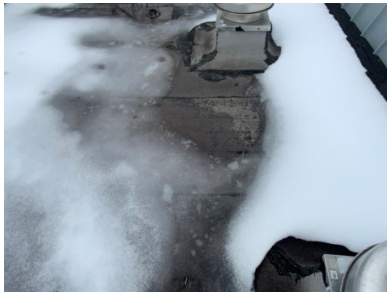
### Roofing in Poor condition.

Modified Bitumen  
Main Building Montrose Center Roof

Active roof leaks present at time of visit - AssetCALC ID: 10388317

Uniformat Code: B3010  
Recommendation: **Replace in 2027**

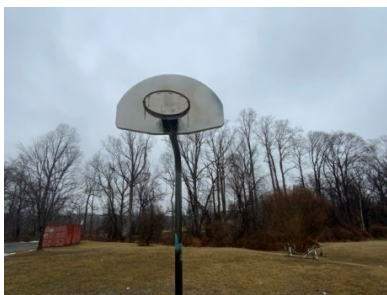
### Sports Apparatus in Poor condition.

Basketball, Backboard w/ Pole  
Site Montrose Center Site Sports Fields & Courts

General deterioration and missing net - AssetCALC ID: 10388426

Uniformat Code: G2050  
Recommendation: **Replace in 2026**

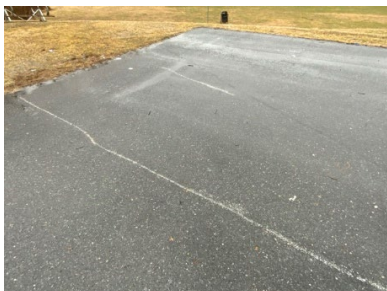
### Athletic Surfaces & Courts in Poor condition.

Basketball/General, Asphalt Pavement  
Site Montrose Center Site Sports Fields & Courts

Paint stripes faded - AssetCALC ID: 10388430

Uniformat Code: G2050  
Recommendation: **Seal & Stripe in 2026**

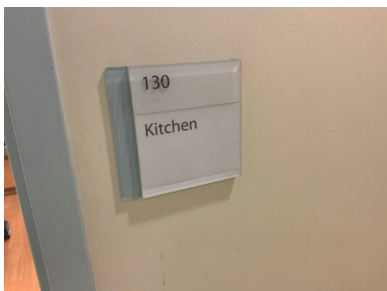
### Signage in Poor condition.

Wall-Mounted, Room Identification  
Main Building Montrose Center Throughout Building

Some of the interior room signage is missing or incorrect. - AssetCALC ID: 10388389

Uniformat Code: C1090  
Recommendation: **Replace in 2027**

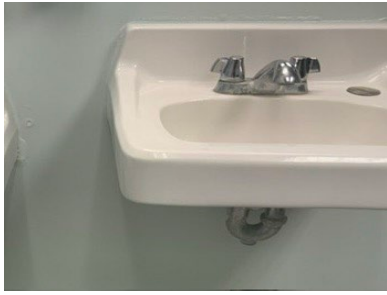
### ADA Restrooms

Lavatory, Pipe Wraps/Insulation  
Main Building Montrose Center Restrooms

Protection around sink traps missing - AssetCALC ID: 10388406

Uniformat Code: Y1050  
Recommendation: **Install in 2026**

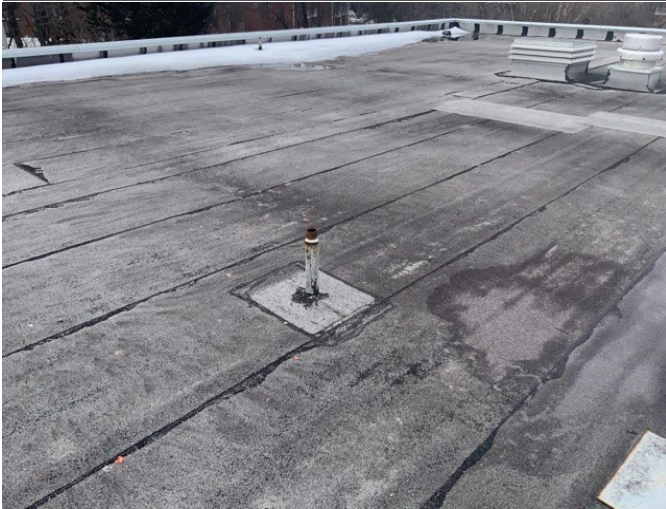
7 - MODIFIED BITUMINOUS ROOFING

The two-story building generally appears structurally sound with no major structural defects observed or reported. The structure is primarily open web steel joists supporting metal deck roof structure supported by CMU bearing walls with brick veneer and EIFS. The primary roof covering is a modified bituminous roof and appears to be in poor condition with several active leaks reported at the time of the visit. The sloped standing seam metal roofs were also observed and appeared in fair condition. Short term lifecycle replacement of the modified bituminous roof is recommended .

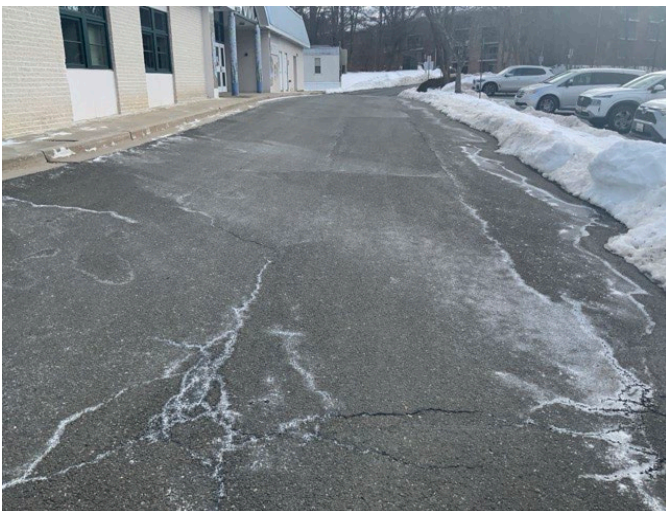
21 - ASPHALT PAVING

The asphalt parking lots are estimated to have been last maintained in 2000 and widespread longitudinal and transverse cracking is visible. Lifecycle replacement is anticipated for the near term. Pavement striping is also in fair condition although some fading is visible. Concrete sidewalk pavement appears in fair condition with some areas of patching evident where underground utilities were run.

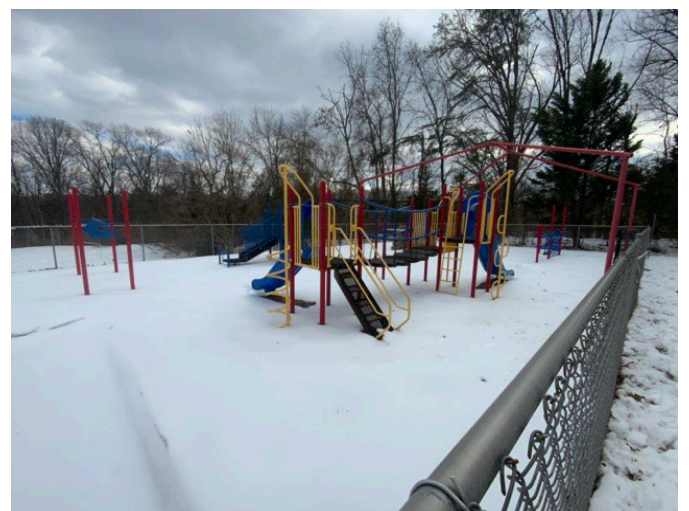
24 - PLAYGROUND OVERVIEW

Site lighting is with pole-mounted LED for some fixtures and wall packs. The basketball court and paving on the north side were not visible due to snow and ice coverage. Playground equipment on the east side appeared in fair condition and near-term lifecycle replacement is anticipated.
