FACILITY CONDITION ASSESSMENT

prepared for

Montgomery County Public Schools
45 West Gude Drive, Suite 4000
Rockville, MD 20850

Rocking Horse Road Center
4910 Macon Road
Rockville, MD 20852

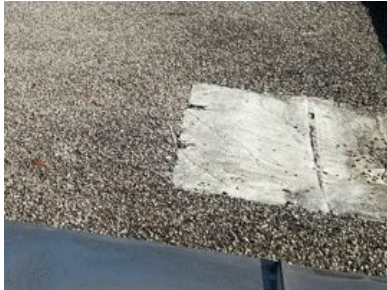
Roofing in Poor Condition.

Any type, Repairs per Man-Day
 Rocking Horse Road Center Rocking Horse
 Road Center Various Locations

roof leaks reported, repairs recommended. - AssetCALC ID: 10496128

Uniformat Code: B3010
 Recommendation: **Repair in 2025**

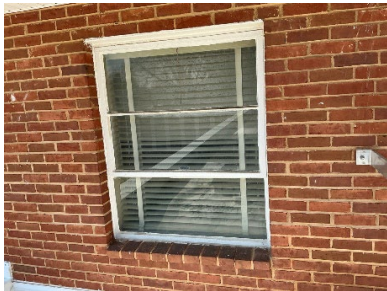
Window in Poor Condition.

Wood, 16-25 SF
 Rocking Horse Road Center Rocking Horse
 Road Center Building Exterior

outdated - AssetCALC ID: 10429156

Uniformat Code: B2020
 Recommendation: **Replace in 2027**

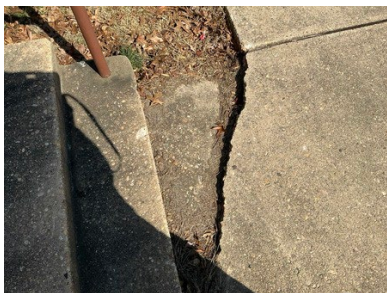
Sidewalk in Poor Condition.

Any pavement type, Sectional Repairs (per
 Man-Day)
 Site Rocking Horse Road Center Site

Uneven sidewalk pavement, Trip hazard - AssetCALC ID: 10429197

Uniformat Code: G2030
 Recommendation: **Repair in 2026**

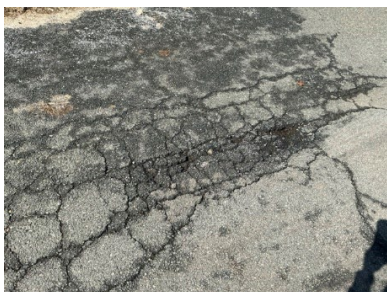
Parking Lots in Poor Condition.

Pavement, Asphalt
 Site Rocking Horse Road Center Site

Cracked asphalt pavement throughout parking lot - AssetCALC ID: 10429098

Uniformat Code: G2020
 Recommendation: **Repair in 2026**

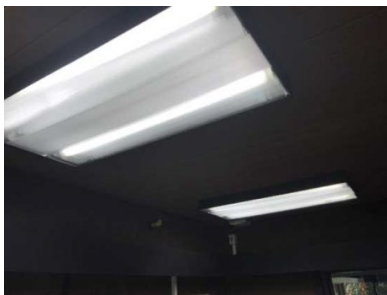
Interior Lighting System in Poor Condition.

The light fixtures throughout most of the facility utilize older, inefficient fluorescent lamps compared to today’s now increasingly affordable and more commonplace LED equivalents. If the facility is to remain in long-term use, replacement with newer LED fixtures is highly recommended to save substantial amounts of energy. - AssetCALC ID: 6940264

Uniformat Code: D5040
 Recommendation: **Replace in 2025**
