# FACILITY CONDITION ASSESSMENT

**Montgomery County Public Schools**  
45 West Gude Drive, Suite 4000  
Rockville, MD 20850

Rollingwood Center  
3200 Woodbine Street  
Chevy Chase, MD 20815

*June 1, 2026*

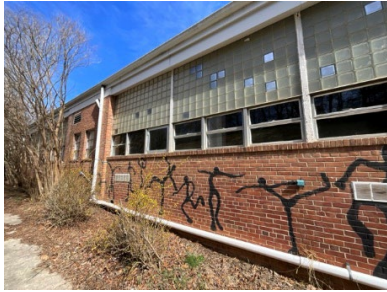
**Glazing in Poor Condition.**

Any type by SF  
Rollingwood Center  
Building Exterior

Windows are very aged and single pane, and no longer function as desired - AssetCALC ID: 10748586

Uniformat Code: B2020  
Recommendation: **Replace in 2027**

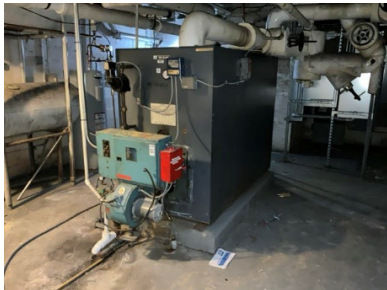
**Boiler in Failed Condition.**

Gas, HVAC  
Rollingwood Center  
Boiler Room

The unit is reportedly non-functional - AssetCALC ID: 10748587

Uniformat Code: D3020  
Recommendation: **Replace in 2026**

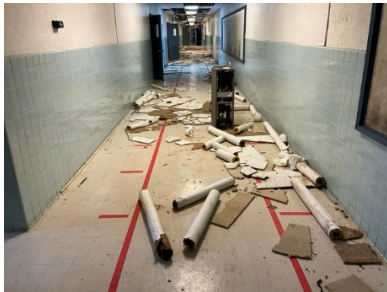
**Plumbing System in Failed Condition.**

Supply & Sanitary, Low Density (excludes fixtures)  
Rollingwood Center  
Throughout Building

Much of the plumbing was stolen, other areas are aged - AssetCALC ID: 10748593

Uniformat Code: D2010  
Recommendation: **Replace in 2026**

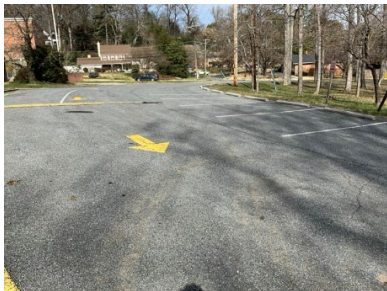
**Parking Lots in Poor Condition.**

Pavement, Asphalt  
Rollingwood Center  
Site

There is cracking and the striping is fading - AssetCALC ID: 10750872

Uniformat Code: G2020  
Recommendation: **Seal & Stripe in 2027**

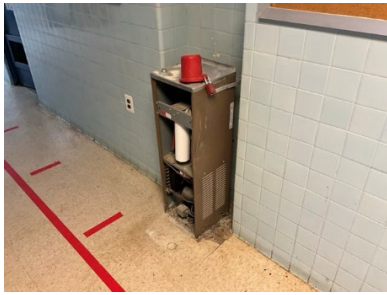
**Drinking Fountain in Failed Condition.**

Wall-Mounted, Single-Level  
Rollingwood Center  
Hallways & Common Areas

The units are damaged and unusable - AssetCALC ID: 10748555

Uniformat Code: D2010  
Recommendation: **Replace in 2026**

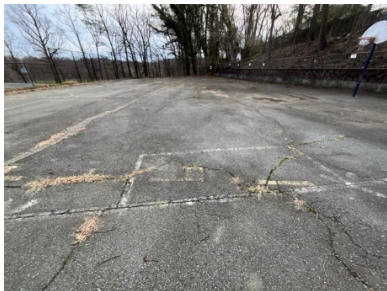
**Athletic Surfaces & Courts in Poor Condition.**

Basketball/General, Asphalt Pavement  
Rollingwood Center  
Site

The court is uneven and damaged - AssetCALC ID: 10750878

Uniformat Code: G2050  
Recommendation: **Mill & Overlay in 2027**

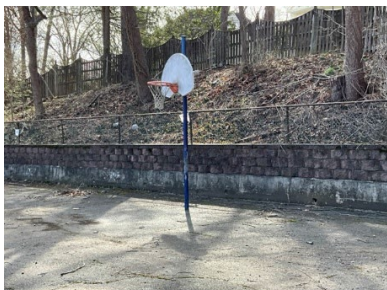
**Sports Apparatus in Poor Condition.**

Basketball, Backboard/Rim/Pole  
Rollingwood Center  
Site

The poles are aged and have degraded - AssetCALC ID: 10750874

Uniformat Code: G2050  
Recommendation: **Replace in 2027**

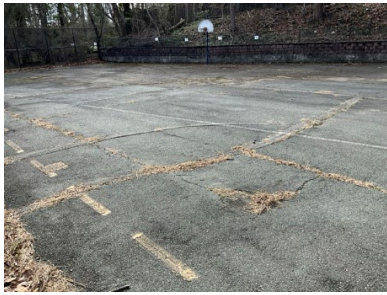
**Athletic Surfaces & Courts in Poor Condition.**

Basketball/General, Asphalt Pavement  
Rollingwood Center  
Site

The court is uneven and cracking - AssetCALC ID: 10750875

Uniformat Code: G2050  
Recommendation: **Seal & Stripe in 2027**

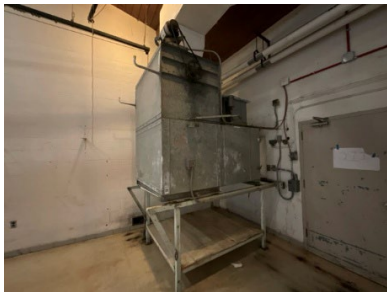
**Air Handler in Failed Condition.**

Interior AHU, Easy/Moderate Access  
Rollingwood Center  
Gymnasium

HVAC no longer functioning - AssetCALC ID: 10748569

Uniformat Code: D3050  
Recommendation: **Replace in 2026**

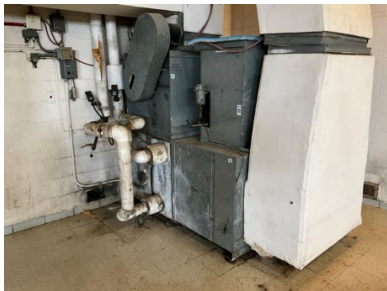
**Air Handler in Failed Condition.**

Interior AHU, Easy/Moderate Access  
Rollingwood Center  
Gymnasium

HVAC no longer functioning - AssetCALC ID: 10748592

Uniformat Code: D3050  
Recommendation: **Replace in 2026**

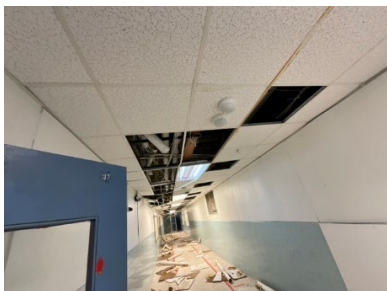
**Suspended Ceilings in Poor Condition.**

Acoustical Tile (ACT)  
Rollingwood Center  
Throughout Building

The ACT is heavily damaged throughout, especially on the lower floor - AssetCALC ID: 10748577

Uniformat Code: C1070  
Recommendation: **Replace in 2026**

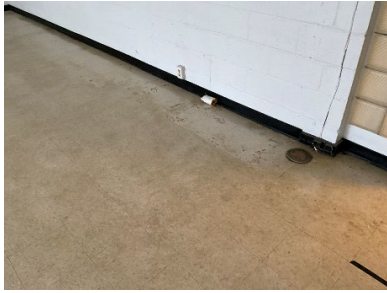
**Flooring in Poor Condition.**

Vinyl Tile (VCT)  
Rollingwood Center  
Throughout Building

The VCT is faded and cracked - AssetCALC ID: 10748567

Uniformat Code: C2030  
Recommendation: **Replace in 2027**

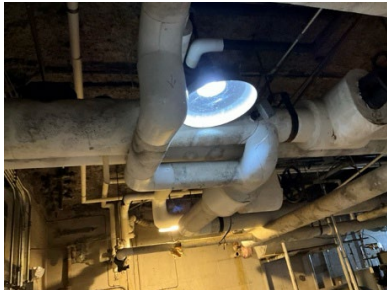
**Interior Lighting System in Poor Condition.**

Full Upgrade, High Density & Standard Fixtures  
Rollingwood Center  
Throughout Building

Much of the lightning is old and rusted - AssetCALC ID: 10748591

Uniformat Code: D5040  
Recommendation: **Replace in 2027**

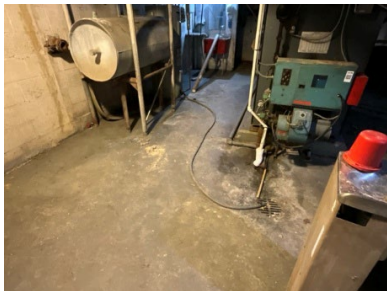
**Flooring in Poor Condition.**

Any surface, with Paint or Sealant  
Rollingwood Center  
Boiler Room

The paint is cracked and peeled - AssetCALC ID: 10748562

Uniformat Code: C2030  
Recommendation: **Prep & Paint in 2027**

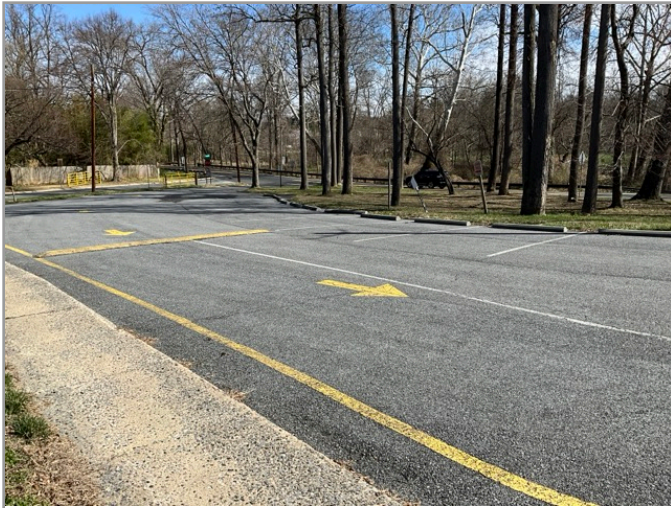
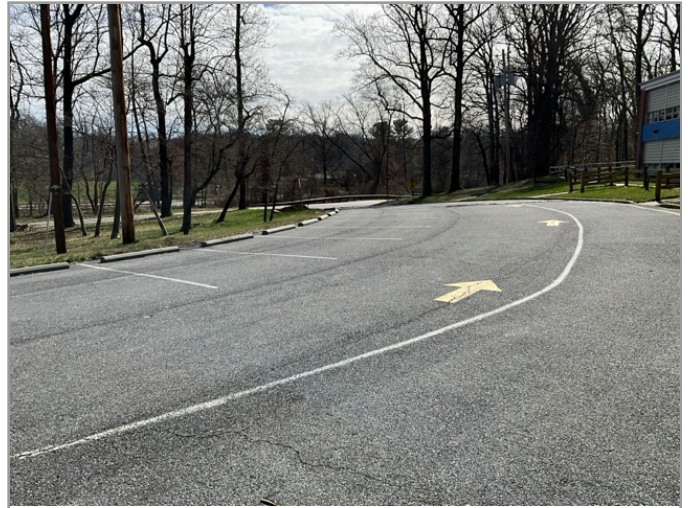
NO ADA PARKING OBSERVED

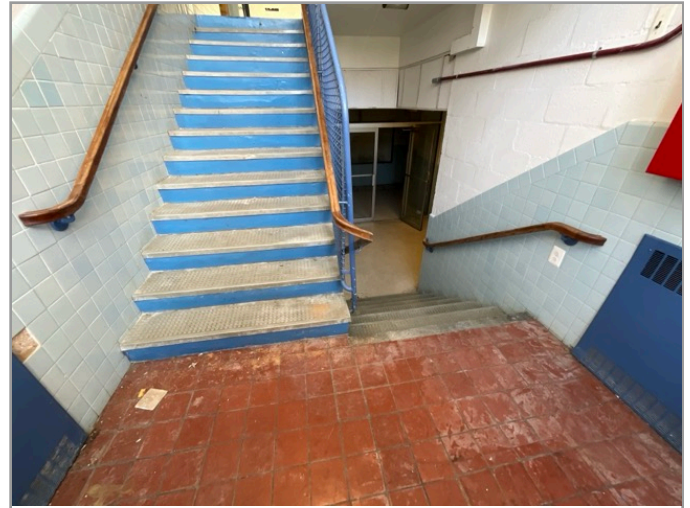
LACK OF PATH

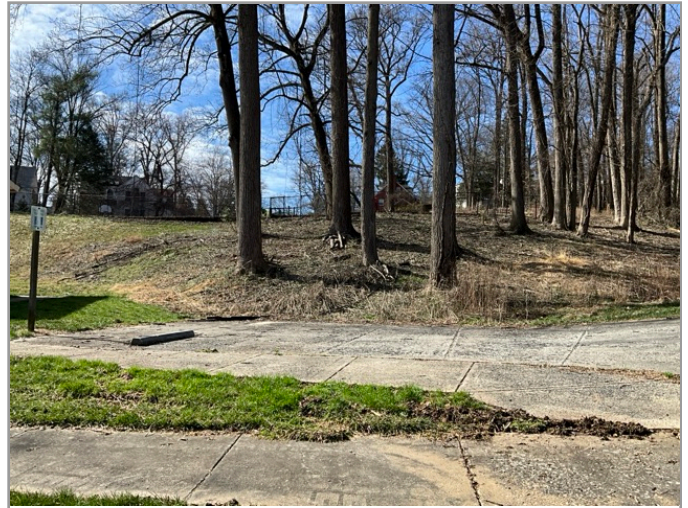
NO ACCESSIBLE ROUTE TO PLAYGROUND
