FACILITY CONDITION ASSESSMENT

Montgomery County Public Schools
45 West Gude Drive, Suite 4000
Rockville, MD 20850

Edward U. Taylor Center
19501 White Ground Road
Boyd's, MD 20841

May 28, 2026

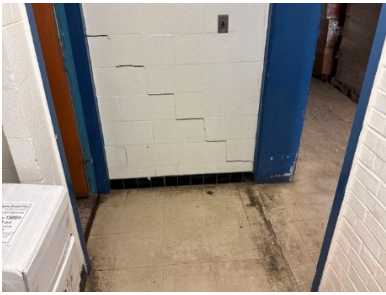
Recommended Follow-up Study: Civil, General Design

Severe structural cracking in CMU walls caused by earthquake fifteen years ago. Cracks have reportedly continued to grow over time. - AssetCALC ID: 10440441

Uniformat Code: P2030
Recommendation: **Design in 2026**

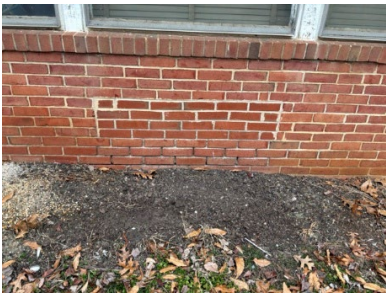
Exterior Walls in Poor condition.

Isolated evidence of deteriorated mortar to be repointed. - AssetCALC ID: 10440433

Uniformat Code: B2010
Recommendation: **Repair/Repoint in 2026**

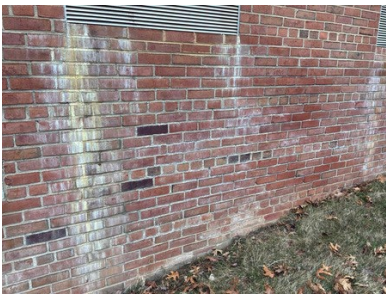
Exterior Walls in Poor condition.

Staining observed throughout brick exteriors. - AssetCALC ID: 10440465

Uniformat Code: B2010
Recommendation: **Maintain in 2027**

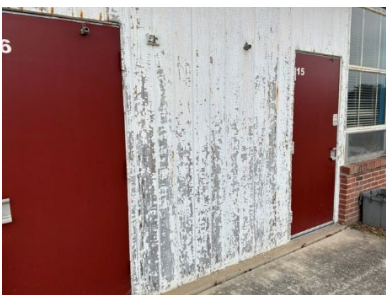
Exterior Walls in Poor condition.

Flaking paint on wood siding throughout exteriors. - AssetCALC ID: 10440436

Uniformat Code: B2010
Recommendation: **Prep and Paint in 2027**

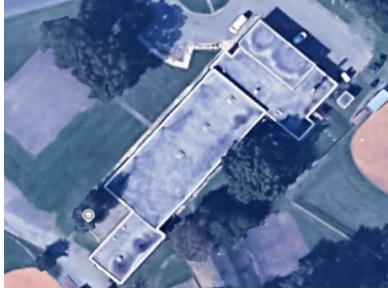
Roofing in Poor condition.

The roofing could not be directly observed due to a lack of safe access (no interior roof hatch). However, consistent evidence of roof leaks were observed throughout the building by way of various stained and damaged ceiling tiles. - AssetCALC ID: 10440473

Uniformat Code: B3010
Recommendation: **Replace in 2027**

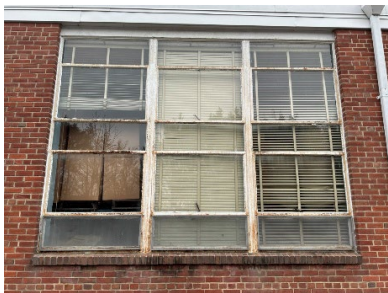
Glazing in Poor condition.

Wooden windows are deteriorated and single pane. - AssetCALC ID: 10440418

Uniformat Code: B2020
Recommendation: **Replace in 2027**

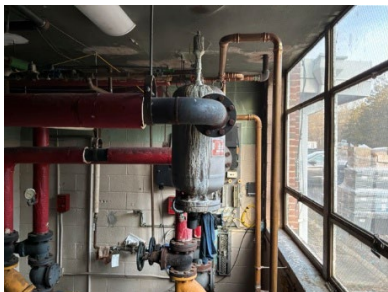
Boiler Supplemental Components in Poor condition.

Evidence of leaks. - AssetCALC ID: 10440404

Uniformat Code: D3020
Recommendation: **Replace in 2027**

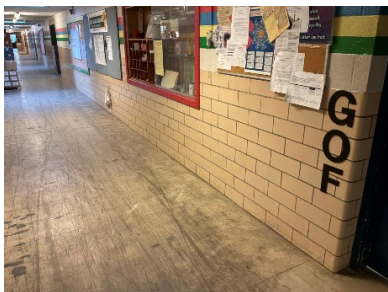
Wall Finishes in Poor condition.

Damage to aging tile finishes in hallways. - AssetCALC ID: 10440471

Uniformat Code: C2010
Recommendation: **Replace in 2027**

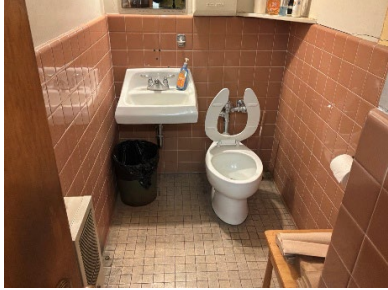
Wall Finishes in Poor condition.

Ceramic tile is aged and damaged from result of earthquake. - AssetCALC ID: 10440429

Uniformat Code: C2010
Recommendation: **Replace in 2027**

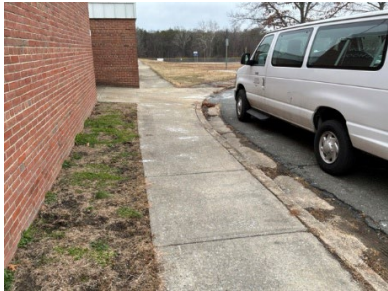
Sidewalk in Poor condition.

Concrete walkways are damaged and uneven. - AssetCALC ID: 10440434

Uniformat Code: G2030
Recommendation: **Replace in 2027**

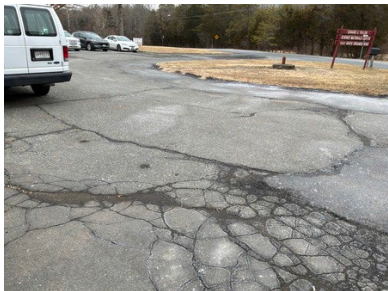
Parking Lots in Poor condition.

Asphalt pavement throughout site is severely deteriorated with alligator cracking and potholes. - AssetCALC ID: 10440466

Uniformat Code: G2020
Recommendation: **Mill and Overlay in 2027**

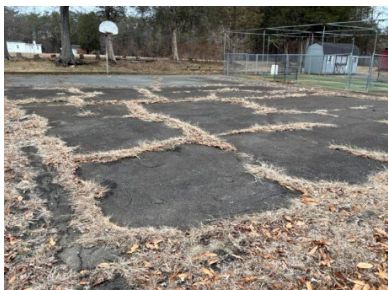
Athletic Surfaces and Courts in Poor condition.

Significant cracking overgrown by weeds. - AssetCALC ID: 10440408

Uniformat Code: G2050
Recommendation: **Replace in 2027**

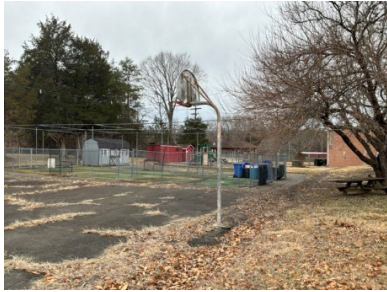
Sports Apparatus in Poor condition.

Corroded and missing nets. - AssetCALC ID: 10440405

Uniformat Code: G2050
 Recommendation: **Replace in 2027**

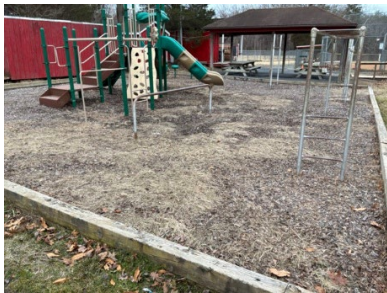
Playground Surfaces in Poor condition.

Wood chips overtaken by weeds. - AssetCALC ID: 10440484

Uniformat Code: G2050
 Recommendation: **Replace in 2027**

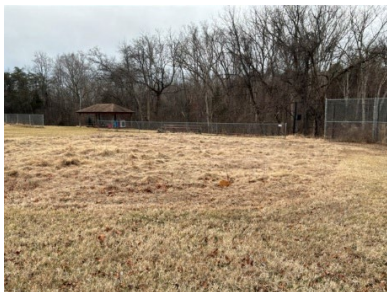
Playfield Surfaces in Poor condition.

Two additional fields are overgrown with weeds. - AssetCALC ID: 10440439

Uniformat Code: G2050
 Recommendation: **Replace in 2027**

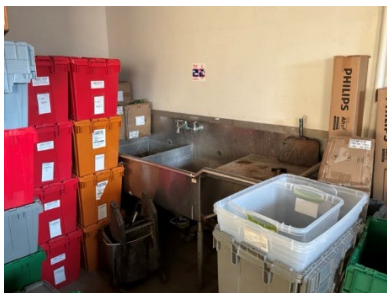
Foodservice Equipment in Failed condition.

Nonfunctional. - AssetCALC ID: 10440442

Uniformat Code: E1030
 Recommendation: **Replace in 2026**

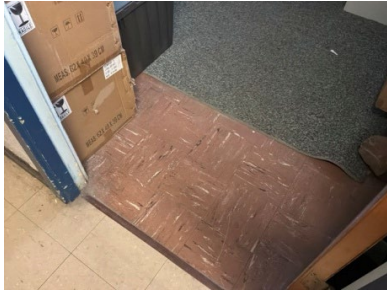
Flooring in Poor condition.

Damaged and missing 9x9 vinyl tiles observed in various areas of the building. - AssetCALC ID: 10440428

Uniformat Code: C2030
Recommendation: **Replace in 2027**

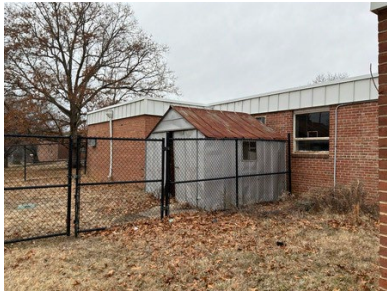
Shed/Gazebo/Shade Structure in Poor condition.

Storage sheds are deteriorated. - AssetCALC ID: 10440468

Uniformat Code: F1020
Recommendation: **Replace in 2027**

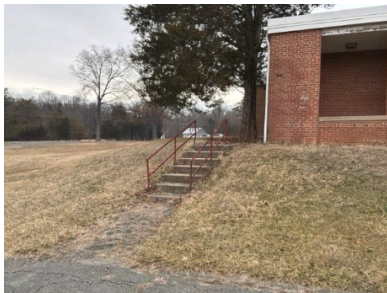
Stair/Ramp Rails in Poor condition.

Corrosion to stair rails down to baseball fields. - AssetCALC ID: 10440472

Uniformat Code: B1080
Recommendation: **Refinish in 2027**

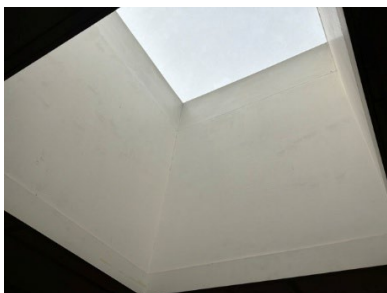
Roof Skylight in Poor condition.

The roof skylights are reportedly broken but has been sealed. Replacement is recommended with full roof replacement. - AssetCALC ID: 10440407

Uniformat Code: B3060
Recommendation: **Replace in 2027**

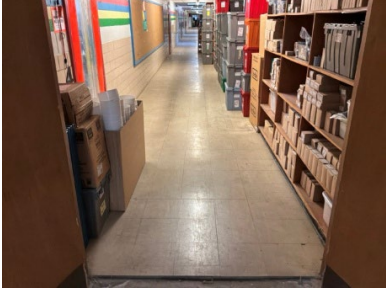
Flooring in Poor condition.

Vinyl tile throughout building is severely worn as the building is primarily used as storage. Cracked and missing tile was also observed. - AssetCALC ID: 10440454

Uniformat Code: C2030
Recommendation: **Replace in 2027**

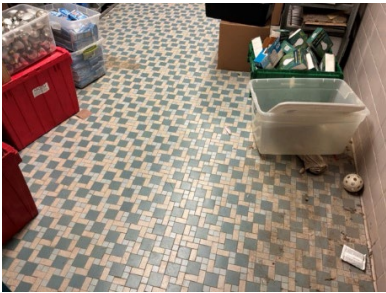
Flooring in Poor condition.

Ceramic tile flooring in restrooms are aged and uneven. - AssetCALC ID: 10440479

Uniformat Code: C2030
Recommendation: **Replace in 2027**

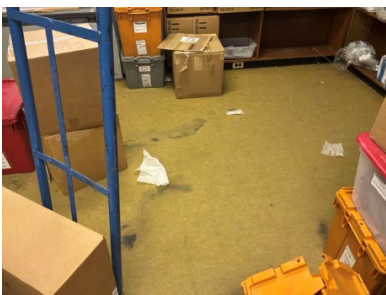
Flooring in Poor condition.

Stained and aged carpet in old media center. - AssetCALC ID: 10440409

Uniformat Code: C2030
Recommendation: **Replace in 2027**

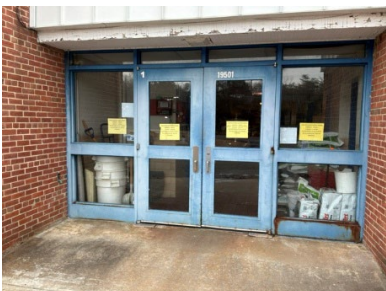
Exterior Door in Poor condition.

Main entrance doors have evidence of corrosion. - AssetCALC ID: 10440480

Uniformat Code: B2050
Recommendation: **Replace in 2027**

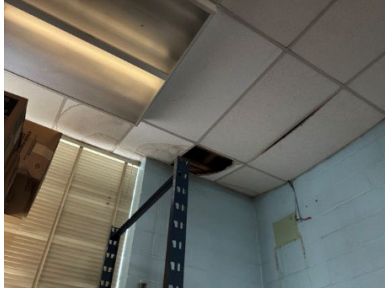
Suspended Ceilings in Poor condition.

Various damage to ceiling tiles throughout building to leaking roof. - AssetCALC ID: 10440476

Uniformat Code: C1070
Recommendation: **Replace in 2027**

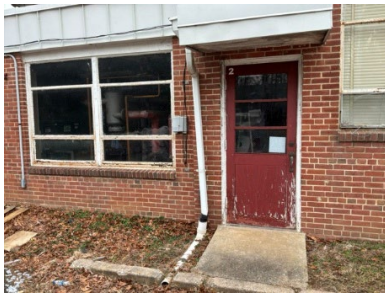
Exterior Door in Poor condition.

Doors to left entrance and boiler room have evidence of general damage, corrosion, and penetrations. - AssetCALC ID: 10440406

Uniformat Code: B2050
Recommendation: **Replace in 2027**

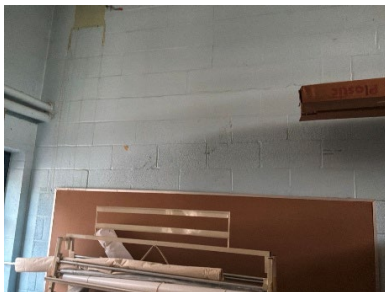
Wall Finishes in Poor condition.

Wall damage was observed throughout including deficiencies ranging from minor stains to flaking paint. - AssetCALC ID: 10440470

Uniformat Code: C2010
Recommendation: **Prep and Paint in 2027**

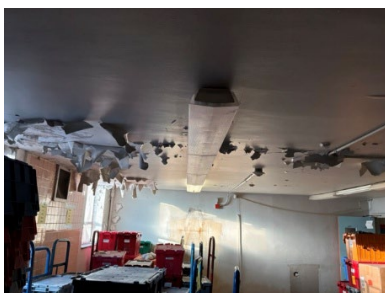
Ceiling Finishes in Poor condition.

Damage to paint ceilings throughout building. - AssetCALC ID: 10440403

Uniformat Code: C2050
Recommendation: **Prep and Paint in 2027**

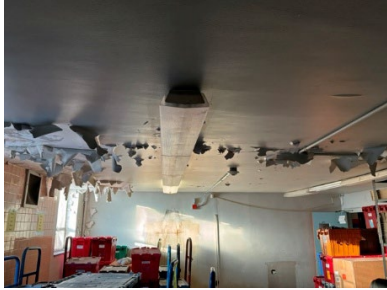
Recommended Follow-up Study: Environmental, Asbestos (ACM) and Lead Base Paint (LBP)

Damage to wall finishes and aging vinyl tiles observed throughout building. - AssetCALC ID: 10440444

Uniformat Code: P2030
 Recommendation: **Evaluate/Report in 2026**
