**BUREAU
VERITAS**

FACILITY CONDITION ASSESSMENT

Montgomery County Public Schools

Tuckerman Center
8224 Lochinver Lane
Potomac, MD 20854

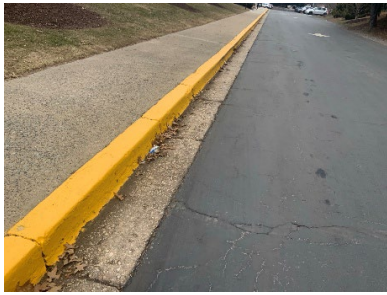
Parking Lots in Poor condition.

Curb and Gutter, Concrete
Site Tuckerman Center Site Parking Areas

Cracking and surface degradation of gutters - AssetCALC ID: 10499450

Uniformat Code: G2020
Recommendation: **Replace in 2026**

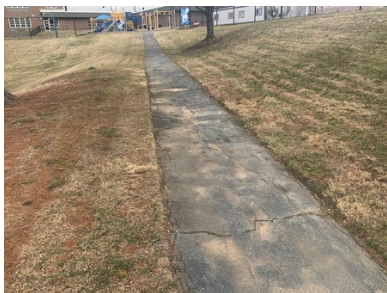
Sidewalk in Poor condition.

Asphalt
Site Tuckerman Center Site Parking Areas

Widespread cracking - AssetCALC ID: 10499447

Uniformat Code: G2030
Recommendation: **Replace in 2026**

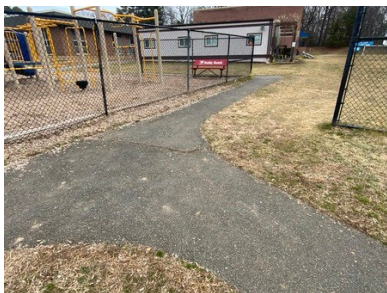
Sidewalk in Poor condition.

Asphalt
Site Tuckerman Center Site Parking Areas

Widespread cracking and surface degradation - AssetCALC ID: 10499462

Uniformat Code: G2030
Recommendation: **Overlay in 2027**

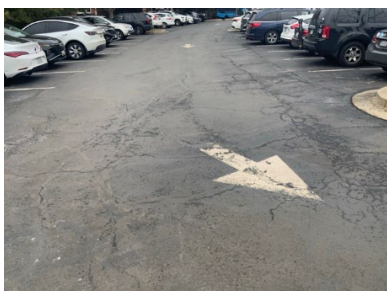
Parking Lots in Poor condition.

Pavement, Asphalt
Site Tuckerman Center Site Parking Areas

Widespread alligator cracking - AssetCALC ID: 10499479

Uniformat Code: G2020
Recommendation: **Cut and Patch in 2026**

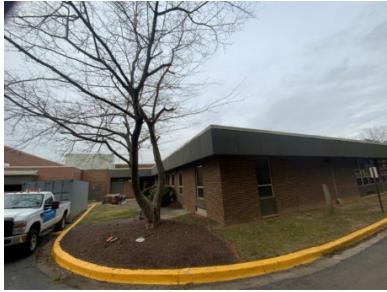
Landscaping in Poor condition.

Mature Trees, Removal or Heavy Trimming
Site Tuckerman Center Site

Tree branches close to roof and building structure - AssetCALC ID: 10499461

Uniformat Code: G2080
Recommendation: **Repair in 2026**

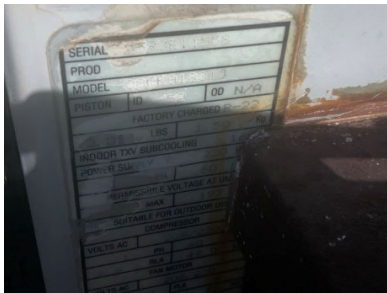
Split System in Poor condition.

Condensing Unit/Heat Pump
Tuckerman Center Tuckerman Center Roof

Severely rusted unit - AssetCALC ID: 10493898

Uniformat Code: D3030
Recommendation: **Replace in 2026**

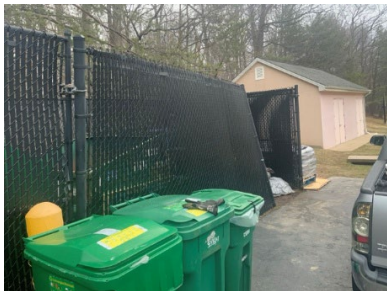
Dumpster Enclosure in Poor condition.

Wood/Vinyl Walls, 8' High (per LF)
Site Tuckerman Center Site General

Walls are leaning - AssetCALC ID: 10499467

Uniformat Code: G2060
Recommendation: **Replace/Install in 2027**

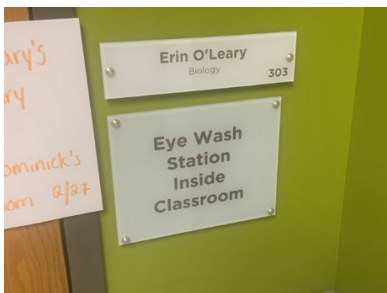
Signage in Poor condition.

Wall-Mounted, Room Identification
Tuckerman Center Tuckerman Center
Throughout Building

Some of the interior room signage is missing or incorrect. - AssetCALC ID: 10493791

Uniformat Code: C1090
Recommendation: **Replace in 2027**

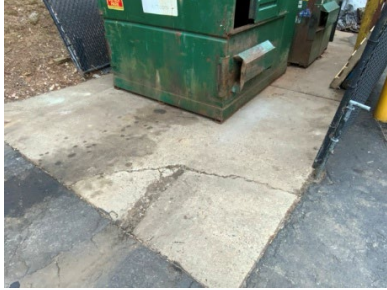
Dumpster Pad in Poor condition.

Concrete
Site Tuckerman Center Site General

Large cracks present in concrete slab - AssetCALC ID: 10499473

Uniformat Code: G2060
Recommendation: **Replace/Install in 2027**

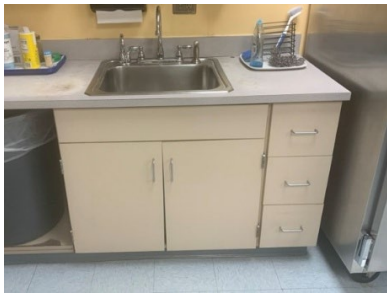
ADA Kitchen and Laundry Areas

Sink/Counter/Maneuverability, Minor
Reconfiguration
Tuckerman Center Tuckerman Center
Breakroom

Sink and counter not accessible - AssetCALC ID: 10601751

Uniformat Code: Y1060
Recommendation: **Modify in 2026**

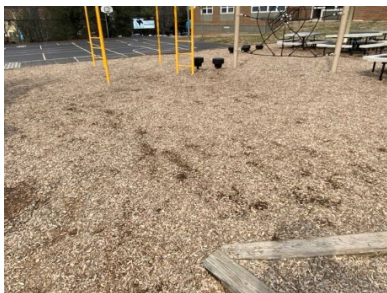
Playfield Surfaces

Rubber, Poured-in-Place
Site Tuckerman Center Site Playground Areas

Uniformat Code: G2050
Recommendation: **Replace in 2029**
