# FACILITY CONDITION ASSESSMENT

**Montgomery County Public Schools**  
45 West Gude Drive, Suite 4000  
Rockville, MD 20850

Carver Educational Services Center  
850 Hungerford Drive  
Rockville, MD 20850

*August 11, 2025*

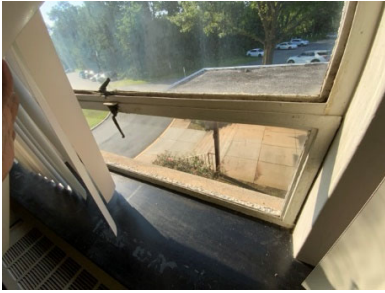
### Glazing in Poor condition.

any type by SF  
Carver Educational Services Center  
Educational Services Center Building Exterior

Windows exhibit cracked glazing, rotted frames, and peeling paint. The presence of lead-based paint is suspected. - AssetCALC ID: 9568824

Uniformat Code: B2020  
Recommendation: **Replace in 2027**

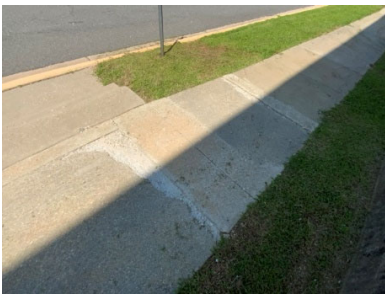
### Sidewalk in Poor condition.

Concrete, Small Areas/Sections  
Site Carver Educational Services Center Site  
Parking Areas

The concrete walkways showed visible signs of separation, cracking, and damage. - AssetCALC ID: 9568800

Uniformat Code: G2030  
Recommendation: **Replace in 2026**

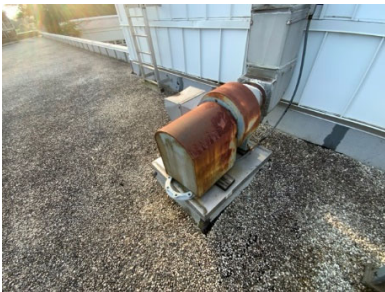
### Exhaust Fan in Poor condition.

Centrifugal, 16" Damper  
Carver Educational Services Center  
Roof

Exhaust fan was visibly rusted, weathered, and corroded. - AssetCALC ID: 9569004

Uniformat Code: D3060  
Recommendation: **Replace in 2026**

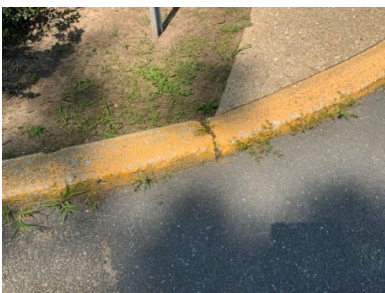
### Concrete Curb or Berm (Per LF) in Poor condition.

any pavement type, Sectional Repairs per  
Man-Day  
Site Carver Educational Services Center Site  
Parking Areas

The curb is cracked and crumbling. - AssetCALC ID: 9568789

Uniformat Code: G2030  
Recommendation: **Repair in 2026**

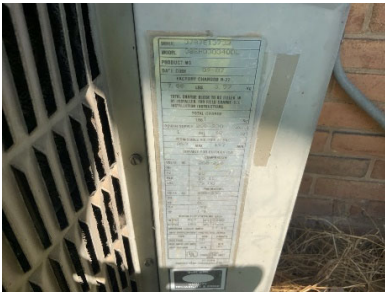
| <u>ID</u> | <u>Location</u><br><u>Description</u> | <u>UF</u><br><u>Code</u> | <u>Description</u> | <u>Condition</u> | <u>Plan Type</u> | <u>Cost</u> |
|---|---|---|---|---|---|---|
| 9568964 | Building<br>Exterior | D3030 | Split System,<br>Interior &<br>Exterior<br>Component<br>Pairing, 2<br>TON,<br>Replace | Poor | Performance/Integrity | \$4,800 |

### Split System in Poor condition.

Interior and Exterior Component Pairing, 2 TON  
Carver Educational Services Center  
Exterior

Condenser is corroded and exceedingly aged far beyond useful life. - AssetCALC ID: 9568964

Uniformat Code: D3030  
Recommendation: **Replace in 2025**

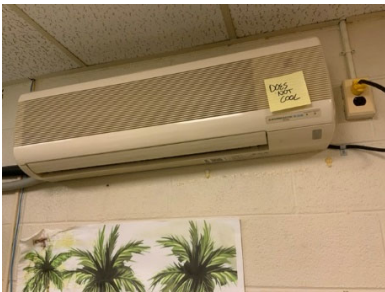
| <u>ID</u> | <u>Location</u><br><u>Description</u> | <u>UF</u><br><u>Code</u> | <u>Description</u> | <u>Condition</u> | <u>Plan Type</u> | <u>Cost</u> |
|---|---|---|---|---|---|---|
| 9568893 | Mechanical<br>Room 62 | D3030 | Split System<br>Ductless,<br>Single Zone,<br>Condenser &<br>Evaporator,<br>1.5 to 2 TON,<br>Replace | Poor | Performance/Integrity | \$4,800 |

### Split System Ductless in Poor condition.

Single Zone, Condenser and Evaporator, 1.5 to 2 TON  
Carver Educational Services Center  
Mechanical Room 62

Unit does not cool. - AssetCALC ID: 9568893

Uniformat Code: D3030  
Recommendation: **Replace in 2025**

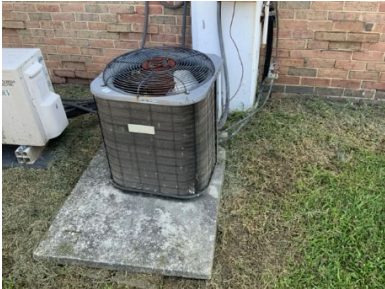
### Split System in Poor condition.

Condensing Unit/Heat Pump  
Carver Educational Services Center  
Building Exterior

The condenser unit exhibits significant deterioration, including rusted cabinets panels, bent or damaged coil fins, and excessive dirt and debris buildup. - AssetCALC ID: 9568847

Uniformat Code: D3030  
Recommendation: **Replace in 2026**

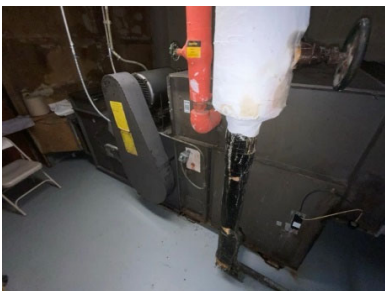
### Air Handler in Poor condition.

Interior AHU, Easy/Moderate Access  
Carver Educational Services Center  
Mechanical Room 136C

Air handler has far exceeded its estimated useful life (EUL). - AssetCALC ID: 9569001

Uniformat Code: D3050  
Recommendation: **Replace in 2026**

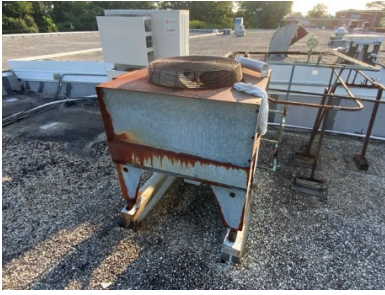
### Split System in Poor condition.

Condensing Unit/Heat Pump  
Carver Educational Services Center  
Roof

The condenser unit is visibly aged, with significant signs of rusting, cracking, and weathering. - AssetCALC ID: 9568986

Uniformat Code: D3030  
Recommendation: **Replace in 2026**

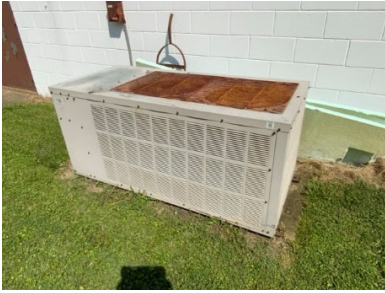
### Split System in Poor condition.

Condensing Unit/Heat Pump  
Carver Educational Services Center  
Building Exterior

The outdoor condenser is severely aged and rust corroded. - AssetCALC ID: 9568814

Uniformat Code: D3030  
Recommendation: **Replace in 2026**

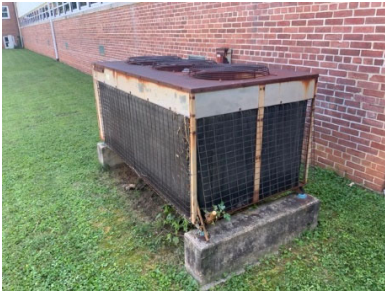
### Split System in Poor condition.

Condensing Unit/Heat Pump  
Carver Educational Services Center Building  
Exterior

The condensing unit is severely aged, exhibiting extensive surface corrosion, worn fan components, and degraded coil fins. - AssetCALC ID: 9568821

Uniformat Code: D3030  
Recommendation: **Replace in 2026**
