# FACILITY CONDITION ASSESSMENT

**Montgomery County Public Schools**  
45 West Gude Drive, Suite 4000  
Rockville, MD 20850

*January 5, 2026*

English Manor Elementary School  
4511 Bestor Drive  
Rockville, MD 20853

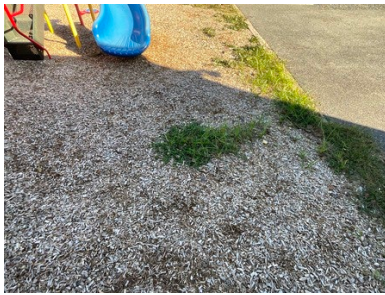
### Playground Surfaces in Poor condition.

Engineered Wood Fiber Chips, 3" Depth  
Site English Manor Elementary School Site

The wood playground surface and poor condition with thin coverage, uneven areas and visible weed growth. Several spots shows exposed soil, reducing impact protection and safety. Replenishment of engineered wood fiber and grading are recommended to restore safe play conditions.. - AssetCALC ID: 9928231

Uniformat Code: G2050  
Recommendation: **Replace in 2025**

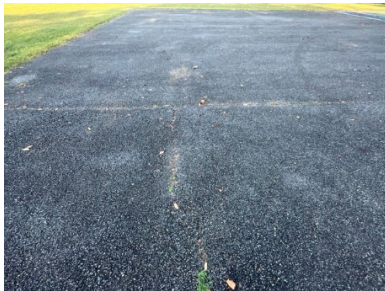
### Athletic Surfaces & Courts in Poor condition.

Basketball/General, Asphalt Pavement  
Site English Manor Elementary School Site

The asphalt basketball court is in poor condition with extensive cracking surface wear and fading. Vegetation growth is visible along cracks, indicating water intrusion. Full, milling and resurfacing are recommended to restore functionality and safety. - AssetCALC ID: 9928241

Uniformat Code: G2050  
Recommendation: **Mill & Overlay in 2027**

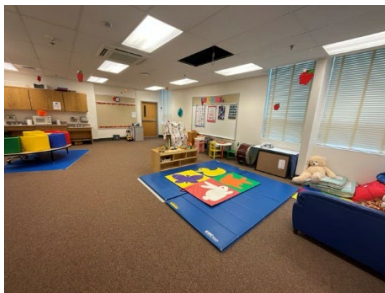
### BAS/HVAC Controls in Poor condition.

Retro-commissioning of System  
English Manor Elementary School Classrooms

According to POC, the heating and cooling systems have shown ongoing performance issues, with some classrooms lacking adequate airflow and temperature balance. This suggests a need for mechanical evaluation and adjustment potentially involving duct balancing or inspection of HVAC control system. - AssetCALC ID: 10069651

Uniformat Code: D8010  
Recommendation: **Repair in 2026**

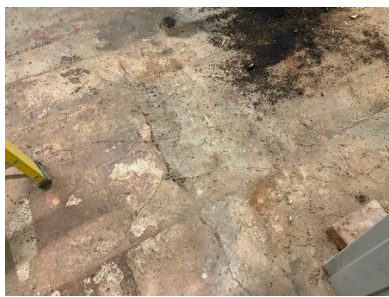
### Flooring in Poor condition.

Concrete  
Main Building English Manor Elementary  
School Main Electric Room

The concrete flooring exhibits widespread, cracking surface, spalling and signs of material deterioration throughout the area. Several sections have deep cracks and uneven surfaces, indicating settlement and wear overtime. There is visible, patching and surface erosion suggesting previous minor repairs that have since failed. The exposed and damaged concrete poses, tripping hazards and negatively affects structural integrity and aesthetics. Full depth, patching and resurfacing are recommended to restore, levelness, durability and safety of the flooring. - AssetCALC ID: 9928096

Uniformat Code: C2030  
Recommendation: **Repair in 2027**
