# FACILITY CONDITION ASSESSMENT

Former Carl Sandburg Learning Center  
451 Meadow Hall Drive  
Rockville, MD 20851

*August 12, 2025*

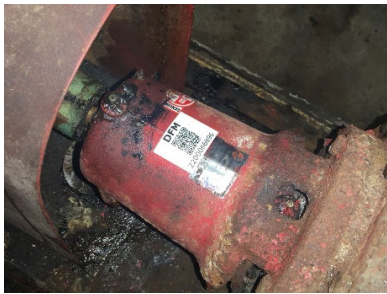
### Pump in Poor condition.

Distribution, HVAC Heating Water  
Main Building Former Carl Sandburg Learning  
Center Boiler Room

Corroded - AssetCALC ID: 9549305

Uniformat Code: D3050  
Recommendation: **Replace in 2025**

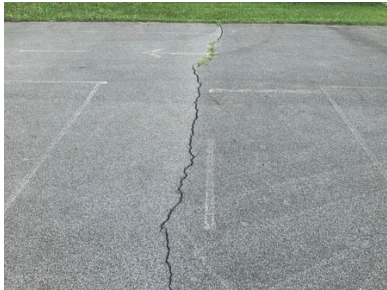
### Parking Lots in Poor condition.

Pavement, Asphalt  
Site Former Carl Sandburg Learning Center  
Site

Cracked asphalt pavement - AssetCALC ID: 9549310

Uniformat Code: G2020  
Recommendation: **Cut and Patch in 2025**

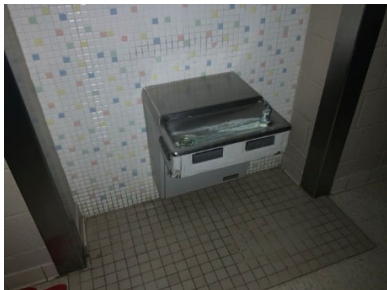
### Drinking Fountain in Poor condition.

Wall-Mounted, Single-Level  
Main Building Former Carl Sandburg Learning  
Center Throughout Building

Rusted - AssetCALC ID: 9549330

Uniformat Code: D2010  
Recommendation: **Replace in 2025**

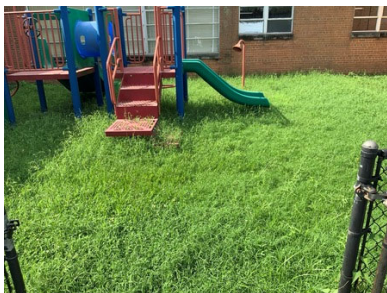
### Playground Surfaces in Poor condition.

Chips Wood, 6" Depth  
Site Former Carl Sandburg Learning Center  
Site

Wood chips are recommended to be installed - AssetCALC ID: 9549290

Uniformat Code: G2050  
Recommendation: **Replace in 2025**

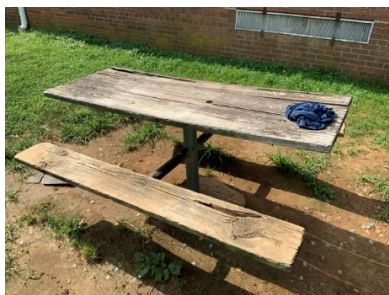
## Picnic Table in Poor condition.

Wood/Composite/Fiberglass  
Site Former Carl Sandburg Learning Center  
Site

Cracked - AssetCALC ID: 9549360

Uniformat Code: G2060  
Recommendation: **Replace in 2026**

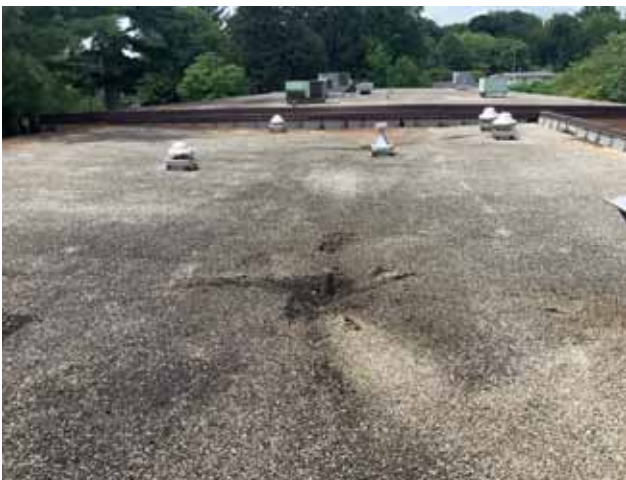
5 - MAIN ROOF

In general, the structure appears to be sound, with no significant areas of settlement or structural-related deficiencies observed. The roof is outdated with a history of leaks reported. The roof is recommended for short-term replacement. The wooden windows are outdated and should be replaced. Good maintenance practices have kept the buildings in good condition, but some components are beginning to show wear and are approaching the end of their expected lifespan. The interior finishes are in fair condition. Typical lifecycle-based interior and exterior finish replacements are budgeted and anticipated.

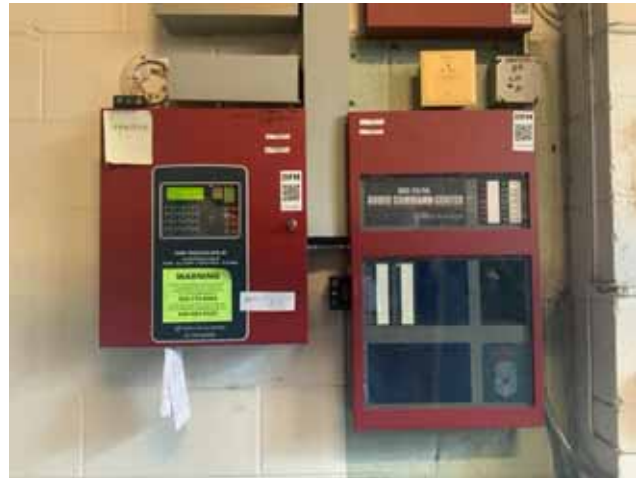
22 - FIRE ALARM PANEL

The central alarm panel appears to be more than 15 years old. Based on its age and because replacement parts and components for this type of equipment may be obsolete, the alarm panel requires replacement.
