FACILITY CONDITION ASSESSMENT

Montgomery County Public Schools
45 West Gude Drive, Suite 4000
Rockville, MD 20850

Bells Mill Elementary School
8225 Bells Mill Road
Potomac, MD 20854

April 10, 2026

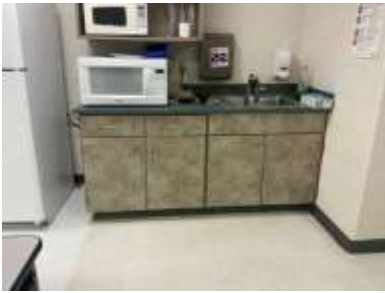
ADA Kitchen & Laundry Areas

Cabinetry, Height/Location/Clearance
Bells Mill Elementary School Teachers Lounge

Uniformat Code: Y1060
Recommendation: **Modify in 2026**

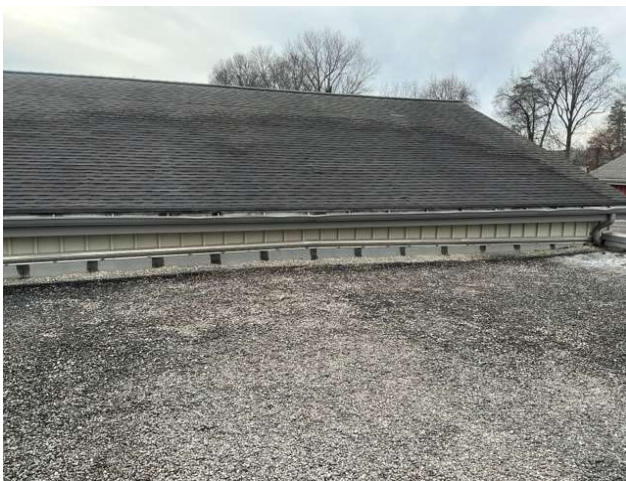
The building structure appeared to be in fair condition, overall. The roof surfaces appeared to be original and may require replacement within the near future. Large deposits of sand granules were observed in the roof gutters which is an indication of wear. The windows appeared to be in good condition. The interior finishes appeared to be in fair condition, overall.

5 - ROOF

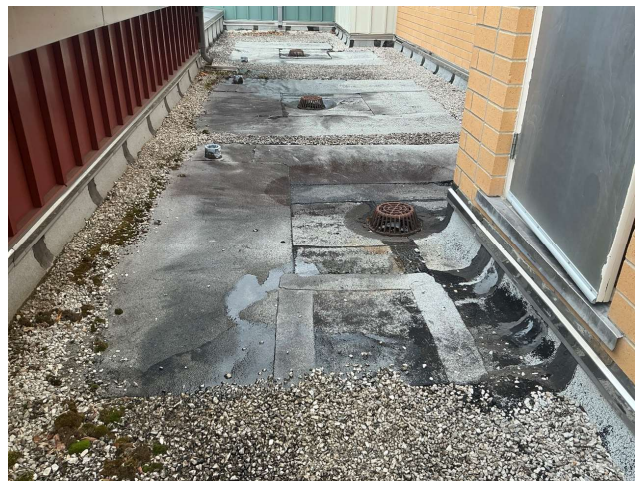
6 - ROOF

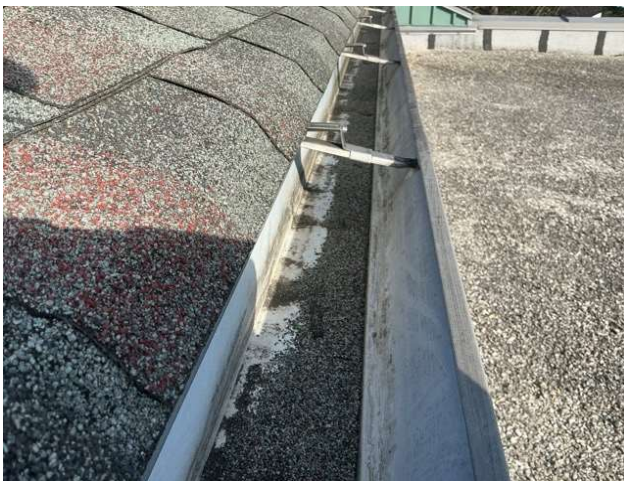
23 - ROOF GUTTER

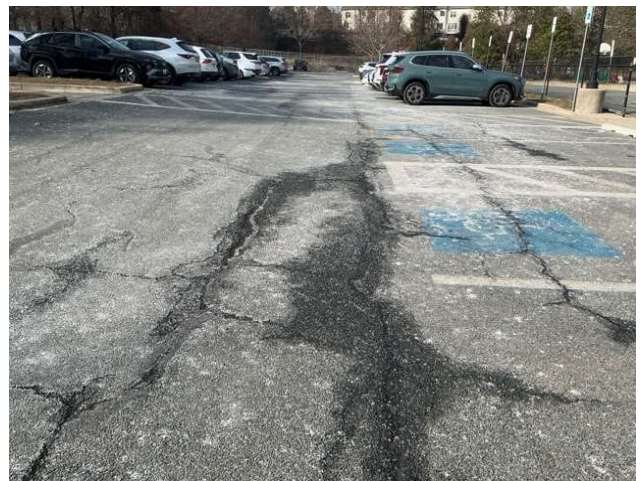
The site is occupied by the school building, playgrounds, ballfields, parking lot and open fields. The sidewalks, parking lots and other site components appeared to be in fair condition. The staff parking lot showed signs of wear. The parking lot surfaces are cracked and the seal coat has deteriorated.

24 - PARKING LOT

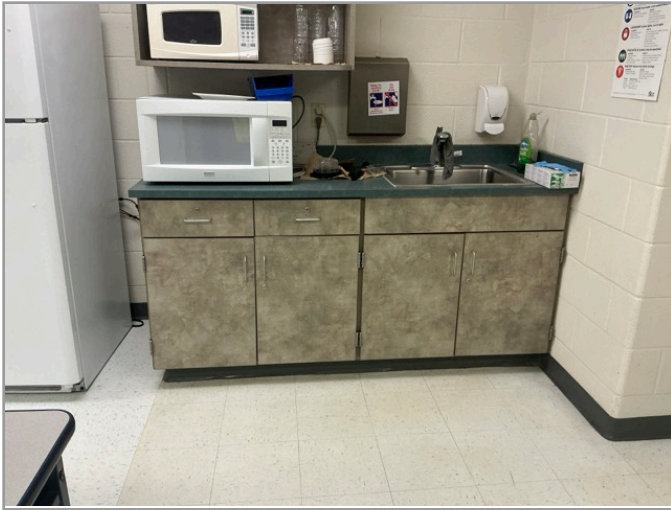
SINK CLEARANCE

Question	Yes	No	NA	Comments
1 Do kitchens/kitchenettes appear to have a minimum compliant path of travel or area of maneuverability ?	✗			
2 Are the appliances centered for a parallel or forward approach with adequate clear floor space ?	✗			
3 Is there an accessible countertop/preparation space of proper width and height ?	✗			
4 Is there an accessible sink space of proper width and height ?	✗			
5 Does the sink faucet have compliant handles ?	✗			
6 Is the plumbing piping under the sink configured to protect against contact ?	✗

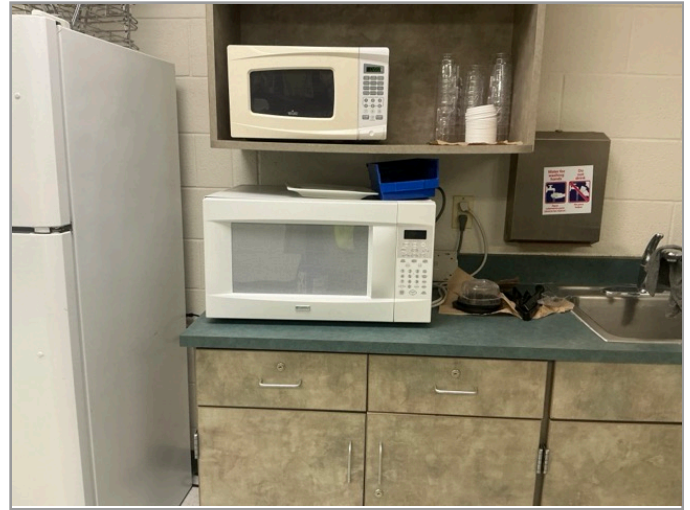
OVEN WITH CONTROLS

7	Are the cooktop/range controls front-mounted (or in a location that does not require reaching across the burners) ?	✘			
---	---	---	--	--	--
