FACILITY CONDITION ASSESSMENT

Brown Station Elementary School
851 Quince Orchard Boulevard
Gaithersburg, MD 20878

172559.25R000-014.354

May 1, 2026

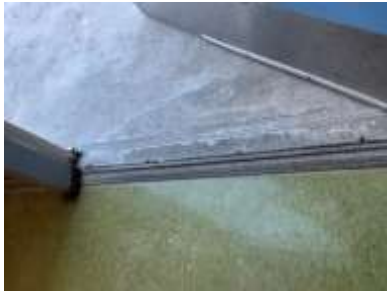
Door Threshold
Main Building Brown Station Elementary
School Building Exterior

ADA Entrances and Doors in Poor condition.

Door threshold needs modification to prevent water damage - AssetCALC ID: 10297274

Uniformat Code: Y1030
Recommendation: **Modify in 2026**

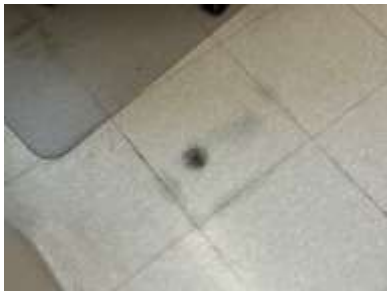
Vinyl Tile (VCT)
Main Building Brown Station Elementary
School Throughout Building

Flooring in Poor condition.

Damaged floor tiles throughout building - AssetCALC ID: 10297271

Uniformat Code: C2030
Recommendation: **Replace in 2026**
