# FACILITY CONDITION ASSESSMENT

**Montgomery County Public Schools**  
45 West Gude Drive, Suite 4000  
Rockville, MD 20850

College Gardens Elementary School  
1700 Yale Place  
Rockville, MD 20850

*172559.25R000-031.354*

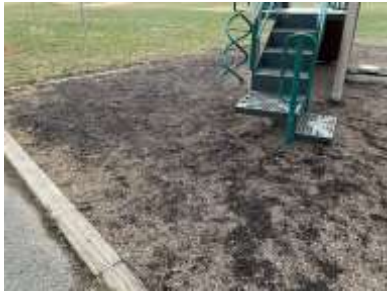
### Playground Surfaces in Poor condition.

Rubber, Poured-in-Place  
Site College Gardens Elementary School Site

Uniformat Code: G2050  
Recommendation: **Replace in 2026**

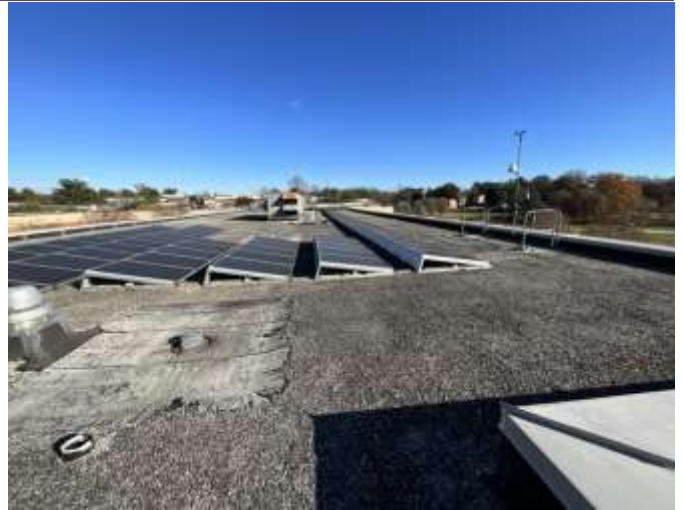
8 - PRIMARY ROOF OVERVIEW

Since the renovation in 2008, some components are beginning to show wear and are approaching the end of their expected lifespan. Typical lifecycle based interior and exterior finish replacements are budgeted and anticipated. The facilities consist of masonry bearing walls with metal roof decking supported by open-web steel joists and over concrete slab and footing foundation system. The glazing is free and clear of defects or fogging. The built-up roof system showed no major deficiencies and is in fair condition.

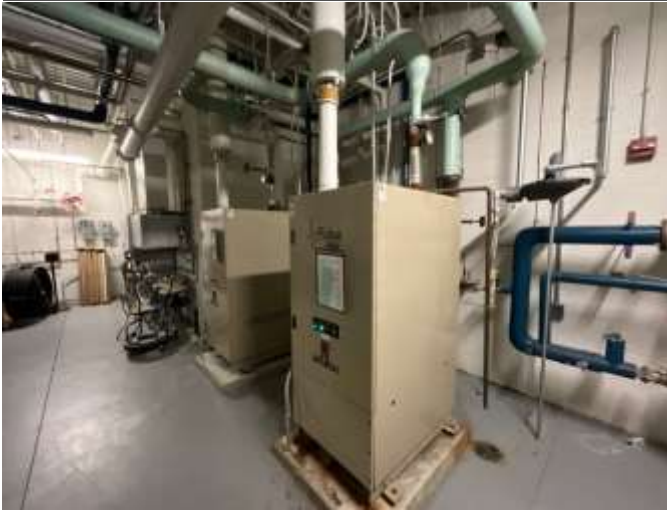
25 - BOILERS AND PUMPS

Most MEPF systems and components were installed during the renovation in 2008 and have been well-maintained since that time. The mechanical system includes boilers and a cooling tower, with air handlers, and water sourced heat pumps. The MEPF infrastructure itself is generally in fair working conditions. The water sourced heat pumps and air handlers are nearing the end of their useful term and should be considered for upgrades. The electrical system included a switchboard, additional panels, and transformers appeared to be in fair condition overall. The generator was in fair condition. In general, the plumbing systems are adequate to serve the facilities, with equipment and fixtures to be updated as needed. The fire alarm and suppression systems appear to be in fair condition. Inspection tags are current. Typical lifecycle replacements and ongoing maintenance will be required.

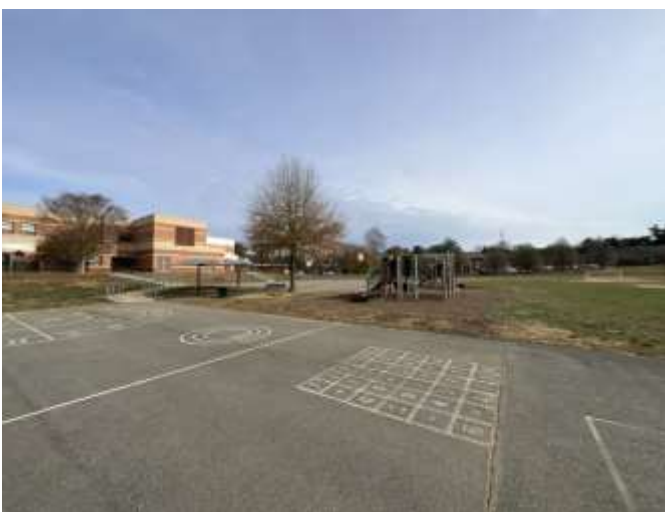
35 - PLAYGROUND

Site maintenance appears to be fair overall, and site improvements and landscaping are generally in fair condition. Sidewalks and the asphalt pavement were observed to be in fair condition. The playground equipment was free of any defects at time of assessment and in good condition. And the outdoor courts are free of any major cracking or heaving.
