# FACILITY CONDITION ASSESSMENT

**Montgomery County Public Schools**  
45 West Gude Drive, Suite 4000  
Rockville, MD 20850

Georgian Forest Elementary School  
3100 Regina Drive  
Silver Spring, MD 20906

*October 3, 2025*

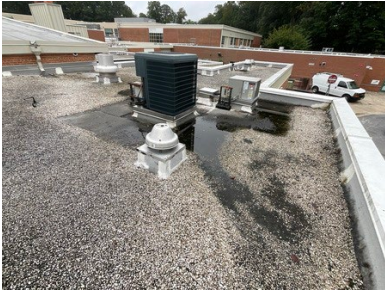
### Roofing in Poor Condition.

Modified Bitumen  
Georgian Forest Elementary School Georgian  
Forest Elementary School Roof

Ponding on roof above kitchen around the HVAC unit. - AssetCALC ID: 9731671

Uniformat Code: B3010  
Recommendation: **Replace in 2026**

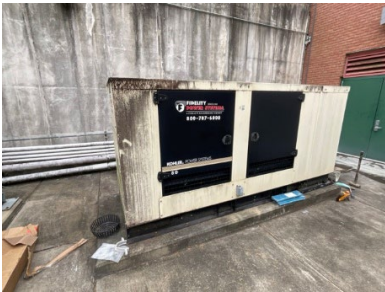
### Generator in Poor Condition.

Gas or Gasoline  
Georgian Forest Elementary School Georgian  
Forest Elementary School Building Exterior

Generator is aged well beyond expected lifespan, and the exterior shroud has quite a bit of corrosion and dirt.  
- AssetCALC ID: 9731627

Uniformat Code: D5010  
Recommendation: **Replace in 2027**

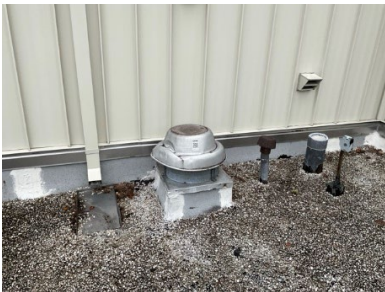
### Exhaust Fan in Poor Condition.

Roof or Wall-Mounted, 10" Damper  
Georgian Forest Elementary School Georgian  
Forest Elementary School Roof

Exhaust fan is exceedingly aged, bent, and corroded. - AssetCALC ID: 9731625

Uniformat Code: D3060  
Recommendation: **Replace in 2026**

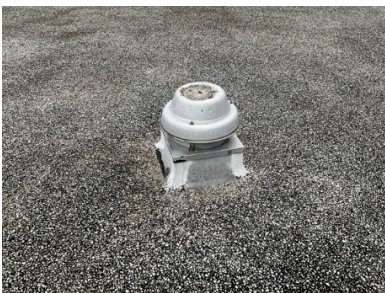
### Exhaust Fan in Poor Condition.

Roof or Wall-Mounted, 10" Damper  
Georgian Forest Elementary School Georgian  
Forest Elementary School Roof

Unit is aged beyond expected lifespan and is making noise. - AssetCALC ID: 9731547

Uniformat Code: D3060  
Recommendation: **Replace in 2027**

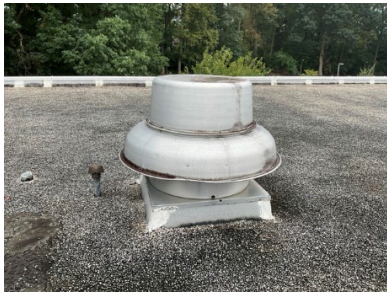
### Exhaust Fan in Poor Condition.

Roof or Wall-Mounted, 24" Damper  
Georgian Forest Elementary School Georgian  
Forest Elementary School Roof

Exhaust fan is exceedingly aged and corroded. - AssetCALC ID: 9731529

Uniformat Code: D3060  
Recommendation: **Replace in 2027**

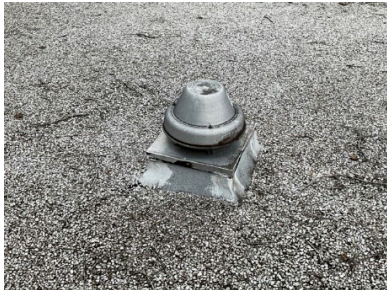
### Exhaust Fan in Poor Condition.

Roof or Wall-Mounted, 10" Damper  
Georgian Forest Elementary School Georgian  
Forest Elementary School Roof

Exhaust fan is exceedingly aged and corroded - AssetCALC ID: 9731594

Uniformat Code: D3060  
Recommendation: **Replace in 2027**

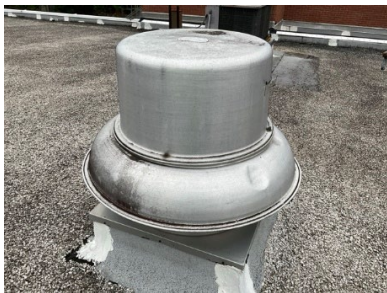
### Exhaust Fan in Poor Condition.

Roof or Wall-Mounted, 16" Damper  
Georgian Forest Elementary School Georgian  
Forest Elementary School Roof

Exhaust fan is exceedingly aged and corroded. - AssetCALC ID: 9731613

Uniformat Code: D3060  
Recommendation: **Replace in 2027**

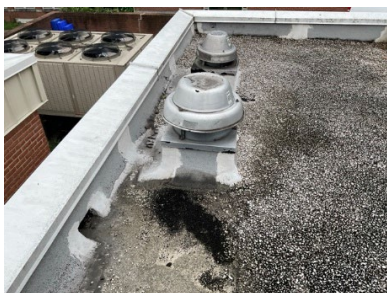
### Exhaust Fan in Poor Condition.

Centrifugal, 12" Damper  
Georgian Forest Elementary School Georgian  
Forest Elementary School Roof

Exhaust fan is exceedingly aged and corroded. - AssetCALC ID: 9731561

Uniformat Code: D3060  
Recommendation: **Replace in 2027**

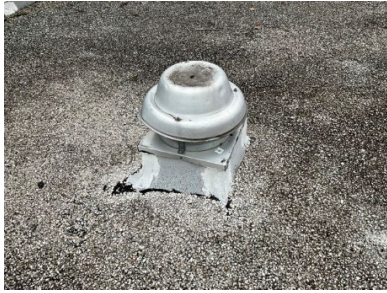
### Exhaust Fan in Poor Condition.

Roof or Wall-Mounted, 10" Damper  
Georgian Forest Elementary School Georgian  
Forest Elementary School Roof

Exhaust fan is exceedingly aged and corroded. - AssetCALC ID: 9731616

Uniformat Code: D3060  
Recommendation: **Replace in 2027**

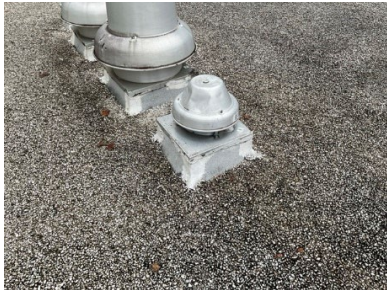
### Exhaust Fan in Poor Condition.

Roof or Wall-Mounted, 10" Damper  
Georgian Forest Elementary School Georgian  
Forest Elementary School Roof

Exhaust fan is exceedingly aged and corroded. - AssetCALC ID: 9731559

Uniformat Code: D3060  
Recommendation: **Replace in 2027**

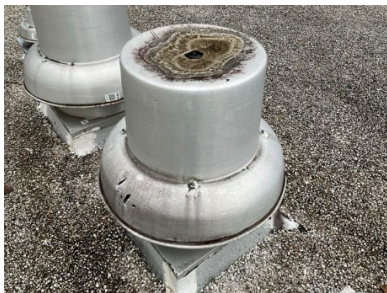
### Exhaust Fan in Poor Condition.

Roof or Wall-Mounted, 16" Damper  
Georgian Forest Elementary School Georgian  
Forest Elementary School Roof

Exhaust fan is exceedingly aged and corroded. - AssetCALC ID: 9731498

Uniformat Code: D3060  
Recommendation: **Replace in 2027**

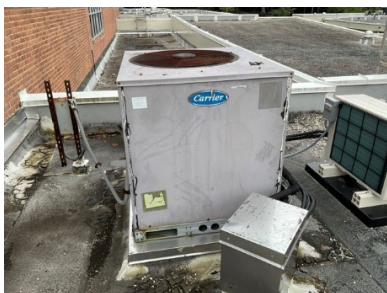
### Split System in Poor Condition.

Condensing Unit/Heat Pump, 5 TON  
Georgian Forest Elementary School Georgian  
Forest Elementary School Roof

Unit is corroded on the exterior and is well beyond expected lifespan. Data plate model number is hidden. - AssetCALC ID: 9731673

Uniformat Code: D3030  
Recommendation: **Replace in 2025**

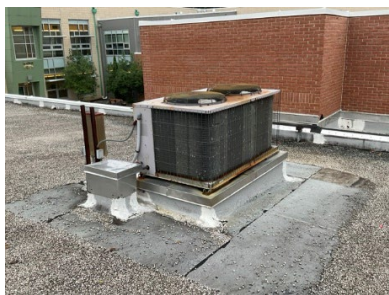
**Split System in Poor Condition.**

Condensing Unit/Heat Pump  
Georgian Forest Elementary School Georgian  
Forest Elementary School Roof

Unit is exceedingly aged double life and corrosion damaged. - AssetCALC ID: 9731490

Uniformat Code: D3030  
Recommendation: **Replace in 2027**
