FACILITY CONDITION ASSESSMENT

Harmony Hills Elementary School
13407 Lydia Street
Silver Spring, MD 20906

172559.25R000-060.354

January 12, 2026

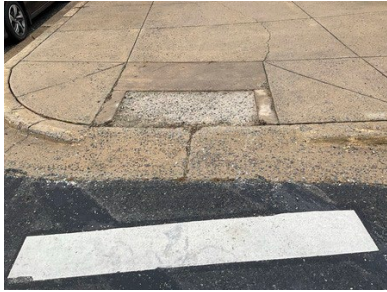
Sidewalk in Failed condition.

any pavement type, Sectional Repairs (per Man-Day)
 Site Harmony Hills Elementary School Site
 General

Remove and replace 7 damaged and/or dislodged ADA ramp pads - AssetCALC ID: 9893451

Uniformat Code: G2030
 Recommendation: **Repair in 2025**

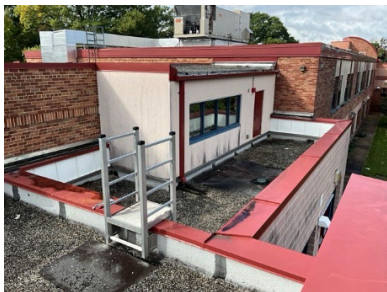
Exterior Walls in Poor condition.

any painted surface, 1-2 Story Building
 Main Building Harmony Hills Elementary School
 Roof

Faded and stained paint. - AssetCALC ID: 9960242

Uniformat Code: B2010
 Recommendation: **Prep & Paint in 2026**

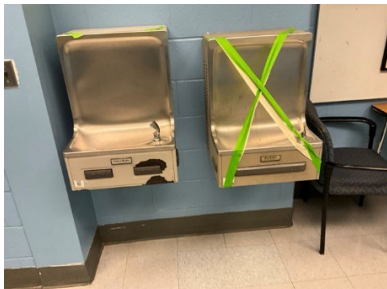
Drinking Fountain in Poor condition.

Wall-Mounted, Bi-Level
 Main Building Harmony Hills Elementary School
 Throughout Building

Aged, rusted, inoperable - AssetCALC ID: 9893569

Uniformat Code: D2010
 Recommendation: **Replace in 2026**

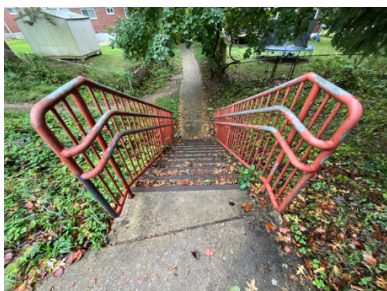
Fences & Gates in Poor condition.

Fence, any Painted Surface
 Site Harmony Hills Elementary School Site
 General

Paint worn and faded - AssetCALC ID: 9893414

Uniformat Code: G2060
 Recommendation: **Prep & Paint in 2026**

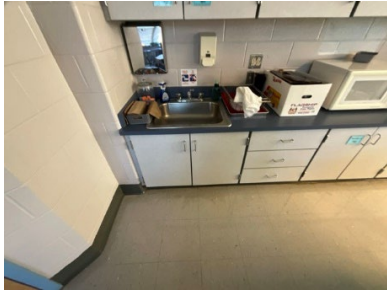
ADA Kitchen & Laundry Areas

Priority Score: **63.8**

Accessible clearance not provided at sink - AssetCALC ID: 10094483

Uniformat Code: Y1060
Recommendation: **Modify in 2026**

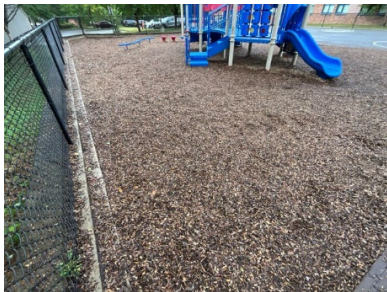
Playfield Surfaces

Priority Score: **55.6**

Uniformat Code: G2050
Recommendation: **Replace in 2029**

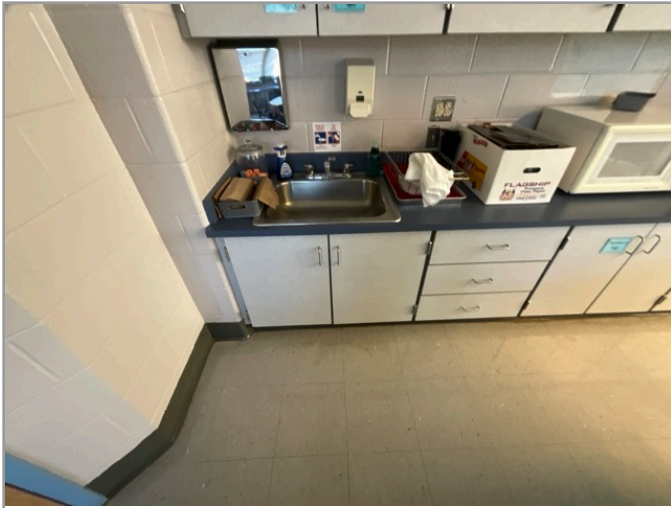
SINK CLEARANCE

Question		Yes	No	NA	Comments
1	Do kitchens/kitchenettes appear to have a minimum compliant path of travel or area of maneuverability ?	✗			
2	Are the appliances centered for a parallel or forward approach with adequate clear floor space ?	✗			
3	Is there an accessible countertop/preparation space of proper width and height ?	✗			
4	Is there an accessible sink space of proper width and height ?		✗		Accessibility requires reconfiguration
5	Does the sink faucet have compliant handles ?	✗			
6	Is the plumbing piping under the sink configured to protect against contact ?		✗		Accessibility requires reconfiguration
