FACILITY CONDITION ASSESSMENT

Montgomery County Public Schools

Flora M. Singer Elementary School

February 26, 2026

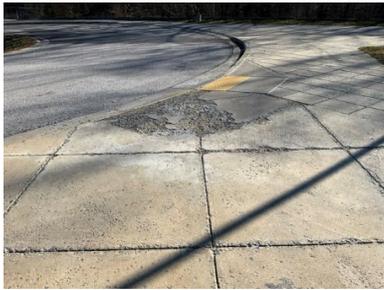
Sidewalk in Poor condition.

Concrete, Small Areas/Sections
 Site Flora M. Singer Elementary School Site
 Parking Areas

Sections of the pedestrian walkway near the student drop off area were observed to be damaged and could create trip hazards. Replacement is recommended in the short term. - AssetCALC ID: 10095151

Uniformat Code: G2030
 Recommendation: **Replace in 2026**

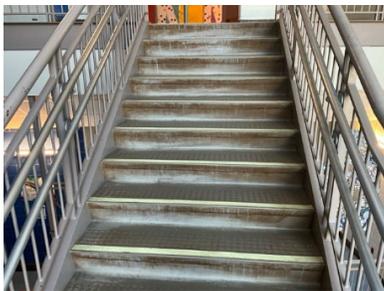
Stair Treads in Poor condition.

Raised Rubber Tile
 Main Building Flora M. Singer Elementary
 School Interior Stairs

Stair treads were observed to be worn and could create a hazard. Replacement is anticipated in the short term. - AssetCALC ID: 10094910

Uniformat Code: B1080
 Recommendation: **Replace in 2026**

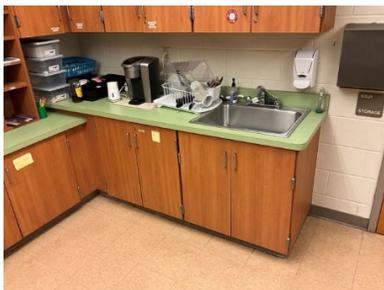
ADA Kitchen & Laundry Areas

Sink/Counter/Maneuverability, Full
 Reconfiguration
 Flora M. Singer Elementary School Staff
 Lounge

The kitchen area at the staff lounge was observed not to be ADA compliant. Replacement is anticipated in the short term. - AssetCALC ID: 10199718

Uniformat Code: Y1060
 Recommendation: **Renovate in 2026**

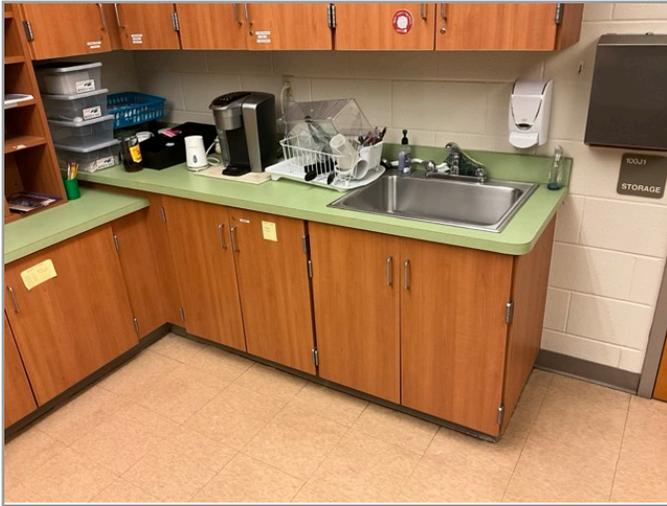
KITCHEN CABINETS

Question	Yes	No	NA	Comments
1 Do kitchens/kitchenettes appear to have a minimum compliant path of travel or area of maneuverability ?	✗			
2 Are the appliances centered for a parallel or forward approach with adequate clear floor space ?			✗	
3 Is there an accessible countertop/preparation space of proper width and height ?		✗		
4 Is there an accessible sink space of proper width and height ?		✗		
5 Does the sink faucet have compliant handles ?	✗			
6 Is the plumbing piping under the sink configured to protect against contact ?		✗
