FACILITY CONDITION ASSESSMENT

Briggs Chaney Middle School
1901 Rainbow Drive
Silver Spring, MD 20905

172559.25R000-141.354

May 7, 2026

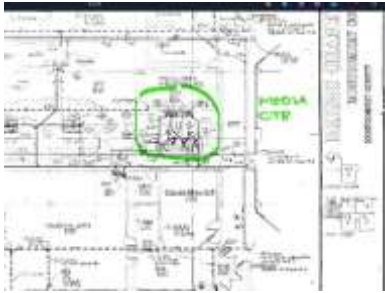
Piping and Valves in Failed condition.

Piping Cast Iron, Sanitary Drainage, 4 IN
Main Building Briggs Chaney Middle School
Common area restrooms near Media Center

The restrooms near the Media Center have been closed due to clogged pipes. Plumbing contractors have not been able to cure the problem. New sanitary line is recommended for the restrooms. - AssetCALC ID: 10069151

Uniformat Code: D2020
Recommendation: **Replace in 2026**

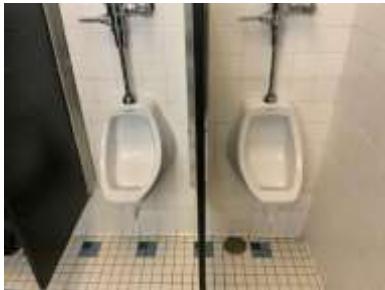
Urinal in Poor condition.

Standard
Main Building Briggs Chaney Middle School
Boys Locker Rooms

Several urinals are out of service - AssetCALC ID: 10068676

Uniformat Code: D2010
Recommendation: **Replace in 2026**

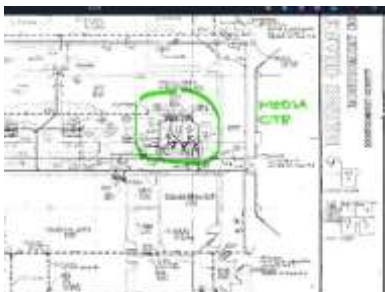
Recommended Follow-up Study: Plumbing, Sanitary Sewer System

Plumbing, Sanitary Sewer System
Main Building Briggs Chaney Middle School
Common area restrooms

POC reports that sanitary drainpipe, associated with the restrooms closest to the Media Center, is obstructed and remains so despite repeat attempts to clear it. As result, the restrooms have been closed. - AssetCALC ID: 10069152

Uniformat Code: P2030
Recommendation: **Evaluate/Report in 2026**

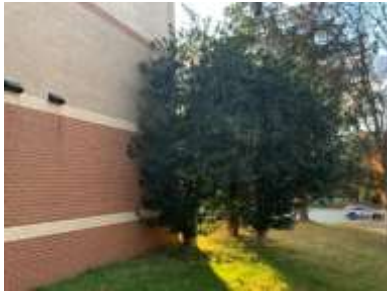
Landscaping in Failed condition.

Mature Trees, Removal or Heavy Trimming
Site Briggs Chaney Middle School Site General

Mature tree growing into building structure - AssetCALC ID: 10068452

Uniformat Code: G2080
Recommendation: **Repair in 2025**

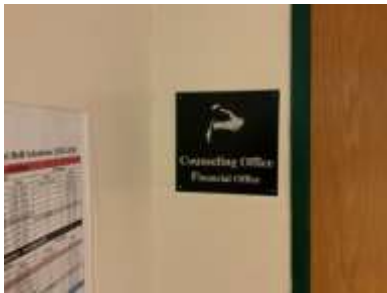
Signage in Poor condition.

Wall-Mounted, Room Identification
Main Building Briggs Chaney Middle School
Throughout Building

Some of the interior room signage is missing, incorrect or of inconsistent design. - AssetCALC ID: 10068713

Uniformat Code: C1090
Recommendation: **Replace in 2027**

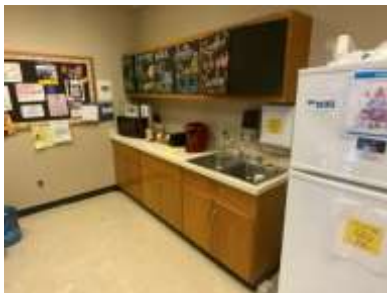
ADA Kitchenette

Sink/Counter/Maneuverability, Full
Reconfiguration
Main Building Briggs Chaney Middle School

Uniformat Code: Y1060
Recommendation: **Renovate in 2025**

Reconfigure breakroom kitchenette for ADA accessibility. - AssetCALC ID: 10499641

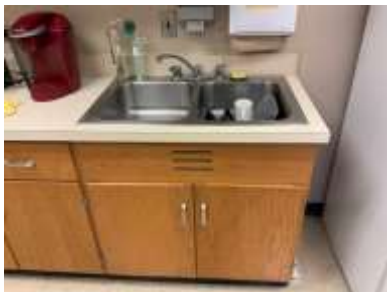
ADA Miscellaneous

Level III Study, Includes Measurements
Main Building Briggs Chaney Middle School

Uniformat Code: Y1090
Recommendation: **Evaluate/Report in 2025**

Study to make recommendations for accessibility of kitchenette - AssetCALC ID: 10499642

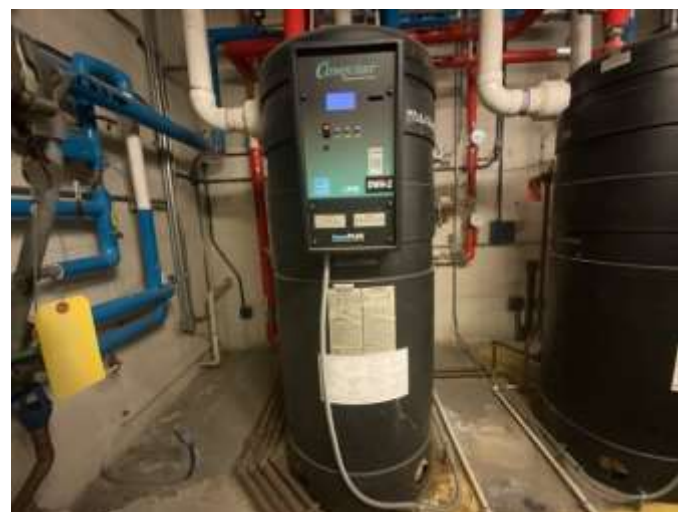
12 - WATER HEATER

Domestic hot water is provided by gas water heaters, both of which are in the main mechanical room. Water heaters appear to be relatively recent replacements and are in fair condition. The plumbing infrastructure in the original building is estimated to be from 1991, and near-term lifecycle replacement is anticipated. Also, the POC reports that sanitary drainpipe, associated with the restrooms closest to the Media Center, is obstructed and remains so despite repeat attempts to clear it. As result, the restrooms have been closed. Fixtures in the original building are estimated to be at least 20 years old and lifecycle replacement is anticipated in the near term.

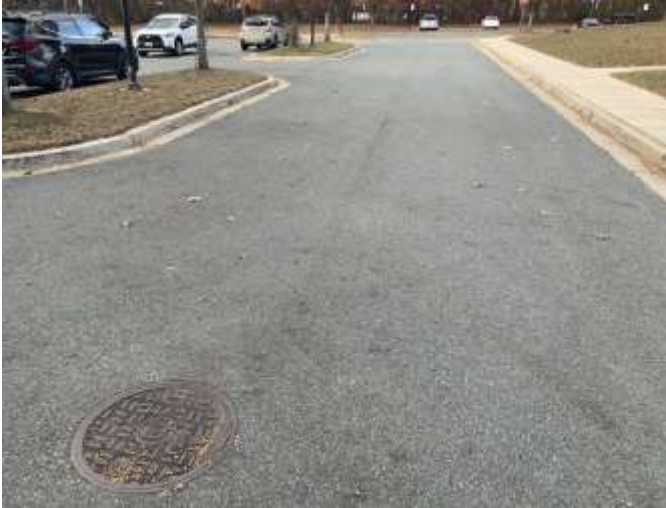
31 - ASPHALT PARKING LOTS

The asphalt parking lots are estimated to be original installations and appear in fair condition with isolated areas of cracking, and lifecycle replacement is anticipated for the near term. Pavement striping is also in fair condition, having been redone recently. Concrete pavement is in generally fair condition throughout the site and near-term lifecycle replacement is not anticipated.

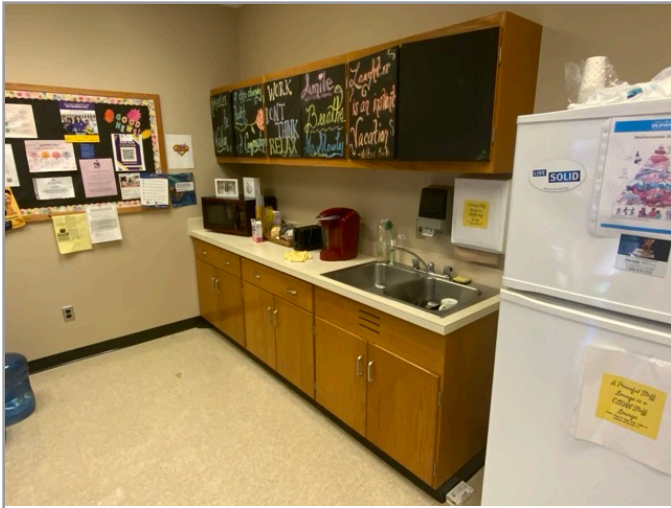
BREAKROOM OVERVIEW

Question		Yes	No	NA	Comments
1	Do kitchens/kitchenettes appear to have a minimum compliant path of travel or area of maneuverability ?	X			
2	Are the appliances centered for a parallel or forward approach with adequate clear floor space ?		X		
3	Is there an accessible countertop/preparation space of proper width and height ?		X		
4	Is there an accessible sink space of proper width and height ?		X		
5	Does the sink faucet have compliant handles ?	X			
6	Is the plumbing piping under the sink configured to protect against contact ?	X
