FACILITY CONDITION ASSESSMENT

Montgomery County Public Schools

Herbert Hoover Middle School
8810 Postoak Road
Potomac, MD 20854

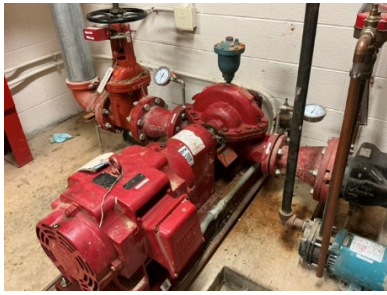
Pump in Poor condition.

Fire Suppression
Main Building Herbert Hoover Middle School
048 - Mechanical

Heavily rusted - AssetCALC ID: 10500475

Uniformat Code: D4010
Recommendation: **Replace in 2027**

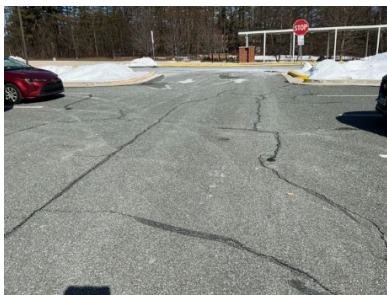
Parking Lots in Poor condition.

Pavement, Asphalt
Site Herbert Hoover Middle School Parking lots

Cracking throughout - AssetCALC ID: 10394488

Uniformat Code: G2020
Recommendation: **Mill & Overlay in 2027**

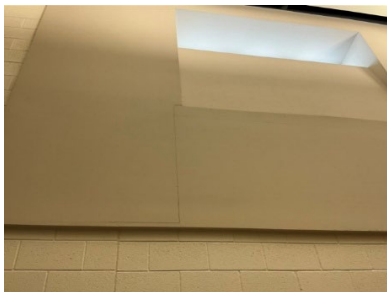
Interior Wall Construction in Poor condition.

Gypsum Board/Plaster
Main Building Herbert Hoover Middle School
Hallway @ Stair #5

Cracking at corners and seams - AssetCALC ID: 10500467

Uniformat Code: C1010
Recommendation: **Replace in 2027**

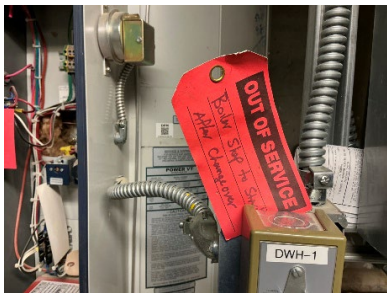
Water Heater in Failed condition.

Gas, Commercial (200 MBH)
Main Building Herbert Hoover Middle School
Utility basement

Not operational - AssetCALC ID: 10500399

Uniformat Code: D2010
Recommendation: **Replace in 2026**

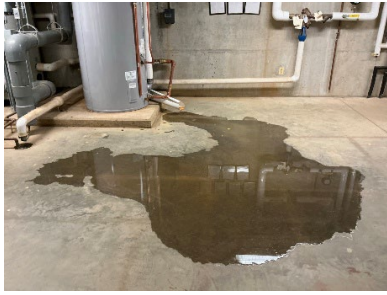
Water Heater in Poor condition.

Gas, Commercial (200 MBH)
Main Building Herbert Hoover Middle School
Utility basement

Small leak coming from clean out - AssetCALC ID: 10500504

Uniformat Code: D2010
Recommendation: **Replace in 2027**

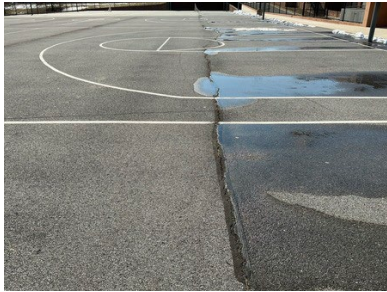
Athletic Surfaces & Courts in Poor condition.

Basketball/General, Asphalt Pavement
Site Herbert Hoover Middle School Site

Large cracking throughout - AssetCALC ID: 10394489

Uniformat Code: G2050
Recommendation: **Mill & Overlay in 2027**

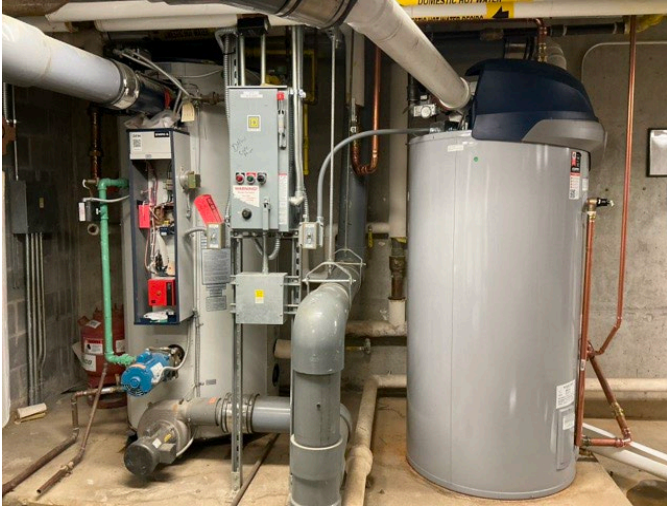
19 - WATER HEATERS

Water is distributed using copper supply and PVC waste, with gas water heaters supplying hot water throughout. End user fixtures can be comprised of toilets, sinks, urinals, and showers along with janitors floor sinks. The system was observed to be in fair condition with one water heater showing evidence of ongoing leaks.

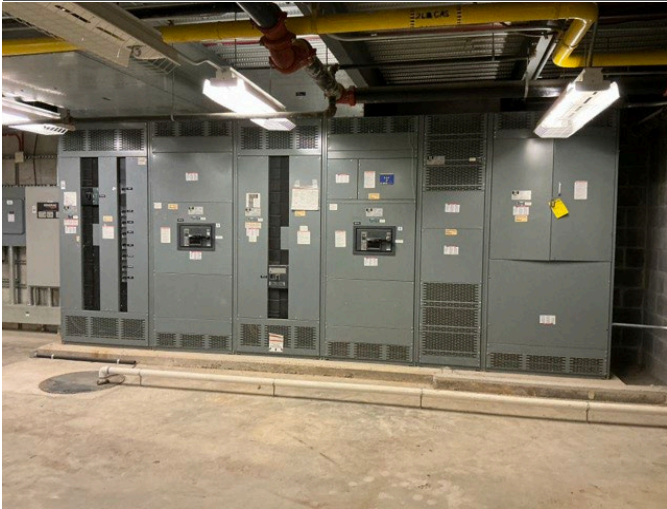
25 - MAIN SWITCHGEAR

The main electrical switchboard located in the main mechanical room acts as the main distribution to the secondary electrical panels and transformers located throughout. This system was totally replaced in the 2013 renovations and are currently well within their expected useful life. A back-up generator was also observed on-site and its condition was similar to the aforementioned electrical equipment.

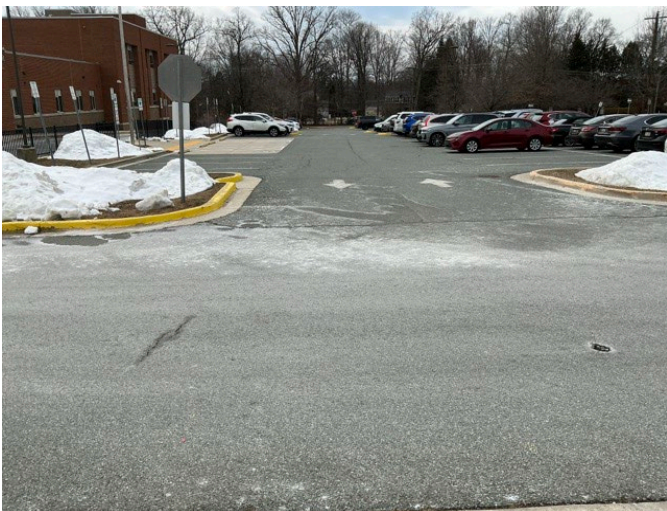
27 - MAIN PARKING LOT

Redeveloped in 2013, the surrounding site was expanded with tennis courts and added recreational areas such as outdoor basketball courts. Site parking lots are located at the front and side of the facility, and were observed to have early stages of cracking but still functional. Site walkways made of concrete wrapped the perimeter of the building and parking along with portions of a community trail weaving between athletic fields. The walking surfaces were all observed to be in fair condition.

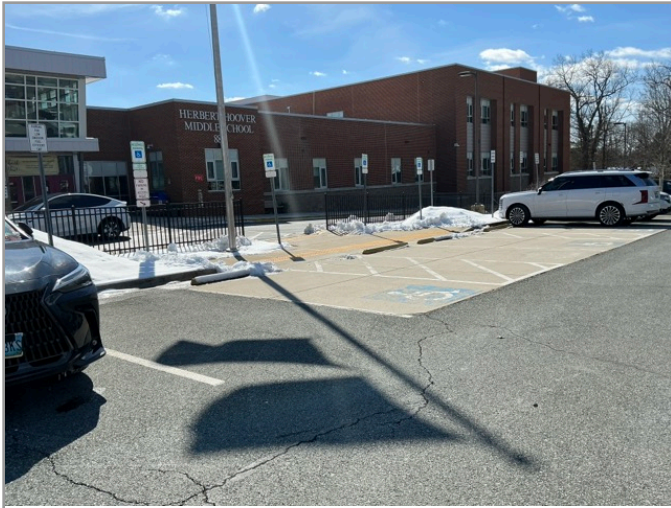
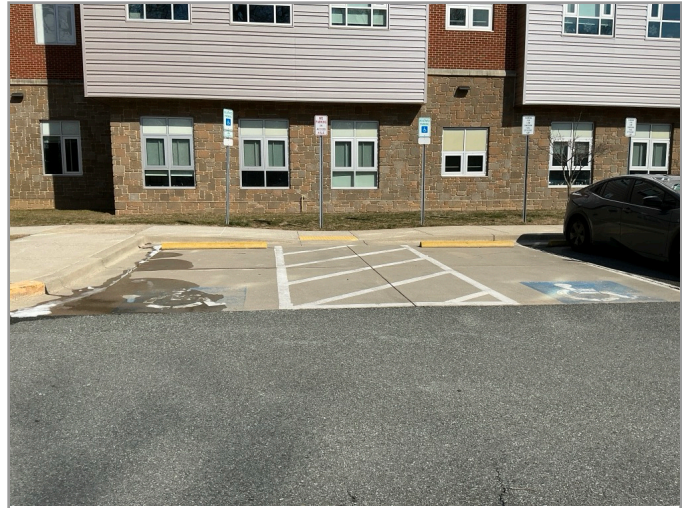
OVERVIEW OF ACCESSIBLE PARKING AREA

2ND AREA OF ACCESSIBLE PARKING

Question		Yes	No	NA	Comments
1	Does the required number of standard ADA designated spaces appear to be provided ?	✘			
2	Does the required number of van-accessible designated spaces appear to be provided ?	✘			
3	Are accessible spaces on the shortest accessible route to an accessible building entrance ?	✘			
4	Does parking signage include the International Symbol of Accessibility ?	✘			
5	Does each accessible space have an adjacent access aisle ?	✘			
6	Do parking spaces and access aisles appear to be relatively level and without obstruction ?	✘

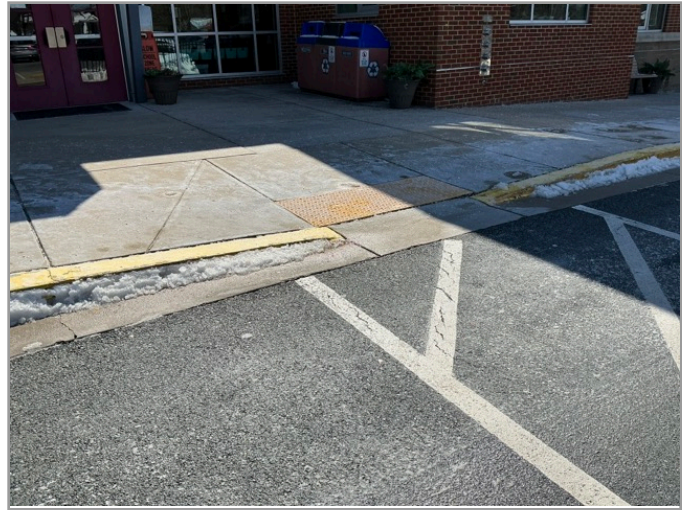
CURB CUT

Question		Yes	No	NA	Comments
1	Is an accessible route present from public transportation stops and municipal sidewalks on or immediately adjacent to the property ?	✗			
2	Does a minimum of one accessible route appear to connect all public areas on the exterior, such as parking and other outdoor amenities, to accessible building entrances ?	✗			
3	Are curb ramps present at transitions through raised curbs on all accessible routes?	✗			
4	Do curb ramps appear to have compliant slopes for all components ?	✗			
5	Do ramp runs on an accessible route appear to have compliant slopes ?	✗			
6	Do ramp runs on an accessible route appear to have a compliant rise and width ?	✗

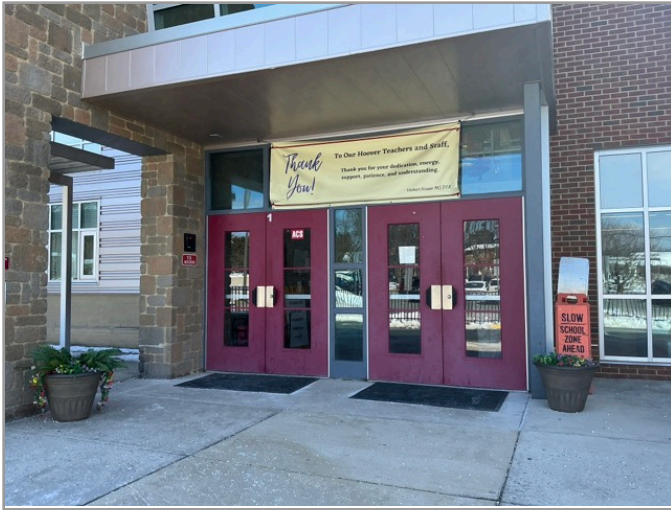
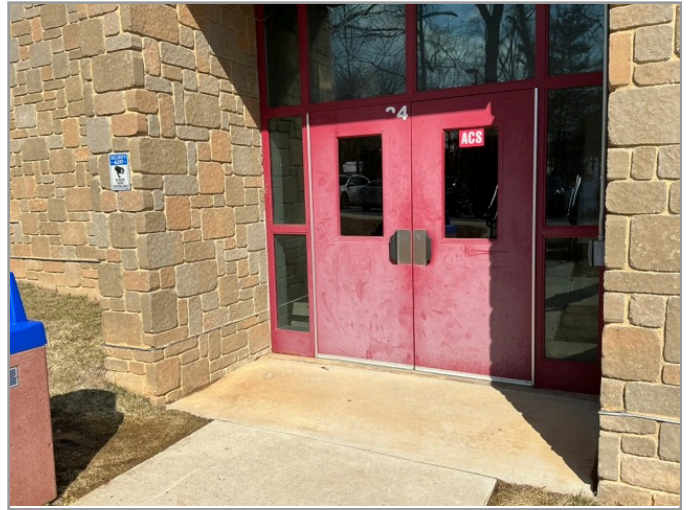
MAIN ENTRANCE

ADDITIONAL ENTRANCE

Question		Yes	No	NA	Comments
1	Do a sufficient number of accessible entrances appear to be provided ?	X			
2	If the main entrance is not accessible, is an alternate accessible entrance provided?	X			
3	Is signage provided indicating the location of alternate accessible entrances ?	X			
4	Do doors at accessible entrances appear to have compliant maneuvering clearance area on each side ?	X			
5	Do doors at accessible entrances appear to have compliant hardware ?	X			
6	Do doors at accessible entrances appear to have a compliant clear opening width ?	X

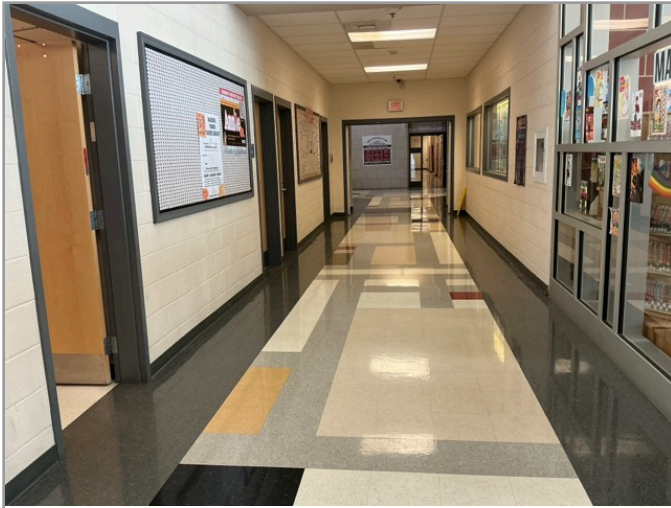
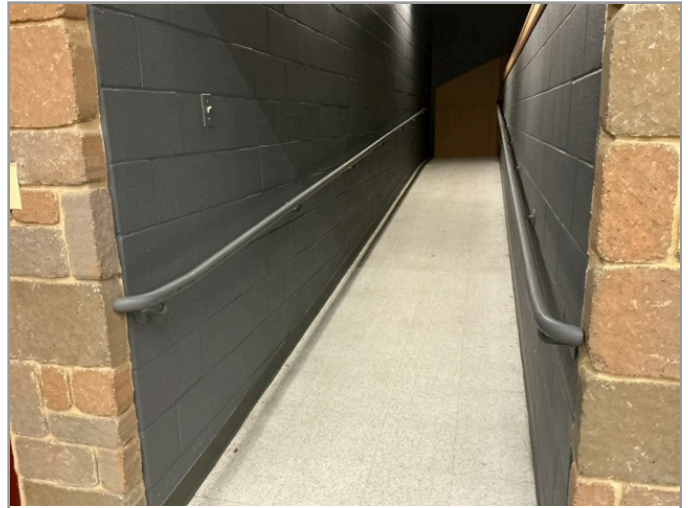
ACCESSIBLE INTERIOR PATH

ACCESSIBLE INTERIOR RAMP

Question		Yes	No	NA	Comments
1	Does an accessible route appear to connect all public areas inside the building ?	X			
2	Do accessible routes appear free of obstructions and/or protruding objects ?	X			
3	Do ramps on accessible routes appear to have compliant slopes ?	X			
4	Do ramp runs on an accessible route appear to have a compliant rise and width ?	X			
5	Do ramps on accessible routes appear to have compliant end and intermediate landings ?	X			
6	Do ramps on accessible routes appear to have compliant handrails ?	X

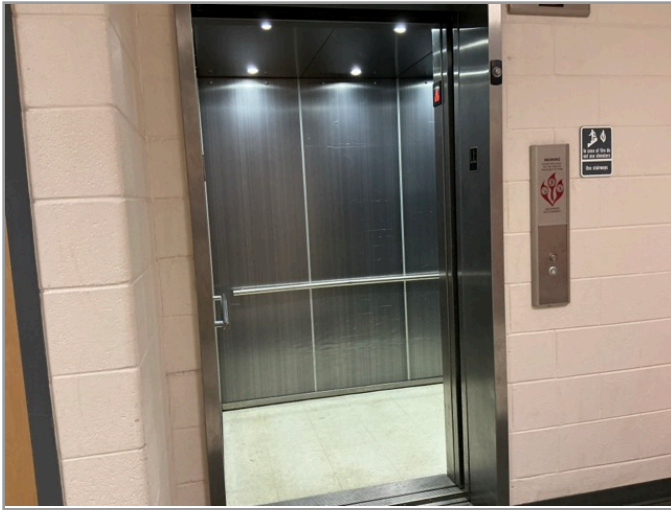
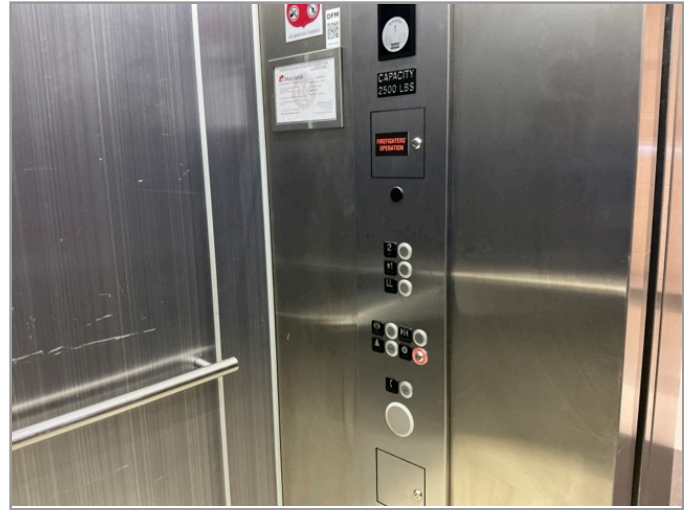
LOBBY LOOKING AT CABS (WITH DOORS OPEN)

IN-CAB CONTROLS

Question		Yes	No	NA	Comments
1	Are hallway call buttons configured with the "UP" button above the "DOWN" button?	✗			
2	Is accessible floor identification signage present on the hoistway sidewalls on each level ?	✗			
3	Do the elevators have audible and visual arrival indicators at the lobby and hallway entrances?	✗			
4	Do the elevator hoistway and car interior appear to have a minimum compliant clear floor area ?	✗			
5	Do the elevator car doors have automatic re-opening devices to prevent closure on obstructions?	✗			
6	Do elevator car control buttons appear to be mounted at a compliant height ?	✗

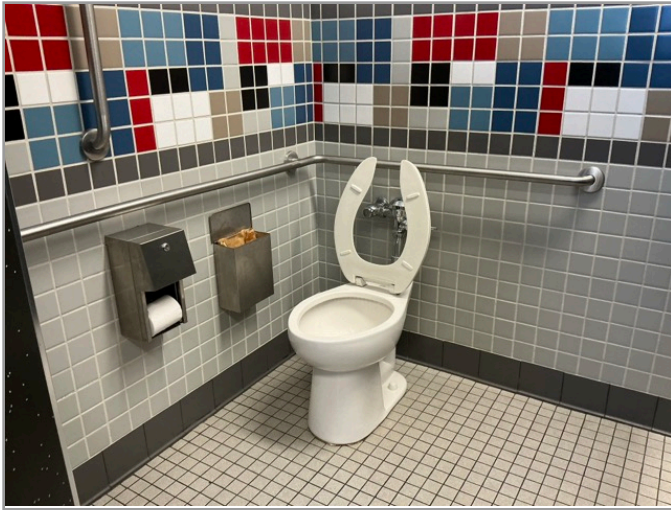
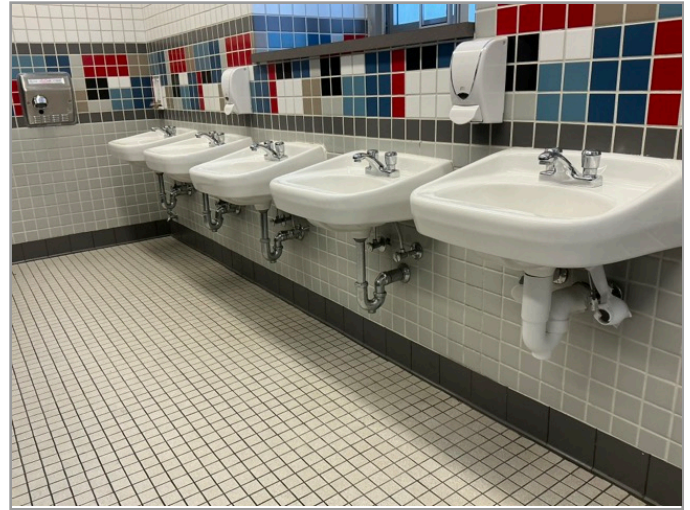
TOILET STALL OVERVIEW

SINK, FAUCET HANDLES AND ACCESSORIES

Question		Yes	No	NA	Comments
1	Do publicly accessible toilet rooms appear to have a minimum compliant floor area ?	✗			
2	Does the lavatory appear to be mounted at a compliant height and with compliant knee area ?	✗			
3	Does the lavatory faucet have compliant handles ?	✗			
4	Is the plumbing piping under lavatories configured to protect against contact ?	✗			
5	Are grab bars provided at compliant locations around the toilet ?	✗			
6	Do toilet stall doors appear to provide the minimum compliant clear width ?	✗
