FACILITY CONDITION ASSESSMENT

Montgomery County Public Schools

Lakelands Park Middle School
1200 Main Street
Gaithersburg, MD 20878

May 26, 2026

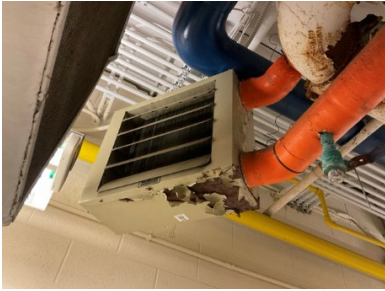
Hydronic
Main Building Lakelands Park Middle School
101E

Unit Heater in Poor condition.

Unit is rusting on the underside resulting in peeling paint and damaged exterior housing. - AssetCALC ID: 10783703

Uniformat Code: D3020
Recommendation: **Replace in 2027**

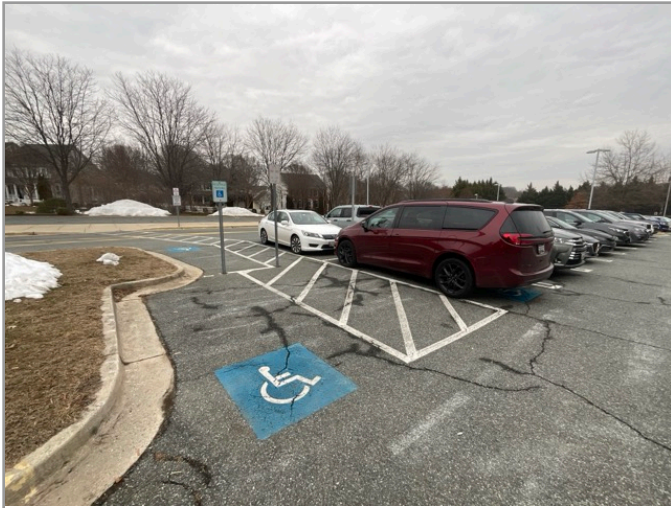
OVERVIEW OF ACCESSIBLE PARKING AREA

Question		Yes	No	NA	Comments
1	Does the required number of standard ADA designated spaces appear to be provided ?	✗			
2	Does the required number of van-accessible designated spaces appear to be provided ?	✗			
3	Are accessible spaces on the shortest accessible route to an accessible building entrance ?	✗			
4	Does parking signage include the International Symbol of Accessibility ?	✗			
5	Does each accessible space have an adjacent access aisle ?	✗			
6	Do parking spaces and access aisles appear to be relatively level and without obstruction ?	✗

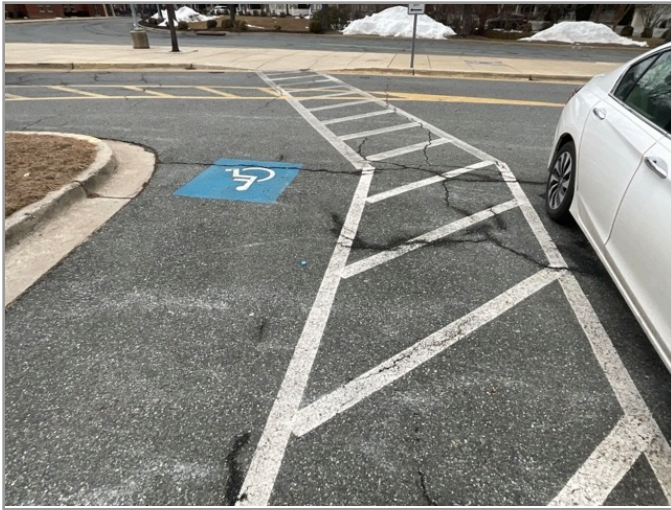
ACCESSIBLE PATH

Question		Yes	No	NA	Comments
1	Is an accessible route present from public transportation stops and municipal sidewalks on or immediately adjacent to the property ?	✗			
2	Does a minimum of one accessible route appear to connect all public areas on the exterior, such as parking and other outdoor amenities, to accessible building entrances ?	✗			
3	Are curb ramps present at transitions through raised curbs on all accessible routes?	✗			
4	Do curb ramps appear to have compliant slopes for all components ?	✗			
5	Do ramp runs on an accessible route appear to have compliant slopes ?	✗			
6	Do ramp runs on an accessible route appear to have a compliant rise and width ?	✗

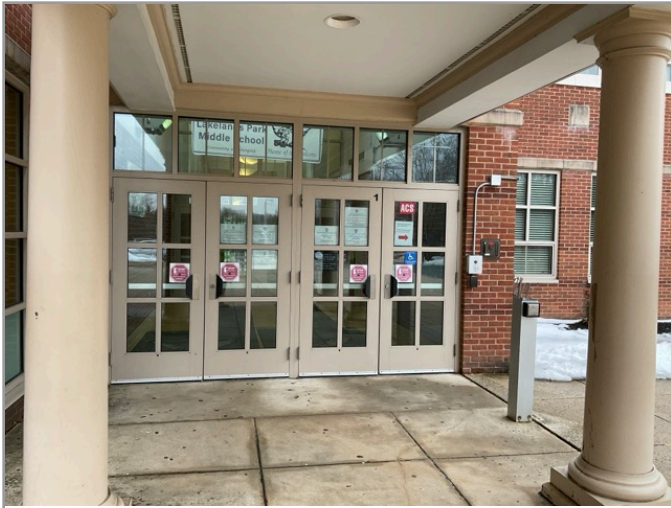
MAIN ENTRANCE

Question		Yes	No	NA	Comments
1	Do a sufficient number of accessible entrances appear to be provided ?	X			
2	If the main entrance is not accessible, is an alternate accessible entrance provided?	X			
3	Is signage provided indicating the location of alternate accessible entrances ?	X			
4	Do doors at accessible entrances appear to have compliant maneuvering clearance area on each side ?	X			
5	Do doors at accessible entrances appear to have compliant hardware ?	X			
6	Do doors at accessible entrances appear to have a compliant clear opening width ?	X

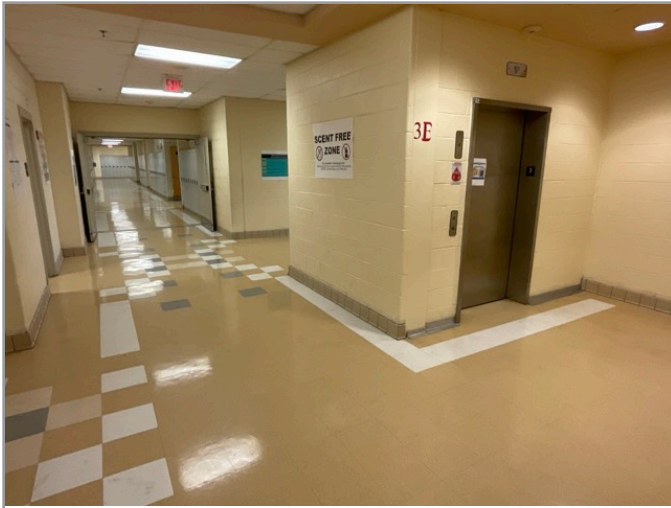
ACCESSIBLE INTERIOR PATH

Question		Yes	No	NA	Comments
1	Does an accessible route appear to connect all public areas inside the building ?	✗			
2	Do accessible routes appear free of obstructions and/or protruding objects ?		✗		
3	Do ramps on accessible routes appear to have compliant slopes ?	✗			
4	Do ramp runs on an accessible route appear to have a compliant rise and width ?	✗			
5	Do ramps on accessible routes appear to have compliant end and intermediate landings ?	✗			
6	Do ramps on accessible routes appear to have compliant handrails ?	✗

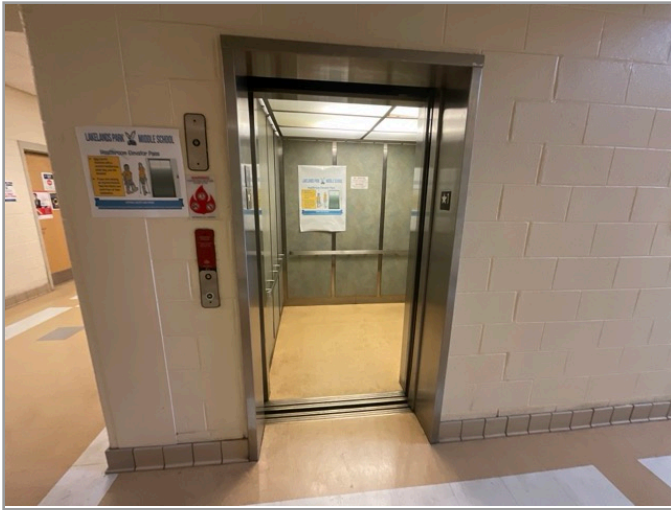
LOBBY LOOKING AT CABS

Question		Yes	No	NA	Comments
1	Are hallway call buttons configured with the "UP" button above the "DOWN" button?	✘			
2	Is accessible floor identification signage present on the hoistway sidewalls on each level ?	✘			
3	Do the elevators have audible and visual arrival indicators at the lobby and hallway entrances?	✘			
4	Do the elevator hoistway and car interior appear to have a minimum compliant clear floor area ?	✘			
5	Do the elevator car doors have automatic re-opening devices to prevent closure on obstructions?	✘			
6	Do elevator car control buttons appear to be mounted at a compliant height ?	✘

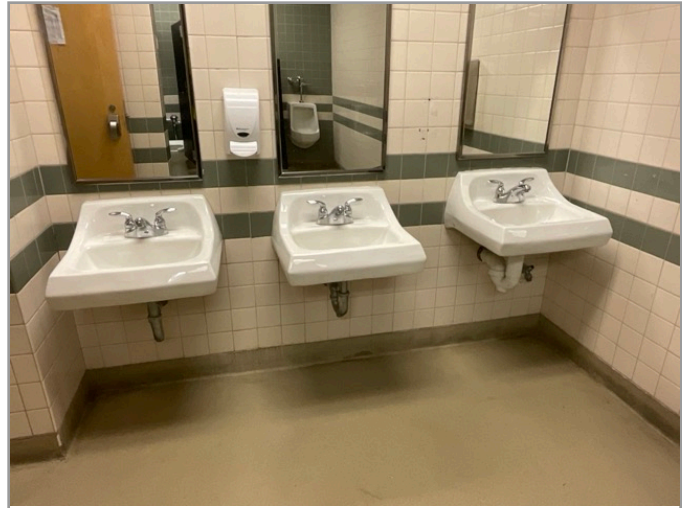
SINK, FAUCET HANDLES AND ACCESSORIES

Question		Yes	No	NA	Comments
1	Do publicly accessible toilet rooms appear to have a minimum compliant floor area ?	✗			
2	Does the lavatory appear to be mounted at a compliant height and with compliant knee area ?	✗			
3	Does the lavatory faucet have compliant handles ?	✗			
4	Is the plumbing piping under lavatories configured to protect against contact ?	✗			
5	Are grab bars provided at compliant locations around the toilet ?	✗			
6	Do toilet stall doors appear to provide the minimum compliant clear width ?	✗
