# FACILITY CONDITION ASSESSMENT

**Montgomery County Public Schools**  
45 West Gude Drive, Suite 4000  
Rockville, MD 20850

Shady Grove Middle School  
8100 Midcounty Highway  
Gaithersburg, MD 20877

May 11, 2026

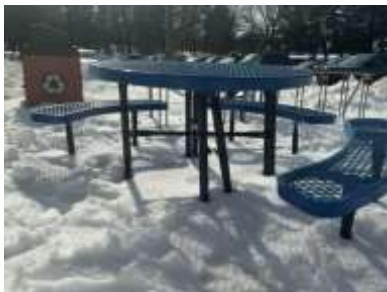
#### Picnic Table in Poor condition.

Metal Powder-Coated  
Site Shady Grove Middle School Site

Leg broken on table - AssetCALC ID: 10308762

Uniformat Code: G2060  
Recommendation: **Replace in 2026**

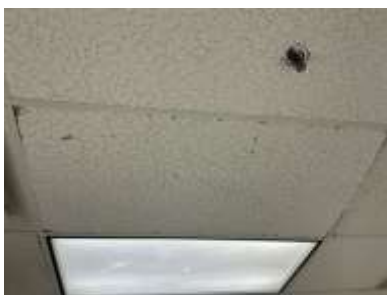
#### Suspended Ceilings in Poor condition.

Acoustical Tile (ACT)  
Main Building Shady Grove Middle School  
Throughout Building

Damaged tiles in various locations - AssetCALC ID: 10308613

Uniformat Code: C1070  
Recommendation: **Replace in 2027**
