FACILITY CONDITION ASSESSMENT

Montgomery County Public Schools
45 West Gude Drive, Suite 4000
Rockville, MD 20850

Julius West Middle School
651 Great Falls Road
Rockville, MD 20850

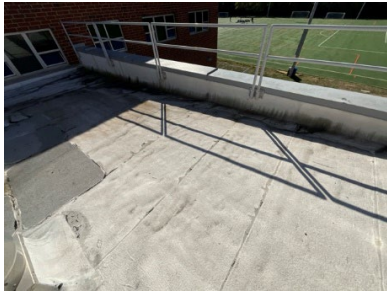
Roofing in Poor Condition.

Modified Bitumen
Julius West Middle School
Roof above Auxiliary Gymnasium

Roof above auxiliary gym has crunchy portions where it appears the finish is bubbling up. - AssetCALC ID: 10027689

Uniformat Code: B3010
Recommendation: **Replace in 2027**

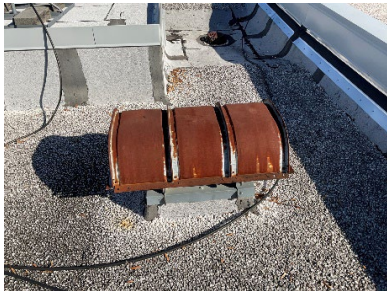
Exhaust Fan in Poor Condition.

Roof or Wall-Mounted, 10" Damper
Julius West Middle School
Roof

Fan housing is heavily corroded. - AssetCALC ID: 10027807

Uniformat Code: D3060
Recommendation: **Replace in 2027**

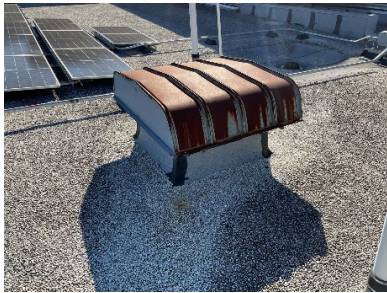
Exhaust Fan in Poor Condition.

Roof or Wall-Mounted, 16" Damper
Julius West Middle School
Roof

Fan housing is heavily corroded. - AssetCALC ID: 10027770

Uniformat Code: D3060
Recommendation: **Replace in 2027**

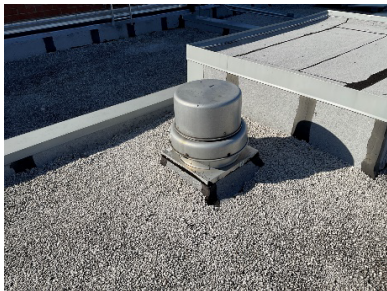
Exhaust Fan in Poor Condition.

Roof or Wall-Mounted, 12" Damper
Julius West Middle School
Roof

Fan making loud clicking noises. - AssetCALC ID: 10027663

Uniformat Code: D3060
Recommendation: **Replace in 2027**

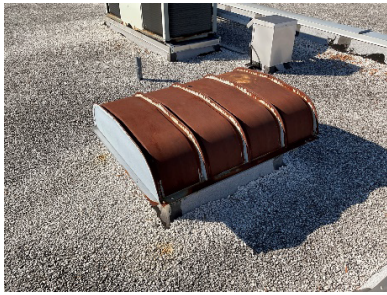
Exhaust Fan in Poor Condition.

Roof or Wall-Mounted, 24" Damper
Julius West Middle School
Roof

Fan housing is heavily corroded. - AssetCALC ID: 10027692

Uniformat Code: D3060
Recommendation: **Replace in 2027**

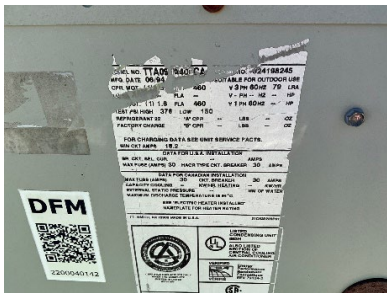
Split System in Poor Condition.

Condensing Unit, 6 to 7.5 TON
Julius West Middle School
Roof

Unit is corroded, exceedingly aged, and uses R22 refrigerant. - AssetCALC ID: 10027660

Uniformat Code: D3030
Recommendation: **Replace in 2026**

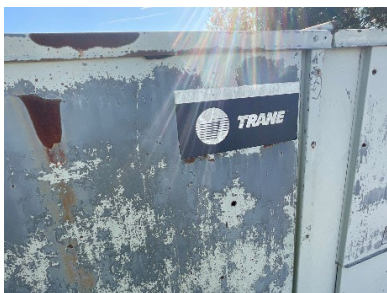
Packaged Unit in Poor Condition.

RTU, Pad or Roof-Mounted
Julius West Middle School
Roof

Unit is corroded and worn on the exterior. - AssetCALC ID: 10027606

Uniformat Code: D3050
Recommendation: **Replace in 2027**

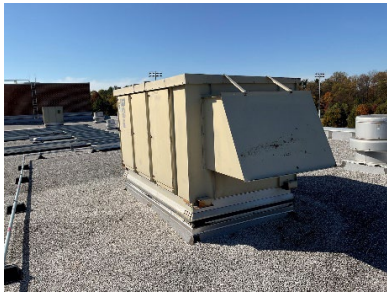
Make-Up Air Unit in Poor Condition.

MUA or MAU, 2000 to 6000 CFM
Julius West Middle School
Roof

Unit is corroded and weathered. - AssetCALC ID: 10027665

Uniformat Code: D3050
Recommendation: **Replace in 2027**

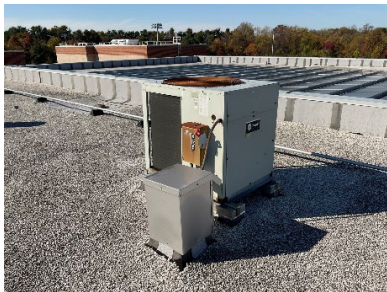
Split System in Poor Condition.

Condensing Unit/Heat Pump
Julius West Middle School
Roof

Unit is corroded on the exterior and is aged well beyond its expected useful lifespan - AssetCALC ID: 10027681

Uniformat Code: D3030
Recommendation: **Replace in 2027**

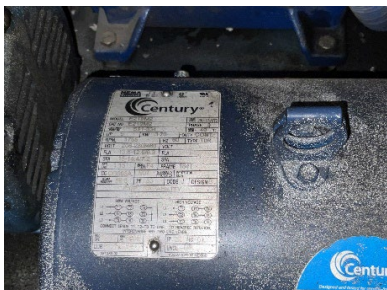
Air Compressor in Poor Condition.

Tank-Style
Julius West Middle School
05 Old Boiler Room

Compressor is extremely loud and was noted by POC as having issues with its functionality. - AssetCALC ID: 10027652

Uniformat Code: D2060
Recommendation: **Replace in 2027**
